Rehabilitation of Schools Damaged by Earthquake in Kraljevo on Sept.3th,2010

Zoran Petraskovich 1, Jasminka Petraskovich Dzuklevski 2

Over forty schools are analyzed and solutions of seismic rehabilitation are given by technology of System DC90. Masonry schools up to four floors and reinforced concrete skeletal structures are analyzed. The paper shows way of researching, technology design and the work carrying out technology. Shows the technologic and design solutions for strengthening the walls, for stiffening the ceilings, for joining ceilings with walls, for vertical prestressing of the walls and the interconnection of the walls. The technology is especially effective on a mass repair of masonry structures with aspect to the level of safety, cost and schedule.

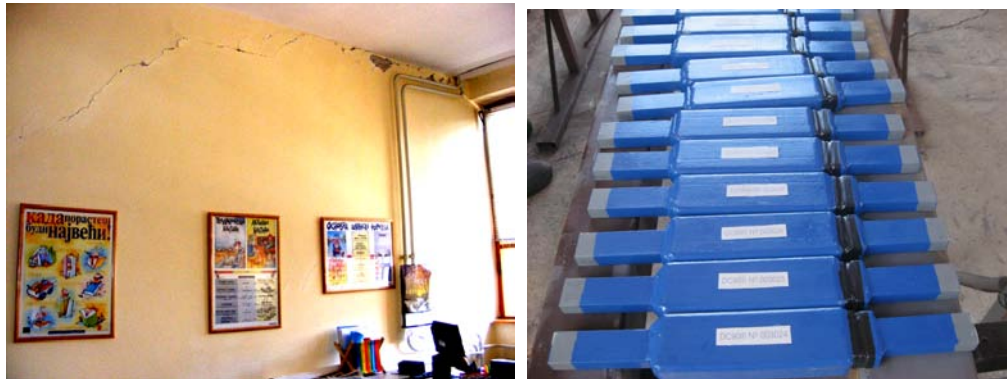
Presentation of existing damage on the structure: photo and description, with particular reference on damage on the basic structural system. The extensive photo documentation shows that the secondary-wall systems suffered significant damage. The damage was due to the large deformability of the system, especially in the transverse direction. Poor quality of concrete walls and large distance to stiffening of concrete in the building length of 60 m caused significant damage to the walls between classrooms. Deformation in the transverse direction exceeds the permissible deformation of reinforced concrete skeletal systems.

At figure.1. is shown wall with damages

Figure 1. Characteristic Damages and Dampers

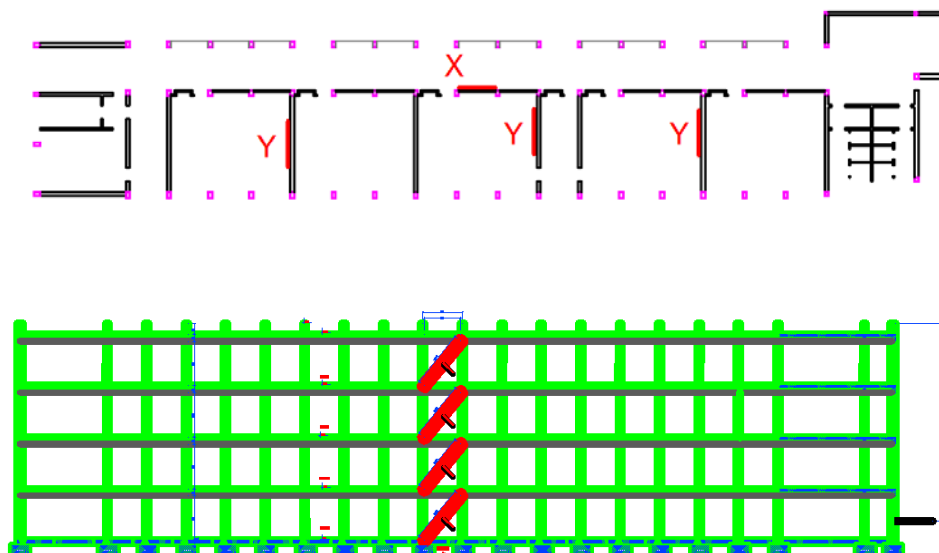
Figure 2 Disposition and Shape of vertical Stiffeners at X direction

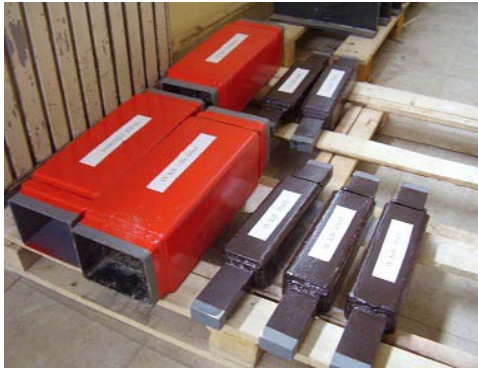
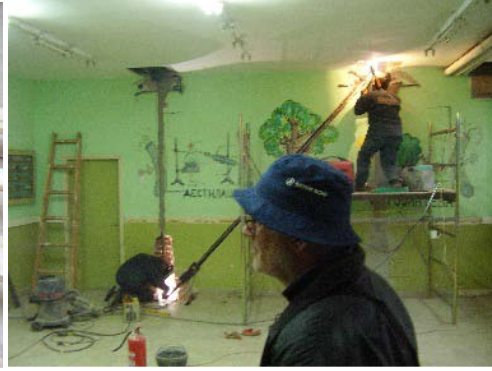
Figure 3. Part of Delivered Equipment-Dampers

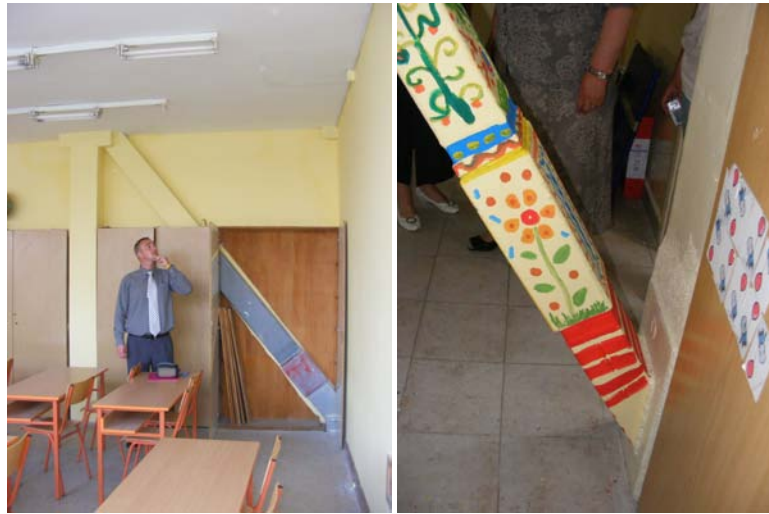
Figure 5. Vertical stiffening in longitudinal Y-direction diagonal square cross-section 260x160x7 with damper. Force in damper +- 1100 kN, displacement +-5mm.

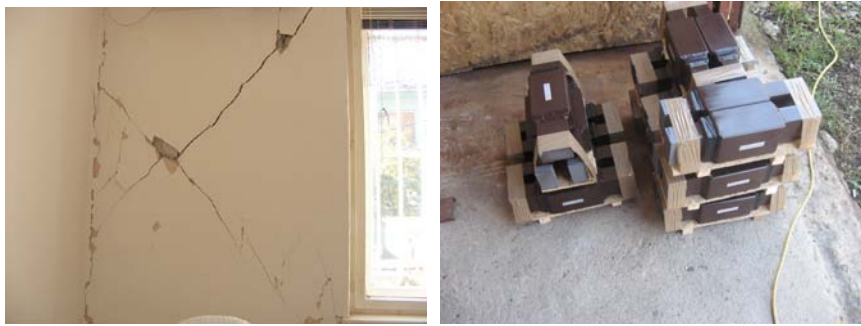
Figure 7. Characteristic Damages, X cracks, and Dampers

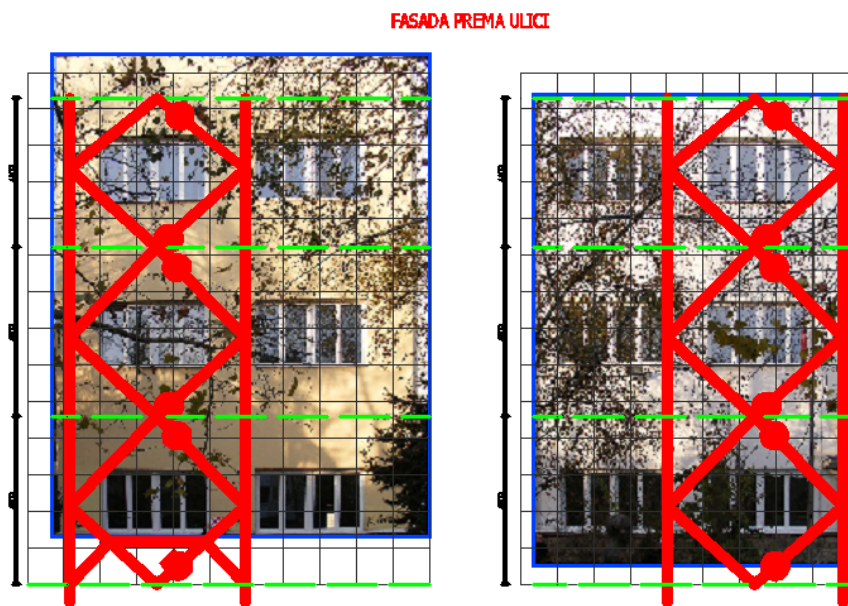
Figure 9. Shape of Stiffeners

At figure 9. shows the ortho-photo shot of the facade with marked vertical stiffeners. The building is damaged badly with crossed diagonal cracks between the windows.

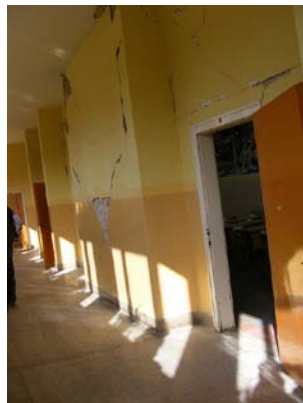
The old part was made of masonry construction with reinforced concrete corners around windows, with a partition wall in the hallway made of brick at side. The wall is unstable and the ground and first floor are not allowed for use until rehabilitation. The pillars are made of brick. The inner columns were badly damaged and degraded.

Figure 10. Characteristic Damages

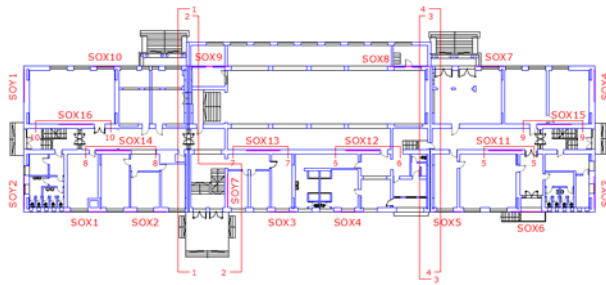
Figure 12. Disposition Stiffeners

The school consists of three constructional parts separated with dilatations. Objects previously strengthened with concrete in the transverse direction. The perceived need for longitudinal reinforcement capacity of facade walls. During the period of observation it was observed a progressive increase in cracks in walls, particularly in the facade of the wall space between windows.

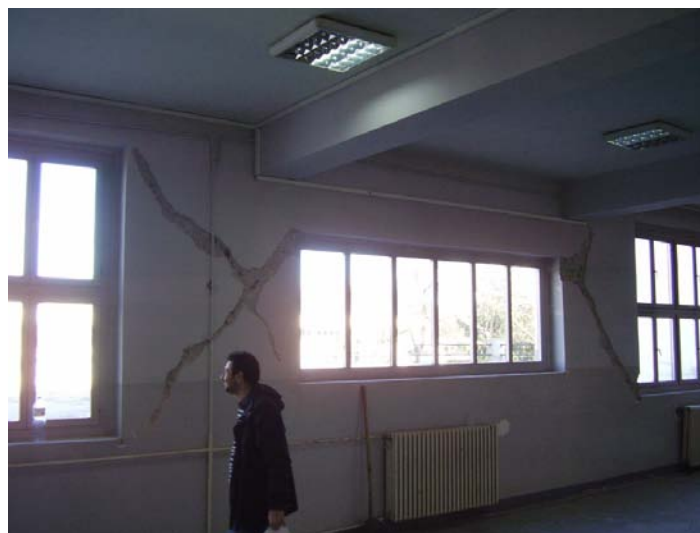
Figure 17. Characteristic Damages

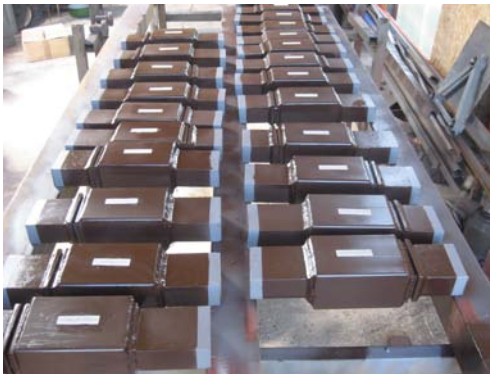
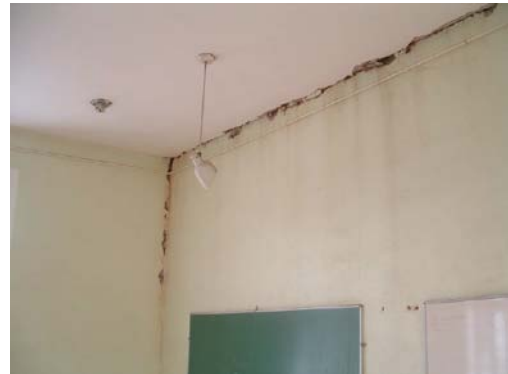
Figure 20. Characteristic Damages and Dampers

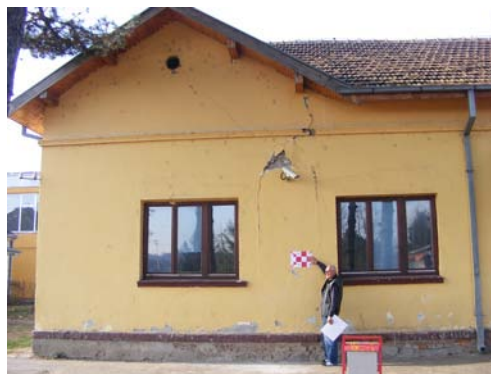
Figure 23Figure 20. Characteristic Damages

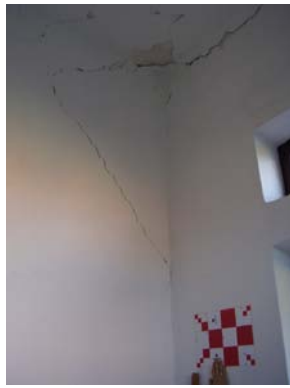
Figure 31. Characteristic Damages

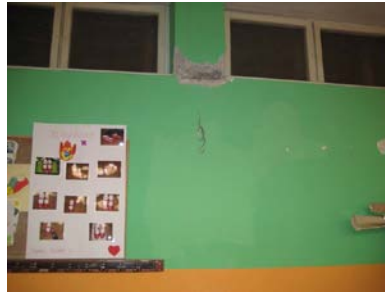
Figure 34. Characteristic Damages

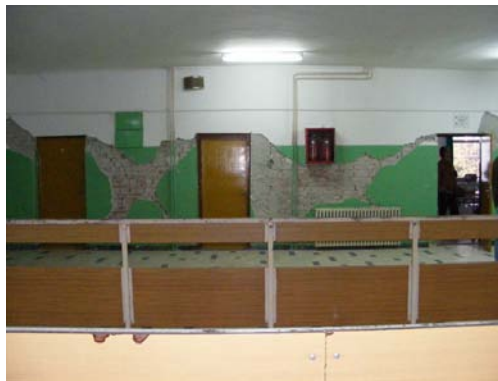
Figure 37. Characteristic Damages

Soft frame reinforced concrete structures has caused large damage on the walls. Vertical oscillations are heavily damaged consoles 3000 mm in length.
