A case study on structural assessment and restoration of King Zog's villa in Durres, Albania

Kujtime Barushi¹, Enea Mustafaraj²

Abstract

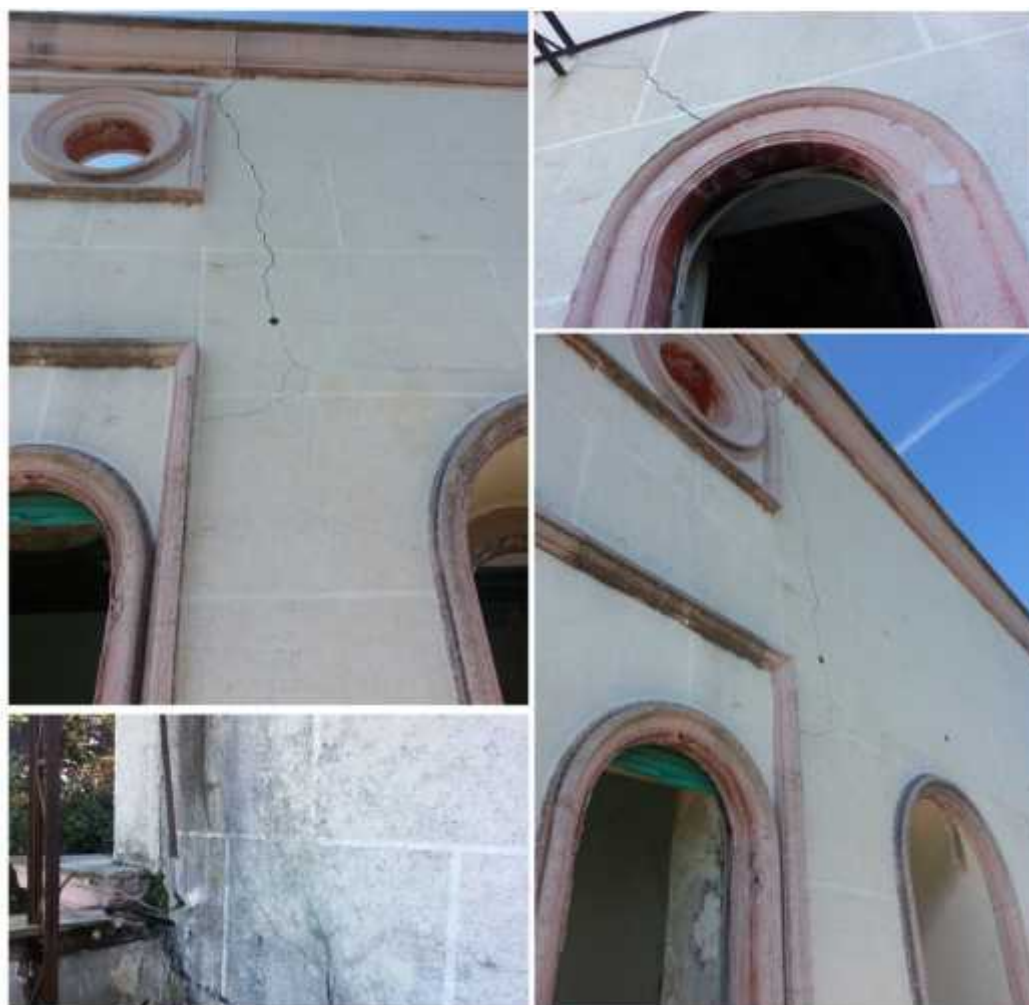
After the inspection it was observed that the structural conditions of the villa are adequate to carry static loads. However, several problems were observed. In the south facade, due to differential settlements vertical diagonal cracks are seen (Figure). These cracks extend along the facade.

Figure 4. Cracks due to settlements

From the assessment point of view, it can be concluded that the King Zog's villa's structural conditions are adequate to carry static loads. However, due to some differential settlements, cracks are observed in the south façade. If left in these conditions, crack propagation during time is inevitable.

The villa is not functional. A detailed restoration project should be conducted preserving the actual materials as much as possible.

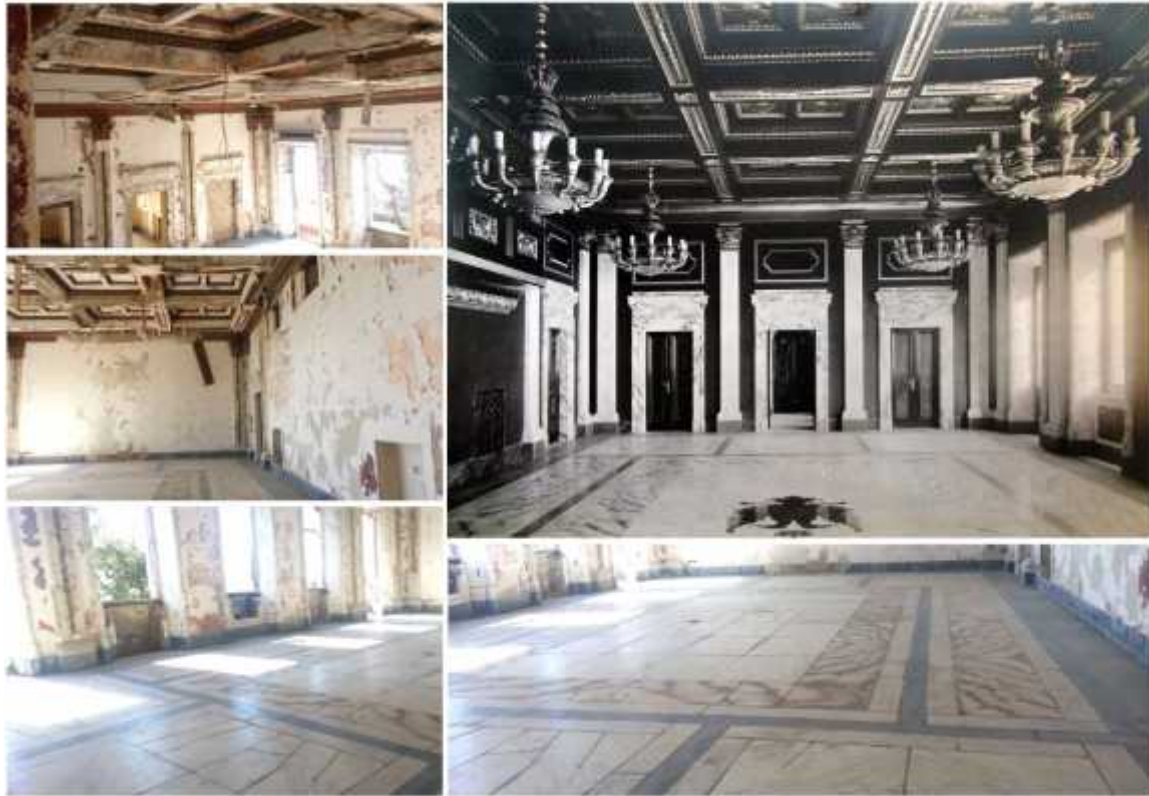
In the current conditions the villa is not functional. There are windows and doors missing (Figure 4). The interior of villa is damaged. Due to improper maintenance, the plaster and render are removed in almost all the rooms (Figure 5,6,7).

Figure 5. Comparison of current conditions and the time when it was built (top right figure)

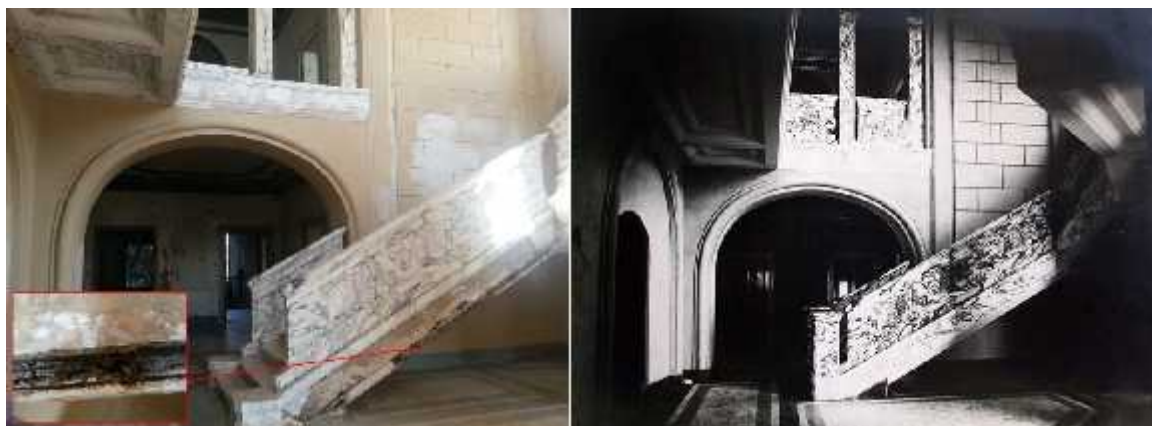
Figure 6. Comparison of current conditions (left) and the time when it was built (right)

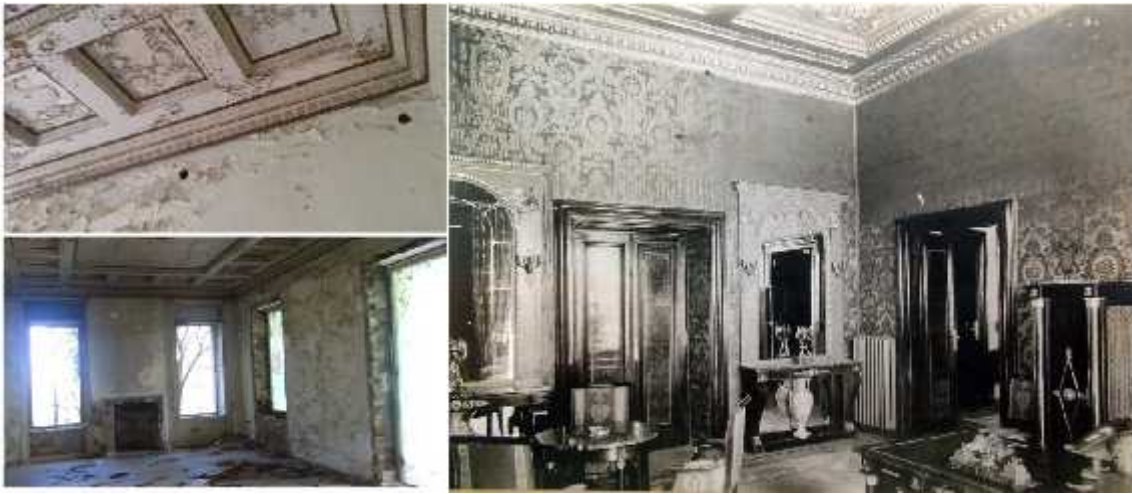
Figure 7. Comparison of current conditions and the time when it was built (right)
