Structural assessment of historical buildings: a case study of five Ottoman Mosques in Albania

Enea Mustafaraj

Department of Civil Engineering, Epoka University, Albania

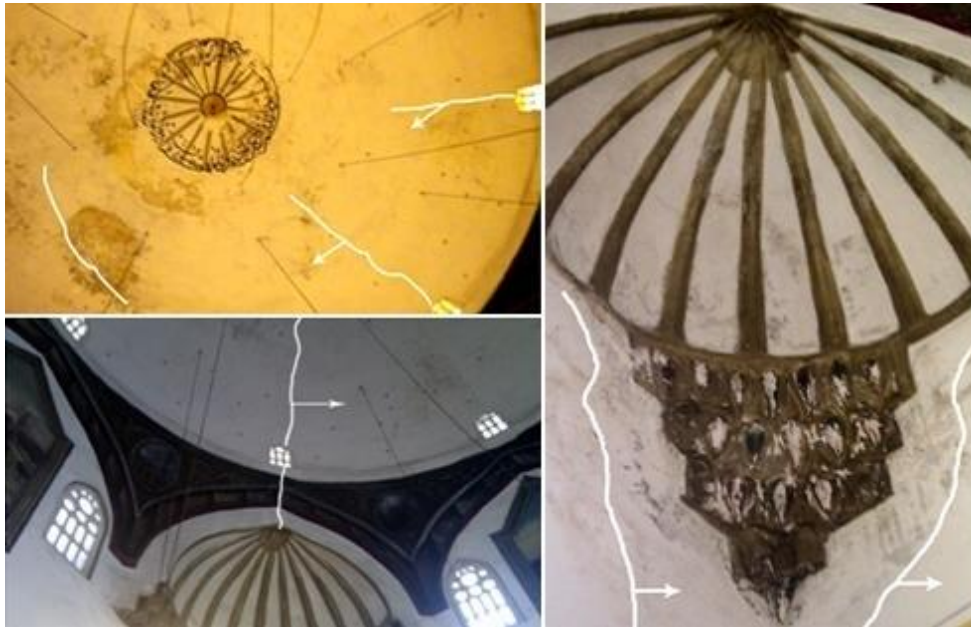
Structural conditions of the roof system of Mirahor Ilyas Beg Mosque in Korça seem adequate to carry static loads. However, there are found many structural cracks. Improper connection of the lanterns hanged at the top of the ceiling, in a later time after the dome was built, has caused extra local stress concentrations causing cracks around the connections (Figure 2).

Other structural cracks may have been caused by earthquake loads. Improper isolation of the roof system, high level of air humidity, leakage and penetration of rainwater inside the structure has caused dark moisture spots in the interior of the mosque.

Spall of plaster can be seen in some zones. There are also found cracks related to the old age of the building and amortization during time. Pendentives and arches suffer from the same problems. Thrust transferred from the dome loads may have exceeded their load carrying capacity.

Figure 2. Cracks in the interior of the dome and pendentives in Mirahor Ilyas Beg Mosque

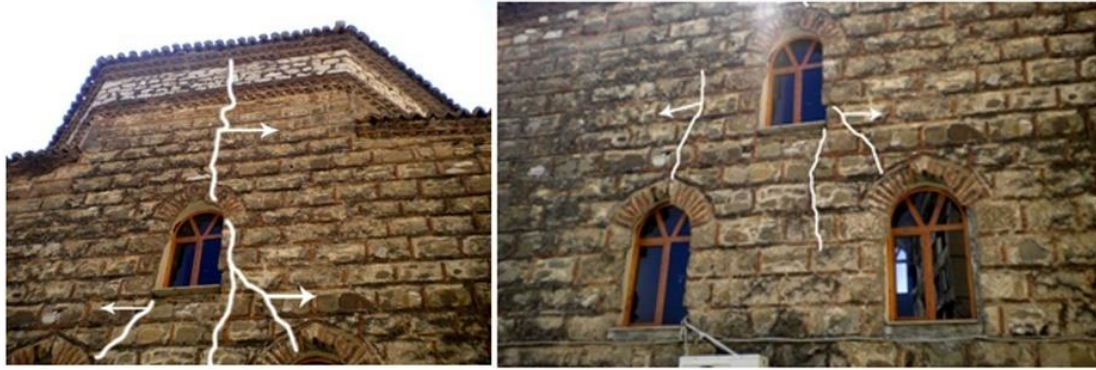
In the load bearing walls of the Naziresha's Mosque serious cracks are present in all façades. Most of the cracks inferred from the damage survey presented a diagonal and vertical trend. Creep of the masonry units is believed to be the cause of vertical parallel cracks which eventually may lead to collapse of the wall. This phenomenon is accompanied by occurrence of chipping and possible local failure. This is very obvious in the north façade where there are massive cracks whose cause is believed to be improper modification of the entrance. Vegetation growth can be seen where masonry units are missing. At the bottom of the walls, due to consequent flooding, sanding phenomenon is seen. There are found voids that grow bigger in time. Crack propagation from pendentives to the load bearing walls is observed in all four façades. In the places where openings are present, a different crack pattern can be seen. Tensile and shear stresses are concentrated close to the edges of these openings possibly due to local concentration of loadings. As a result, every window is cracked at the bottom corners of its frames (Figure 3).

Furthermore, cracks due to differential settlement and suffusion (migration of soil particles through soil skeleton) phenomenon are observed. Hair cracks (small cracks) are seen in the interior of the walls. Further cracks cannot be seen due to local works of rebuilding in the interior of the mosque. However traces of the mentioned cracks of the exterior can be spotted if carefully checked. Based on the problems mentioned above, there is a very concerning situation about structural stability of this mosque.

Figure 3. Propagation of cracks in the load bearing walls, west façade of Naziresha's Mosque

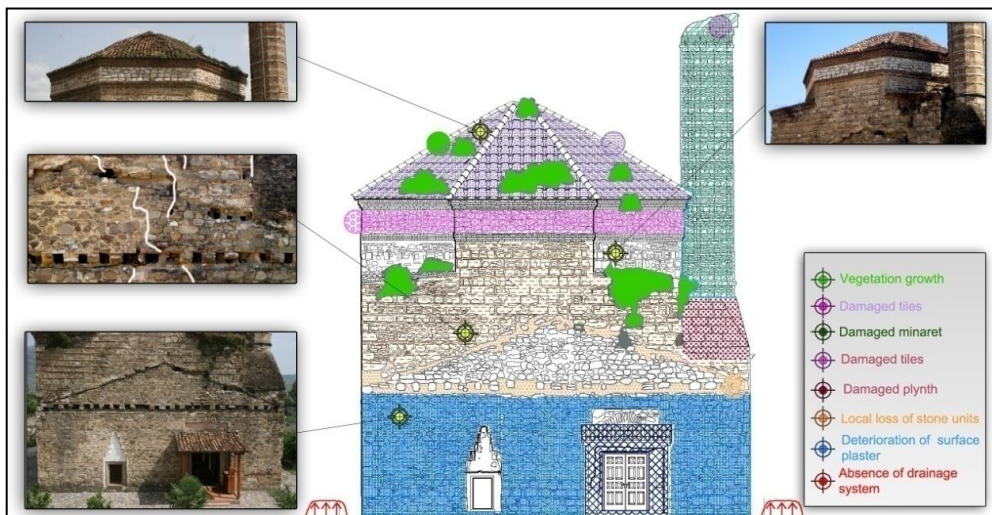
Figure 4. Inspection of structural problems of Naziresha's Mosque

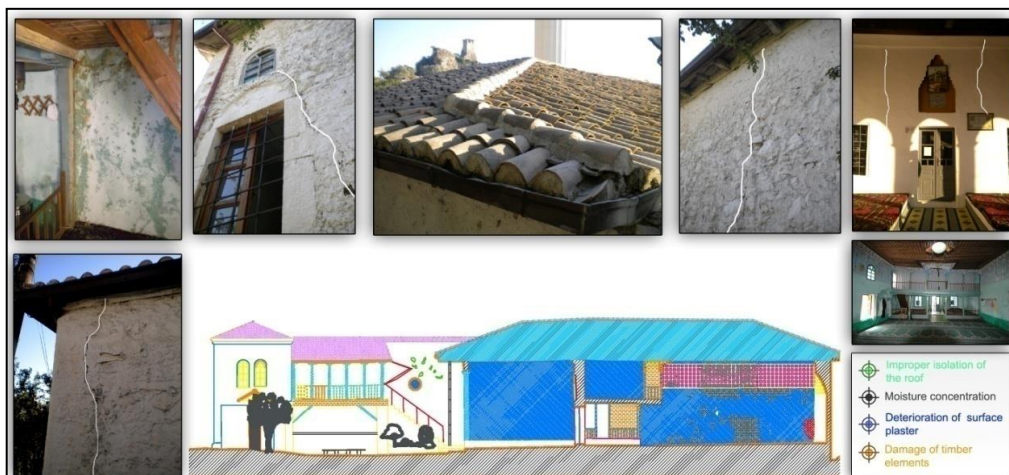
Figure 5. Inspection of structural problems of Murat Beg Mosque

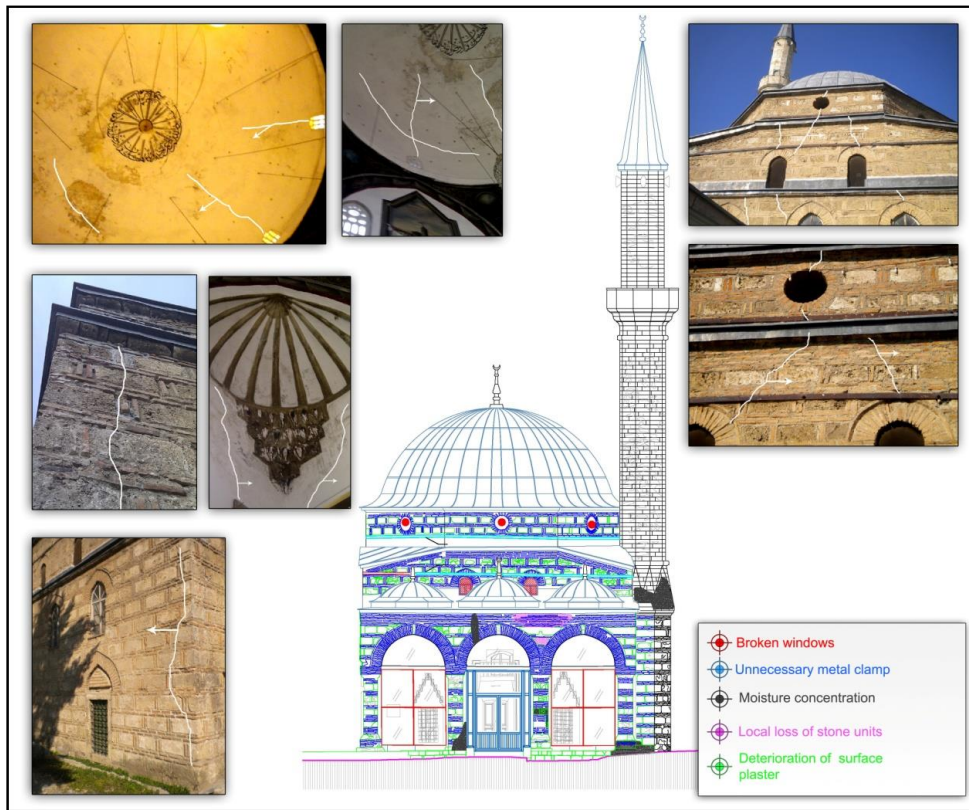
Figure 6. Inspection of structural problems of Mirahor Ilyas Beg Mosque

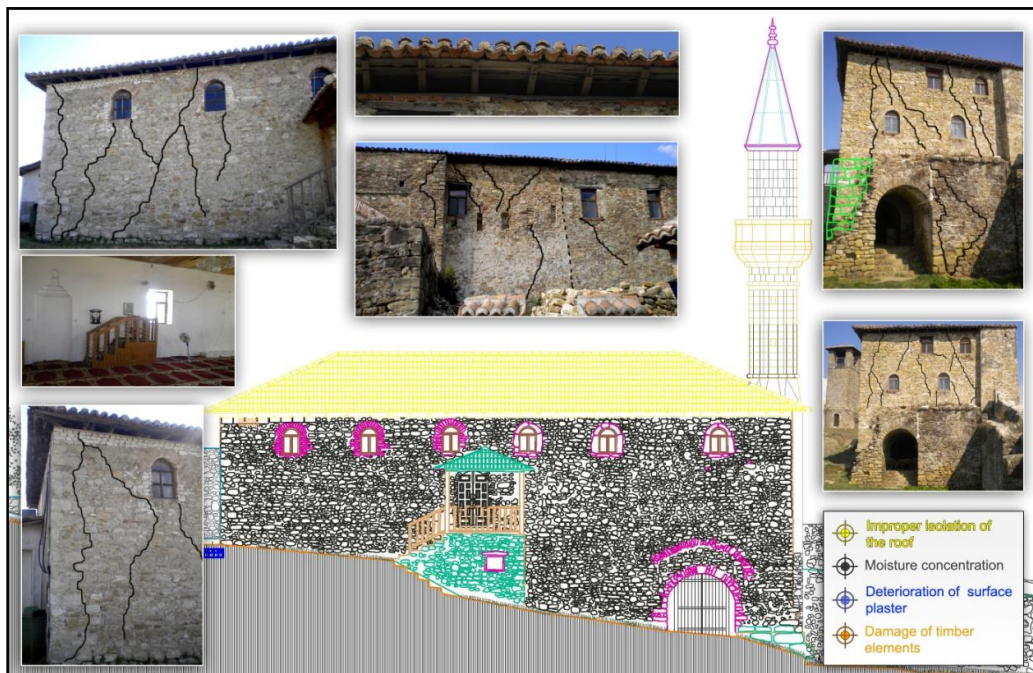
Figure 7. Inspection of structural problems of Mosque of Preza.

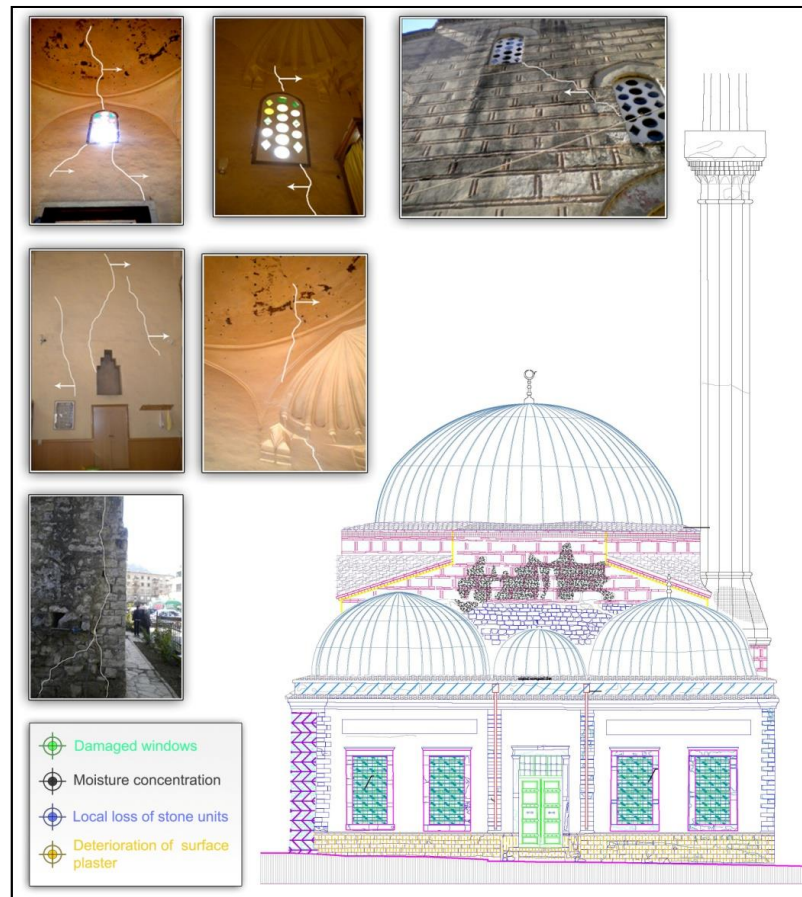
Figure 8. Inspection of structural problems of Leaden Mosque
