## Conditional assessment of Kiri Bridge in Shkoder, Albania

### ABSTRACT

The Kiri bridge is located 1 km in north-west of Shkoder city and it is the only connection for the city of Shkoder and the Vau i Dejes hydropower station. It is a reinforced concrete bridge with 8 spans, 2 sidewalks and steels parapets on both sides.

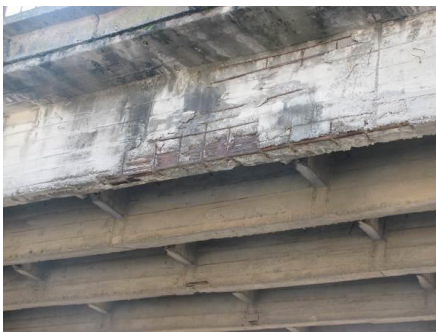
The results from the inspection showed that spalling has occurred in some parts of the concrete as a due to slipping of the structure from its supports. As it can be seen from the figures (Figure 6,7), this phenomenon is more emphasized at the ends of the beams, where the beams have slipped over the bearing shelves or over the abutments. No spalling of the structural elements was detected to have been caused by overstressed compressed concrete or by the corrosion expansion.

Figure 6. Spall of concrete

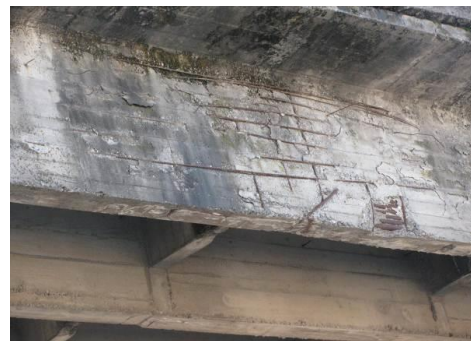
Figure 7. Spall of concrete.

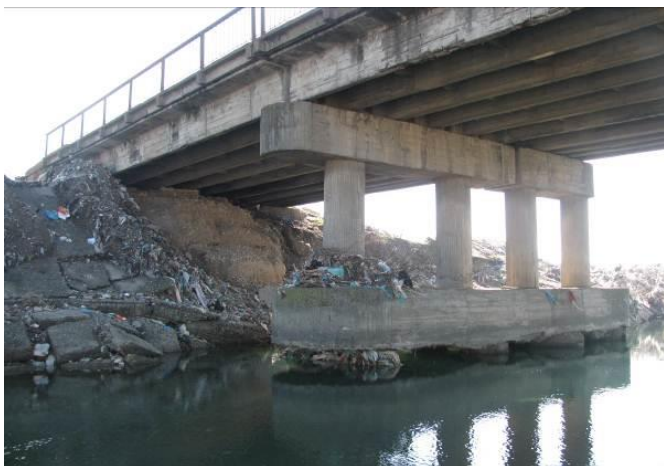
Figure 8.

The inspection team searched for cracks all over the superstructure of the bridge. There were detected different cracks in the upper part of the abutments as well as the presence of some horizontal cracks related to additional normal end shear stresses in the concrete elements caused by horizontal forces applied on the top of the abutments due to friction between superstructure and the support and, later on, applied also on the ballast wall by beam's ends when the ballast wall blocked the displacements of free ends of the superstructure preventing further slipping of them over the bearing shelves. The horizontal forces were result of additional earth pressure produced by the landslide. There are two other major wide cracks on the left abutment (Figure 8,9). Both of them are a consequence of the forces induced to the bearing shelf by the beams during the rotation of the superstructure around its central vertical axis as the result of the direction of the earth pressure caused by the landslide.

The crack openings are relatively wide (less than 1cm) and, apart from the possibility of damage of the concrete during the winter, there may be no further effects on the stability and bearing capacity of the structure. Because the abutment resists a compressive load, the cracks mentioned above will tend to close when they will be resisting bigger loads.

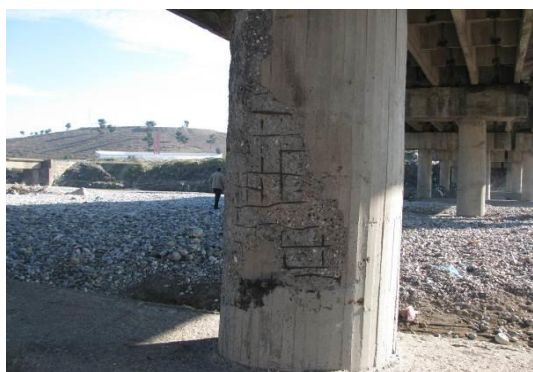
The water-flow mixed with the solid materials produced by the waterway of the bridge has caused the erosion of the concrete at the basement of the abutment and pile as well as the concrete of the abutment itself. Although this kind of damage does not appear to be seriously affecting the stability of the bridge, a long term solution should be found for the new bridge to be built.

Figure 9. Damage of the column

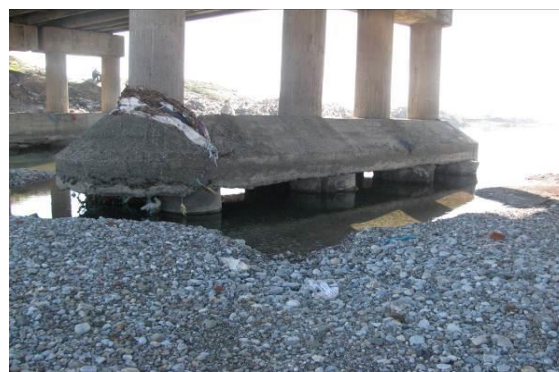
Figure 10. Damage of the piles
