## Effect of errors on execution and design of key details in the object

Alush Shala<sup>1</sup>, Jelena Bleziffer<sup>2</sup>

### ABSTRACT

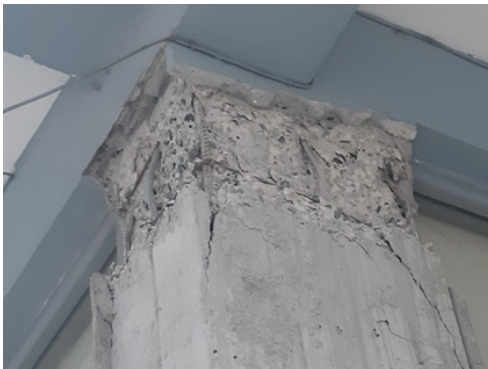
Photo 1

Following we will present the defects presented by the thick layer of plaster which is a problem in itself during the action of dynamic seismic impact. In photos 1 & 3 we have cracks which are due to adequate sampling of the plastering layer, exceeding the optimal layers without the use of reinforcement additives, such as reinforcement meshes, FRP or other connecting additives. Whereas in photo 4 we have cracks instead of continuing the superstructure. In this sequence the connection is not treated properly using materials which accept the eventual stretching forces from dynamic impacts.

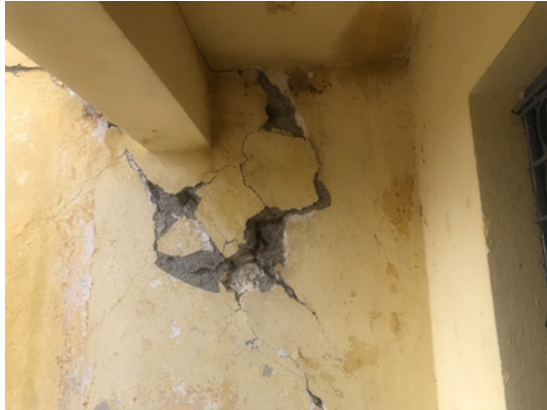
Photo 5

There were also cases of buildings built in 1990-2000 where the beam was supported on the wall and had no connecting strip, which moved it towards the longitudinal axis of the beam as in photo 5.

Another error encountered in the design phase is presented in photo 5, where we have the support of the beam in the wall and it is not connected to a beam in the walls of the building. Here is its displacement from the support in the direction of the longitudinal axis of the beam. In seismic areas it is advisable to provide staggering beams to have a better connection of them. In figure 4 we will present one of the appropriate ways of execution, while figure 3 shows the way executed as in photo 5. The object is built in 1995 and it is not of a high floor to present such damages that it has gone into total collapse.

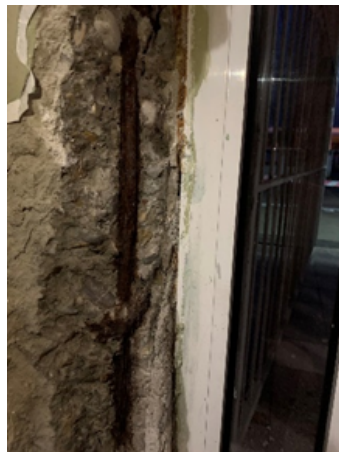
Photo 7

The damages were evident from the age and the absorption of moisture and as consequence there was the corrosion of the reinforcement as in picture 7. From the corrosion of the reinforcement, we have an increase in diameter which with the action of additional earthquake forces has led to the appearance of damages and cracks.

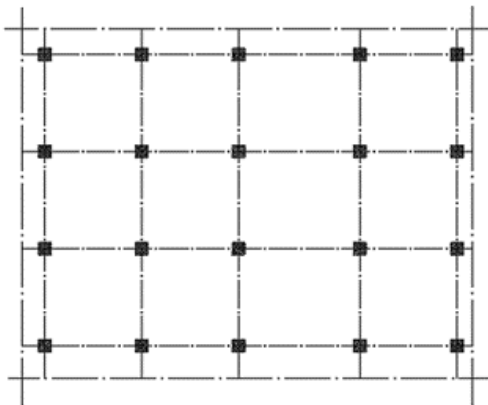
Figure .1 Not good solution, Soft floor

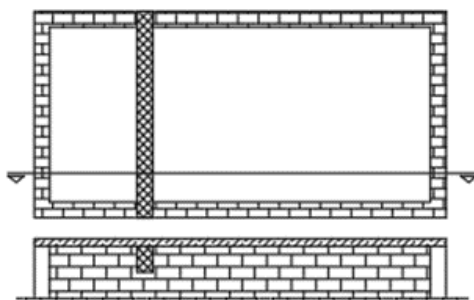
Figure 3. Executed way in photo 5

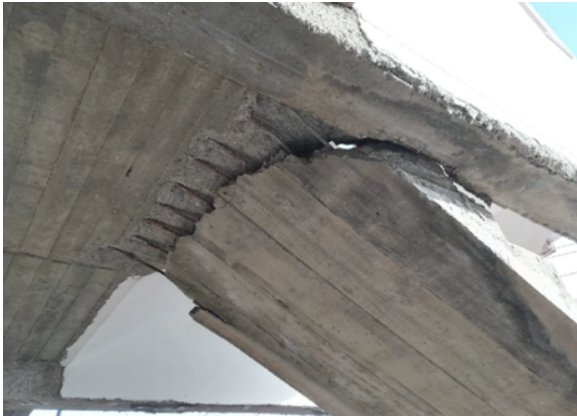
Another error during the design, supervision or execution that we have encountered will be presented in photo 9. In this photo we have the error of connecting the stairs with the floor slab or beam. Such an error is often encountered in our projects but also in execution not according to the detail design which is a serious omission of the supervisor of works.

Photo 7. Wrong ladder support

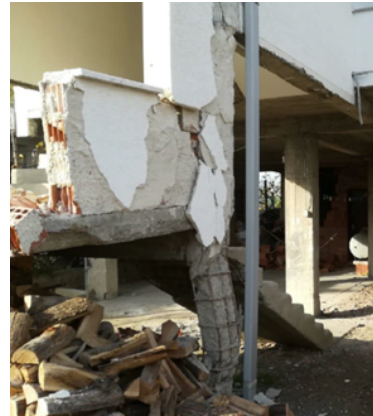
Photo 8. Short element ladder support

In picture 10 we have the creation of the short element in the column which is a mistake when designing the stair support. Always in seismic areas we must eliminate such elements by creating stairwells for and walls to support the stairs in the area between floors.

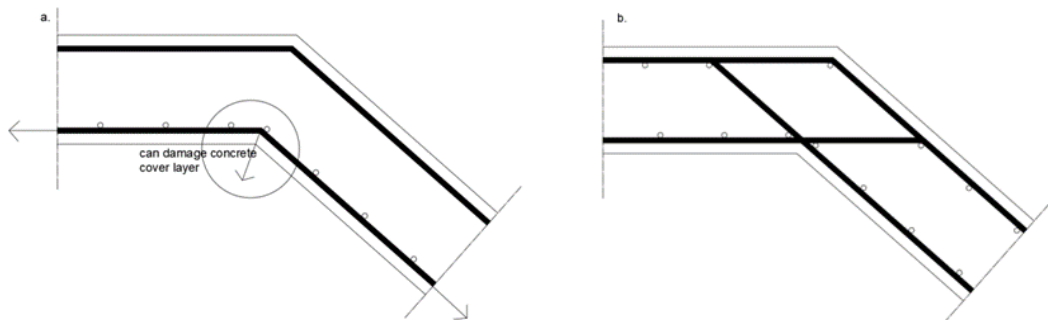
Figure 9. a. Wrong reinforced support, b. Right reinforcement support.
