Structural assessment of the south-west wing timber roofs of the Loreta in Prague

Bledian Nela¹, Jiří Bláha²

ABSTRACT

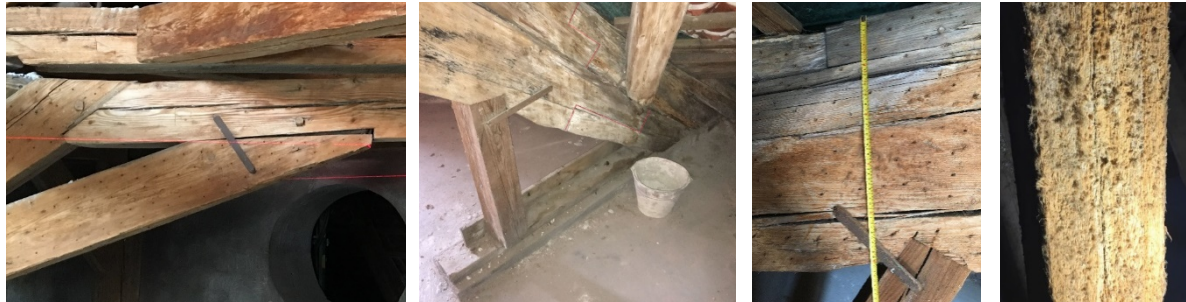
Following UNI-LEGNO [4], a visual inspection was carried out in the southern part of the west wing. The structural timber elements were classified into classes, namely S1, S2 and S3 and according to [4] are obtained the mechanical parameters. The authentic joint connections of the structural timber elements are carpentry joints with some minor late modifications. There are not many archival reports on the past interventions carried out in the roof therefore many statements are made from observation only. Strengthening short columns are seen to reinforce the lower ends of the roof rafters, which are connected to an embedded timber beam on the concrete floor (Figure). Additionally, small diameter holes are seen in the majority of the timber elements which can be due to the injections as a manner of protection against insects (Figure). Furthermore, fireproofing is identified in some elements and metal connectors are detected

in some other as measures of joint reinforcement (Figure 4). Afterwards, in order to perform the timber grading as per [4] the features examined were the wane, growth rate, knots, slope of grains, fissures and other geometric features. The final class found for the timber elements as per these norms was found to be S1 leaning towards S2. This classification gives a range of values to be further assessed and verified with other tests.

Figure 4. Characteristic features on the elements from the visual inspection;

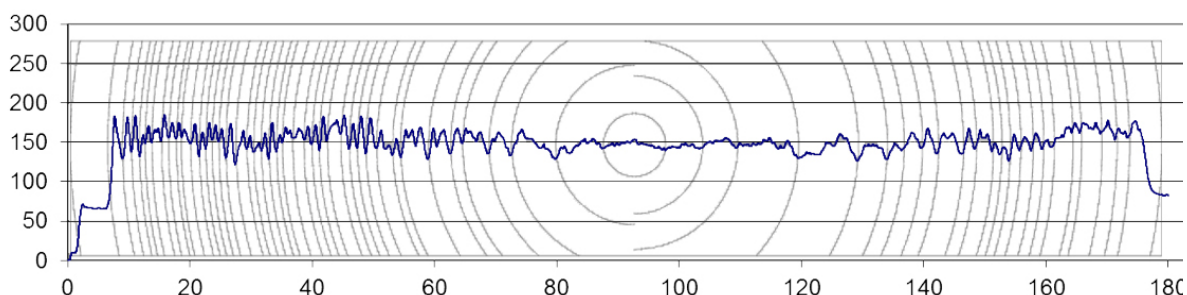
From the output profile of the timber cross-section the damage and decays were able to be observed. Furthermore, following the peaks of the resistances in the results from the Resistograph the rings of the tree are constructed hypothetically and utilized for the qualitative categorization of the element. An example can be seen in Figure 5.

Figure 513. Ring trees and possible damage obtained from resistance microdrilling;

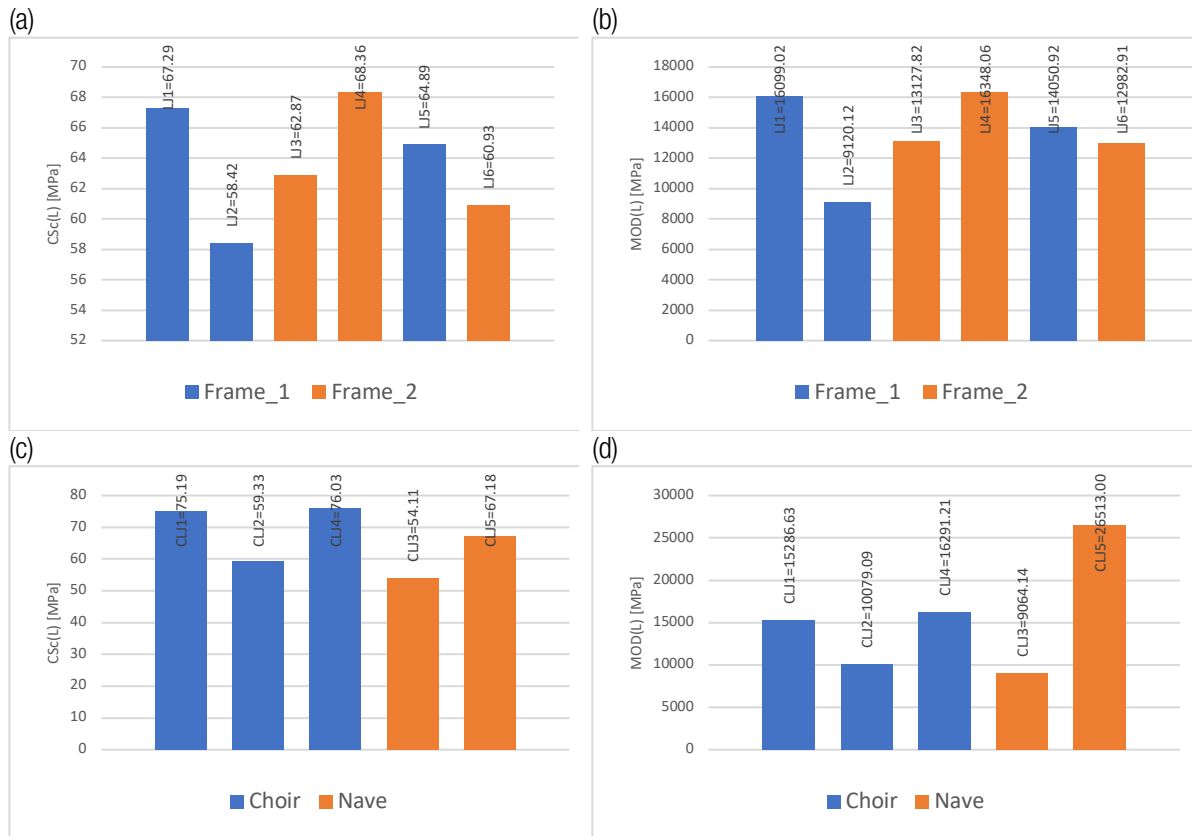
Kloiber et al. [9] provides correlation between the loading jack results and the compressive strength, modulus of elasticity and the density. The correlation follows the results from specimens with 12, 18 and 24% moisture content. However, only the correlation for 12% is used since the moisture measured and shown in the subsequent section, in the frames does not exceed 12%. The correlation between conventional strength measured from loading jack (CSc) and the compressive strength (Sc) with a correlation factor of $R^2=0.887$ is shown in equation (3). The correlation between the modulus of deformability (MOD) from the loading jack and the modulus of elasticity (MOE) with a correlation factor of $R^2=0.679$ is shown in equation (4). Lastly, the correlation between the conventional strength (CSc) and the density (ρ) with a correlation factor of $R^2=0.840$ is shown in equation (5). The results are shown in Table 3. From the Czech annex of Eurocode [7] the elements are classified as C20 structural timber class.

Figure 6. Loading jack results for south part of the west wing CSc (a) and MOD (b) and the Church CSc (c) and MOD (d);

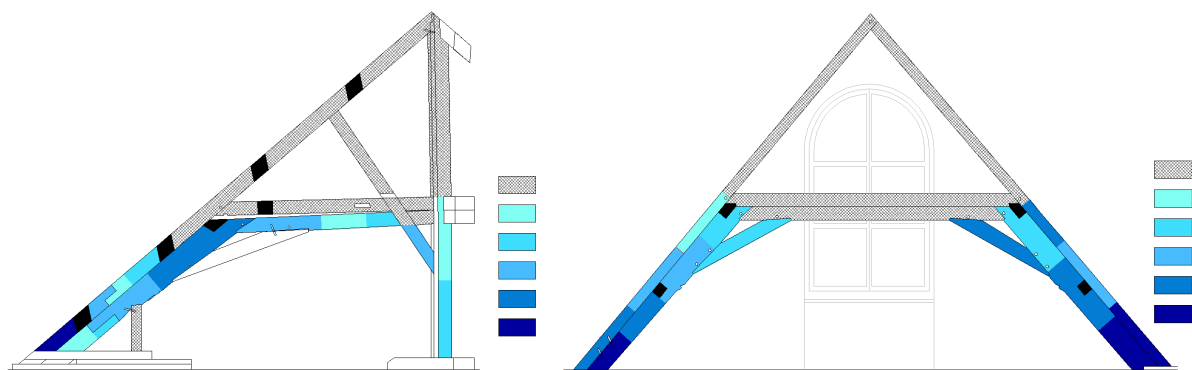
The moisture content provides a significant qualitative measurement of the level of decay and strength of the timber elements. The durability of timber decreases with the increase of moisture above fiber saturation point. This due to the vulnerability of timber towards insects and fungi. Furthermore, the strength and elasticity are reduced, and the elements swell. The moisture content is measured on some elements of interest and is shown in Figure 7. The moisture levels on the timber elements do not present any threat to the health of wood.

Figure 7. Moisture content for the Frame no.1 (left) and Frame no.3 (right);

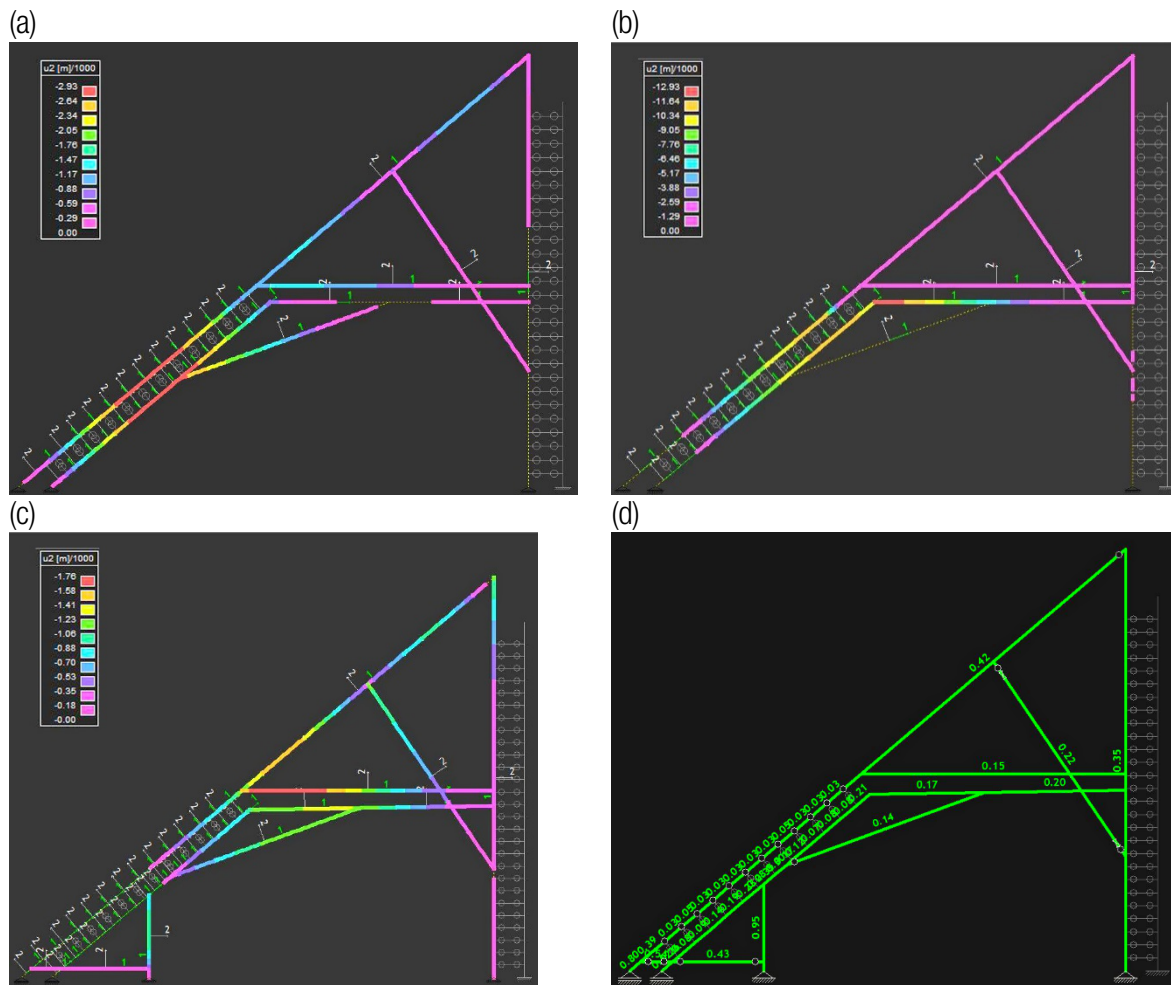
The loading conditions at the time of Scenario 1 are unknown and therefore the results are only relative. A large deflection is seen in Figure 8(a) in the middle of the principal rafter which can justify the need for a strengthening. In Scenario 2 after the removal of the tie beam the diagonal truss starts acting on

tension and loses its function and the horizontal beam on the left side can be seen to suffer a large deflection Figure 8(b), which is still present on the frame. Scenario 3 shows a strengthened frame and reduced deflections seen in Figure 8(c) and the same scenario is evaluated to be stable for the actual level of forces acting on it presented in Figure 8(d). This hypothesis presents a high level of reliability for the cause of deformation. Nevertheless, if more hypothesis can be formed a comparative analysis can be done to assess the most reliable one. After this assessment the frame does not require excessive strengthening measures. A possible strengthening proposal can be the placement of a tie beam at the bottom to take the horizontal thrust.

Figure 8. Results for: Scenario 1 deflections (a), Scenario 2 deflections (b), Scenario 3 deflections (c) and structural stability evaluation (d);
