Strengthening and Restoration of Historical Structures - Mirahor Ilyas Beg Mosque in Korça

Enea Mustafaraj, Yavuz Yardim

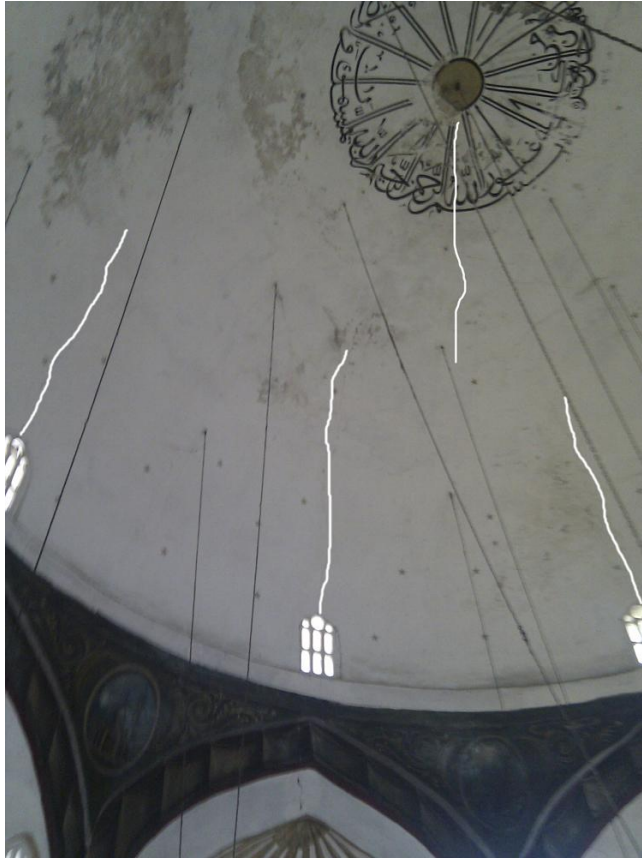
Dome structural conditions seem adequate to carry static load. However, structural cracks are seen throughout it. Improper connection of the lanterns hanged at the top of the ceiling after the dome was built, has caused extra distresses at the very top causing cracks around it (Figure 4). Other structural cracks may have been caused by earthquake loads. Improper isolation system of the roof has caused moisture problems and spalling of plaster (Figure 4).

Figure 4. Cracks on the dome and spalling of plaster

Pendentive and arches suffer from the same problems. Thrust coming from these loads has exceeded the pendentive load carrying capacity. Propagation of these cracks is seen until the bottom of the load bearing walls. Due to inadequate isolation, spalling of plaster is seen too.

The dome is of a high importance. It encloses the maximum volume with a minimum of surface area and distributes loads to supports through a doubly curved plane. Dome is to be designed to resist compressive

and circumferential tensile stresses. For this reason it should be strengthened using FRP laminates along its surface.

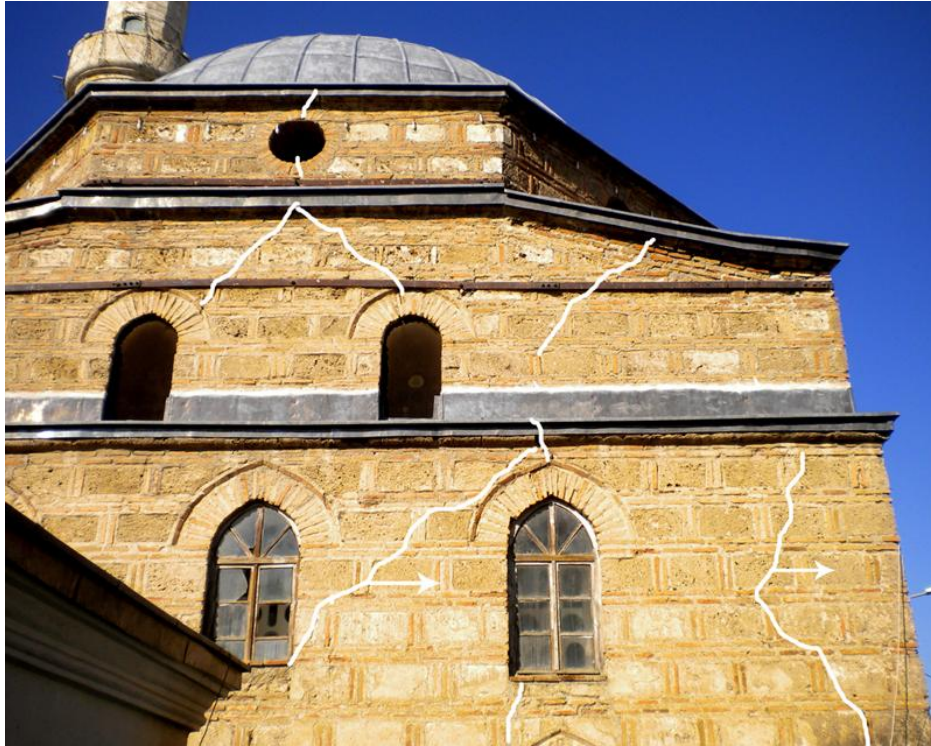
In the load bearing walls, there have been observed serious structural cracks. The causes of those cracks are excessive stress concentrations such as: compressive stress caused by vertical load (static), shear stress caused by lateral load (earthquake) and propagation of cracks due to successive earthquakes and amortization during centuries.

In load bearing walls containing openings, a different crack pattern is observed. As the maximum stresses are located at the edges of these openings, every window is cracked at the bottom corners of its frame. The cracks propagate diagonally from top windows to the lower windows in the same way. It is very dangerous for the stability of the wall (Figure 5).

Figure 5. Cracks on the load bearing walls in the south facade of the mosque

Structural cracks wider than 10 mm should be repaired using longitudinal FRP bars (Figure 7). This technique would provide the load bearing walls with better resistance against tensile stresses, higher shear capacity and more ductility.

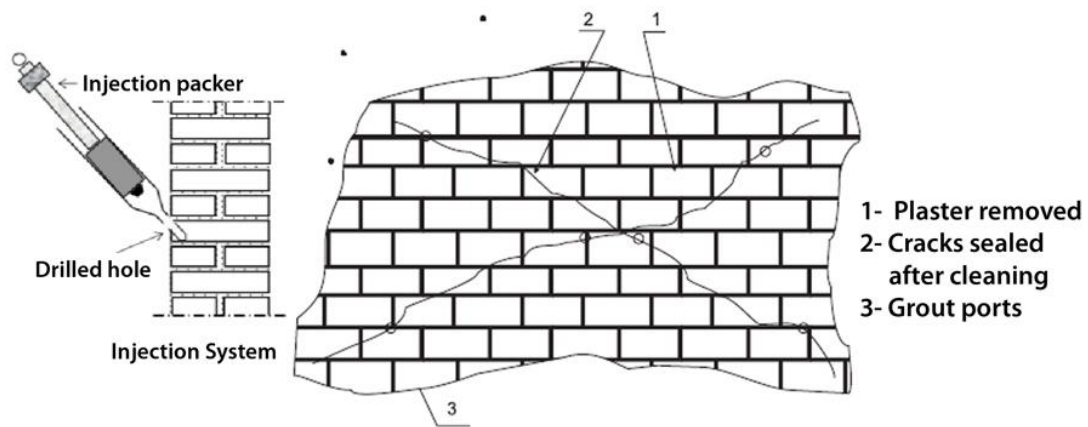
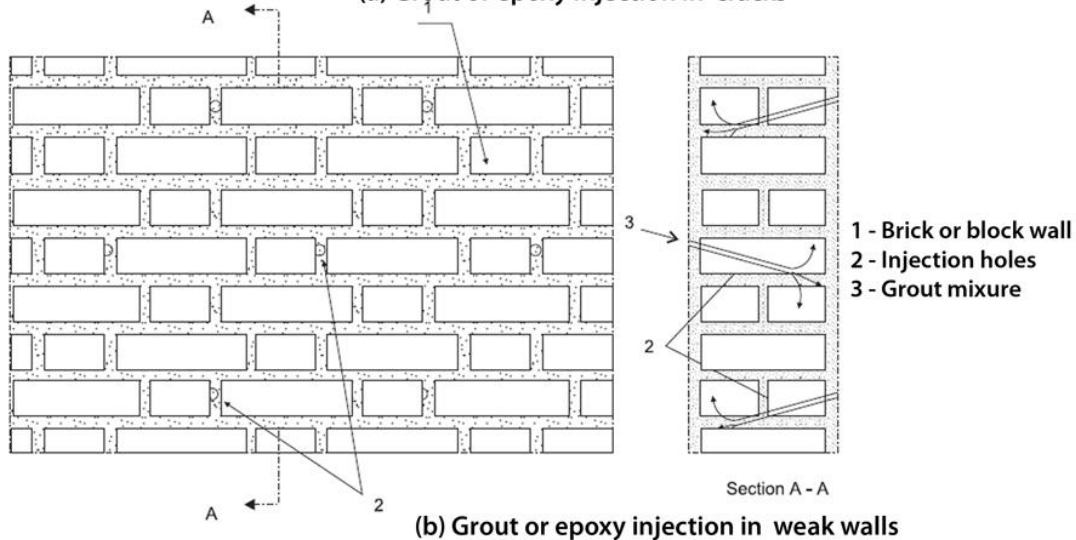
Figure 6. Strengthening by grout or epoxy injection in (a) cracks (b) weak walls

The proposed strengthening methods aim to preserve the mosque's architectural and historical values. Non-structural cracks less than 10 mm should be filled with lime mortar injection (Figure 6). These cracks will be sealed preventing water from penetrating inside of the wall and damaging plaster. This procedure leaves no trace as it is applied inside the wall. Thus, it has no effect on architectural features of the mosque. It is widely used in restoration projects for historical constructions (for example Outeiro Church, Portugal).

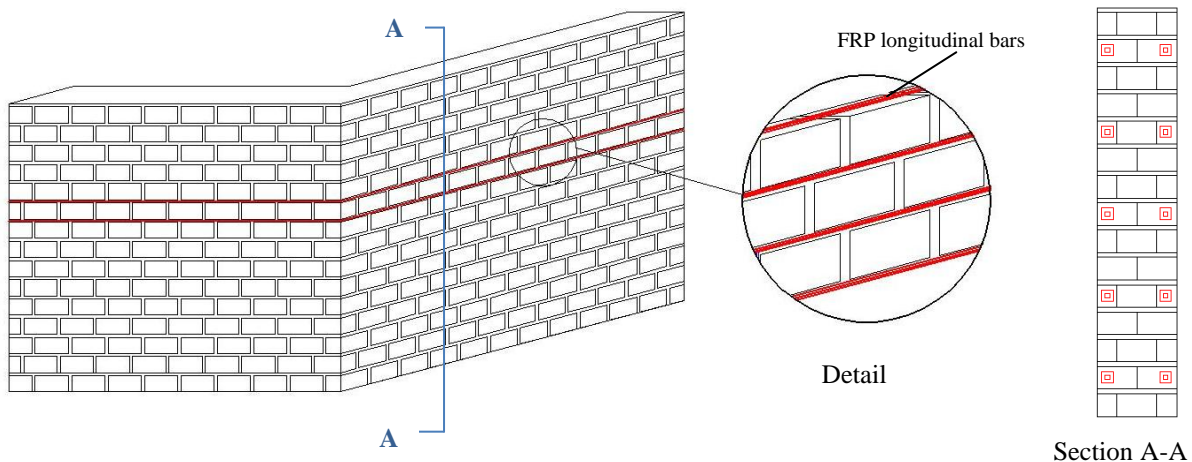
Figure 7. FRP reinforcement in the load bearing wall

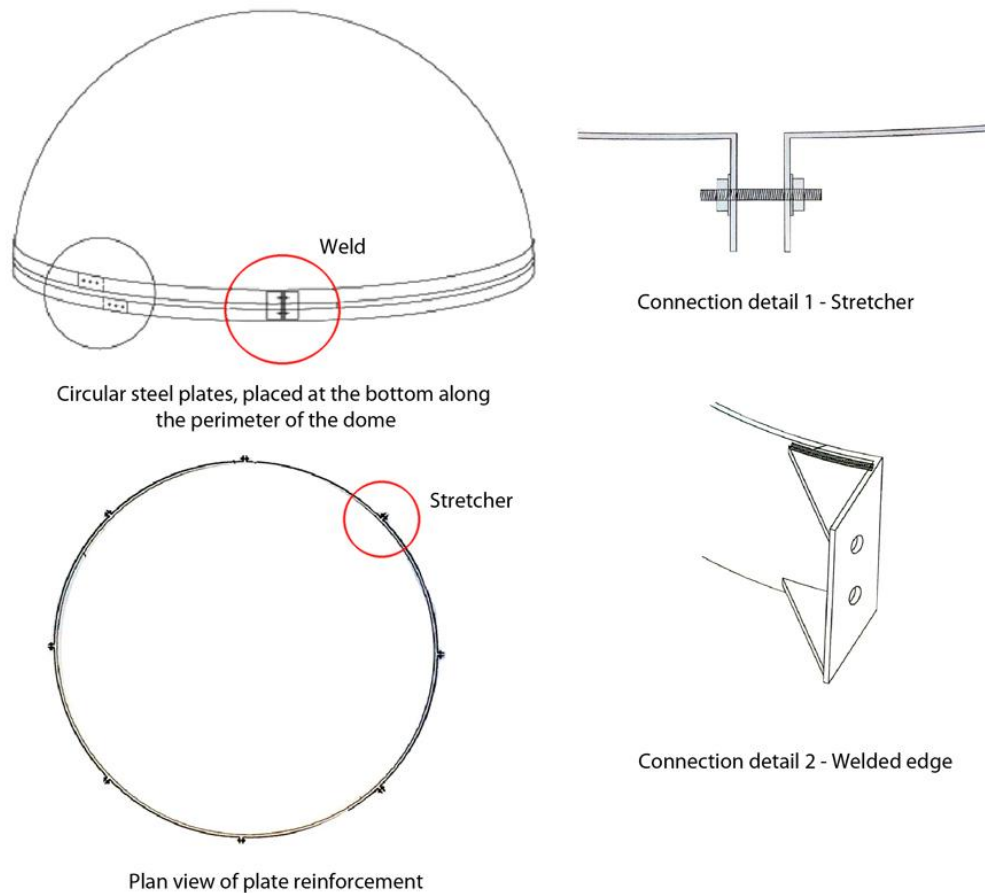
Figure 8. Strengthening with internal and external ring

Moreover, external and internal steel plate rings should be tied at the bottom of the dome (Figure 8). The same procedure was applied in the leaning tower of Pisa. Pre-stressing rings were placed all along the tower.

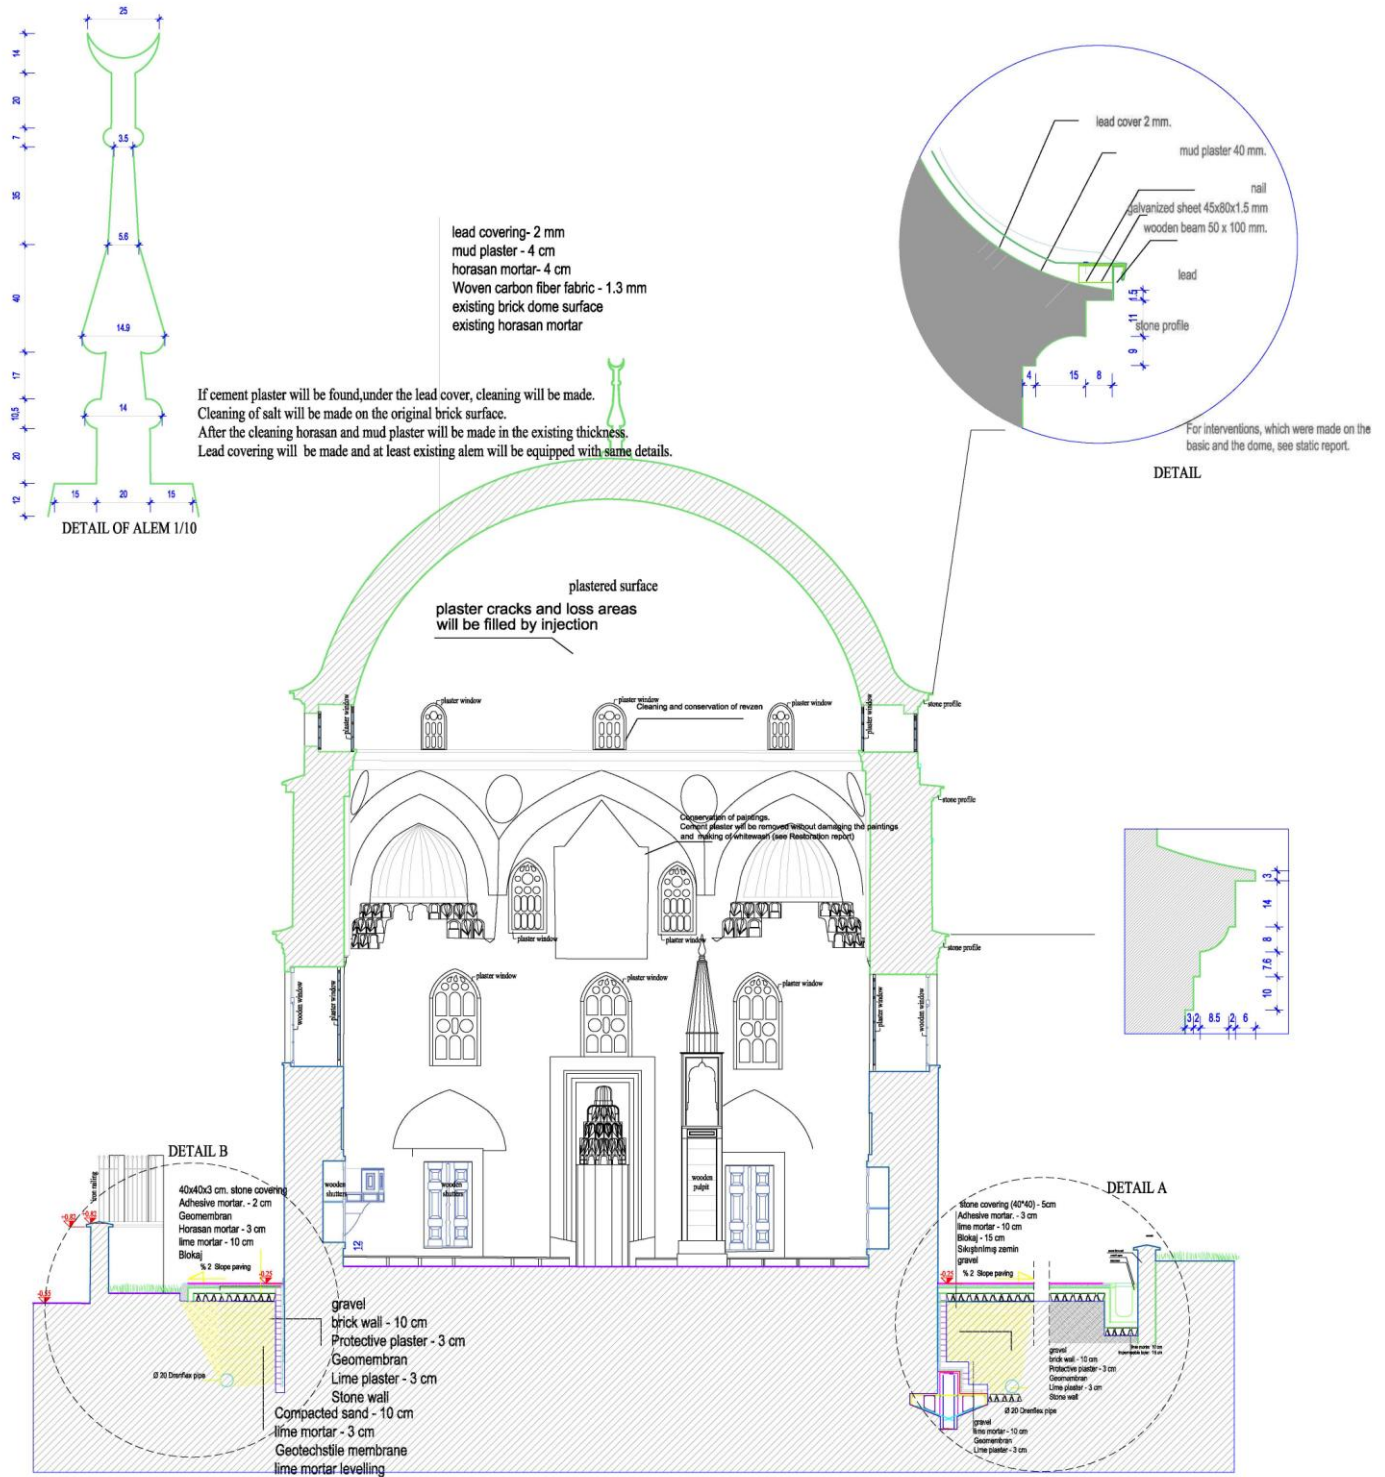
Figure 9. Proposed interventions.

Humidity problems would be solved by creating a new ground water drainage system. It would cover the entire perimeter of the mosque, and would remove all surface and excess water away from the mosque (Figure 9). Even though the leaden cap of the roof was recently replaced (in 2008), water leakage is seen in the dome which has caused spalling of plaster and damage of paint and calligraphic ornaments on it.

It is suggested that the layer of lead is removed, the roof to be properly isolated and then leaden cap to be put back in place.
