EVALUATION OF RECENT EARTHQUAKES IN ALBANIA

Erdal Emre Çeçen, Nikolla Nika, Fatjon Saliu, Anxhela Lama
Metropolitan University of Tirana
Tirana, Albania

Agim Seranaj, Altin Serenaj, Altin Piqari
Polytechnic University of Tirana
Tirana, Albania

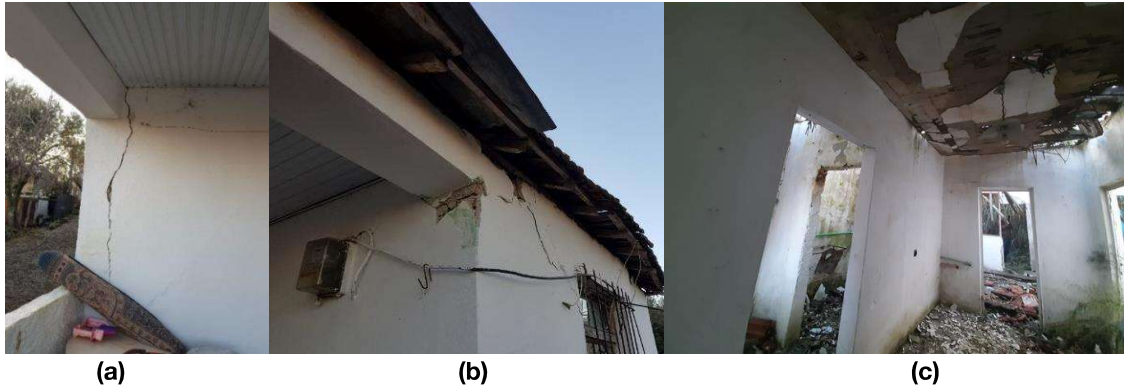
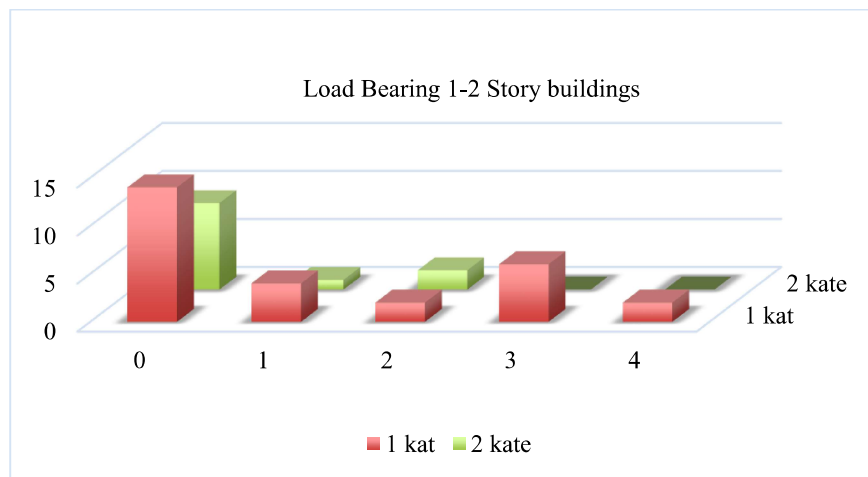
Figure 4. 1-2 Story Buildings with load bearing walls

Figure 4 presents examples from the field that represent the failure due to insufficient or lack of bonding between masonry and RC beams and slabs. This resulted damage of walls and also possibility of falling parts from ceiling and roof.

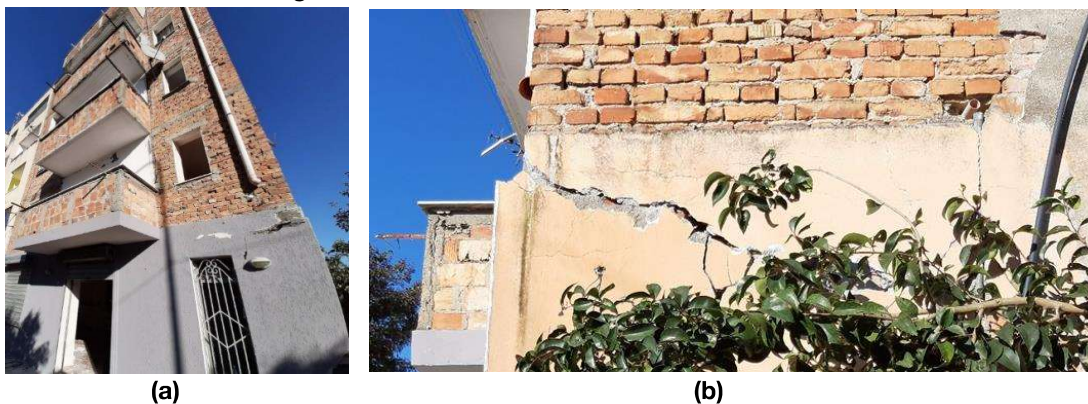
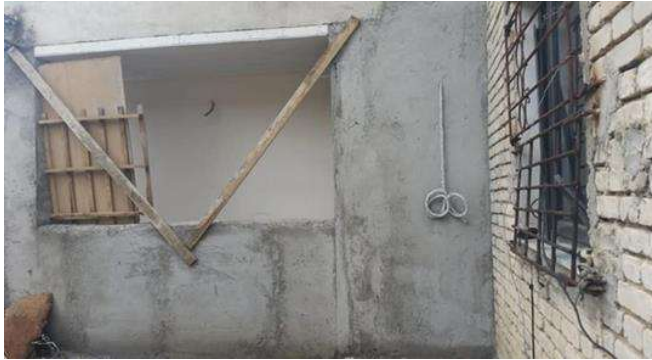
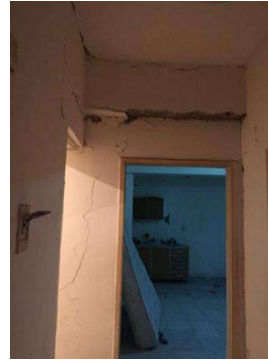
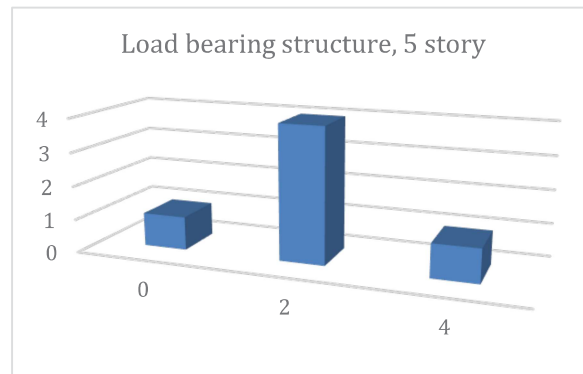
Figure 5. Un-engineered and Un-authorized Additions

Unengineered and unauthorized additions to the existing building causes severe structural damage during earthquakes. Figure 5 shows examples of this type of additions resulting various levels of damages.

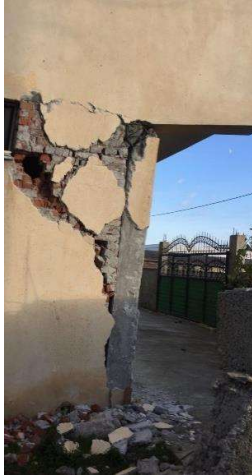
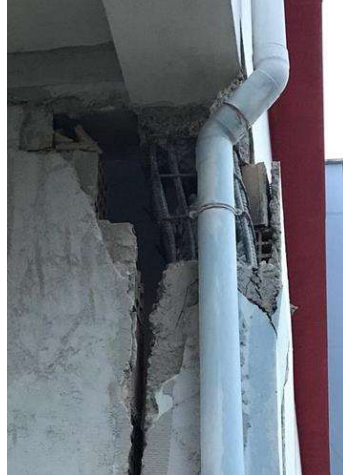
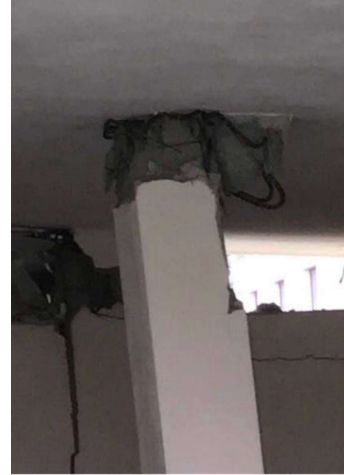
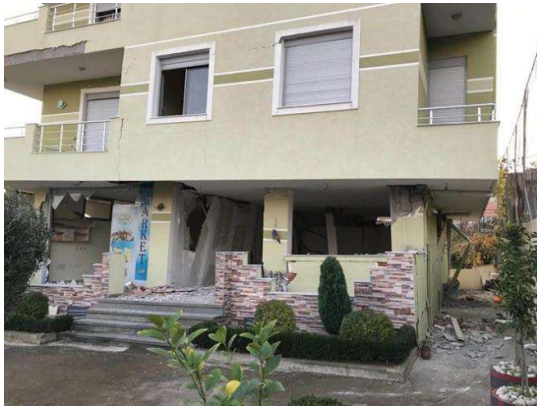
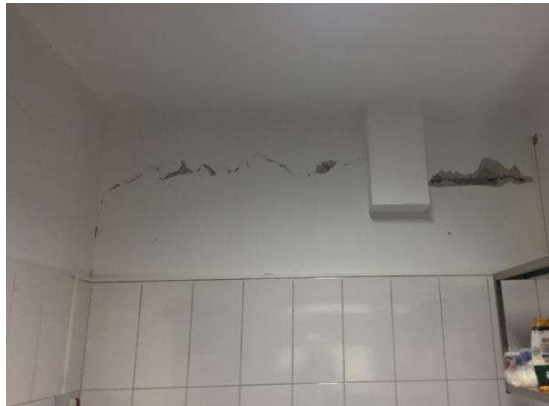
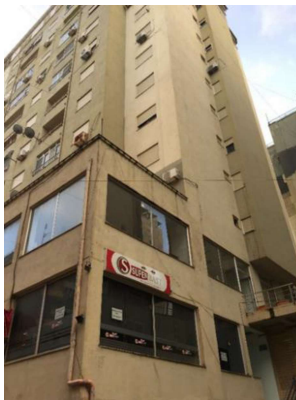
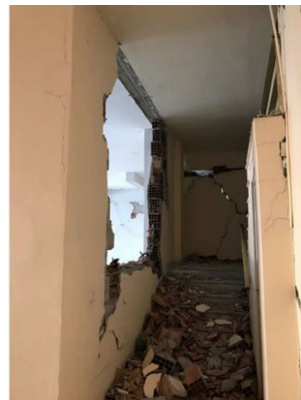
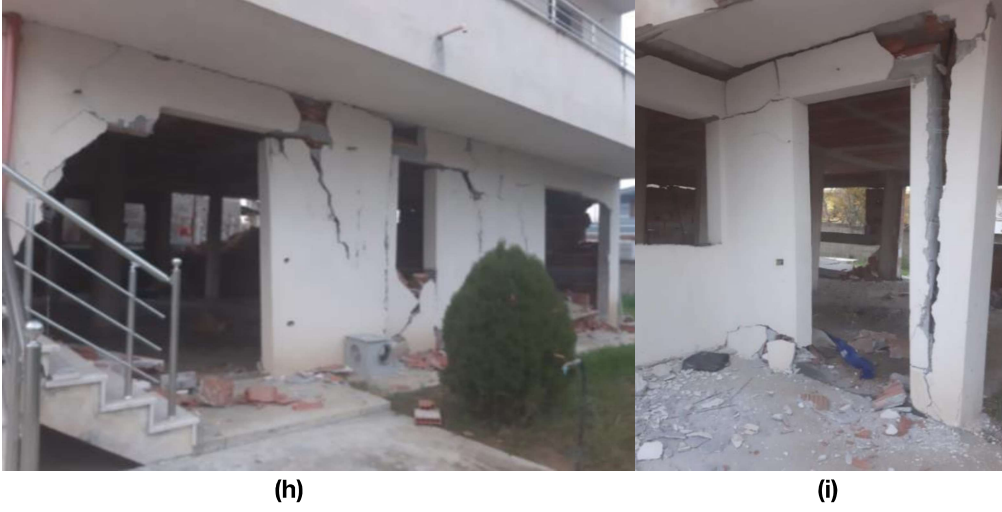
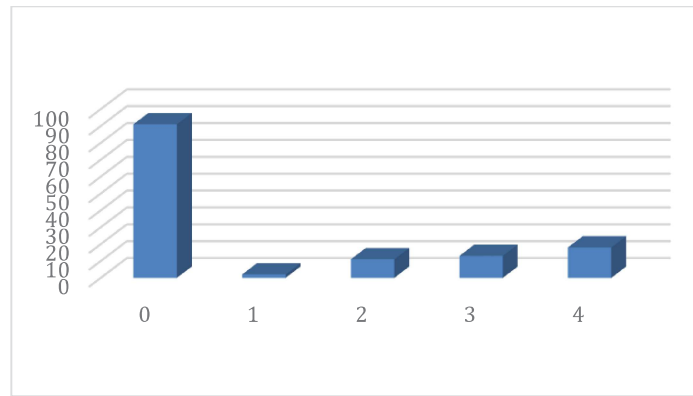
Figure 6. Damages in 1-5 storey Buildings with RC frame and infill walls

The damages are focused mainly cracking of the plaster, cracks in the infill walls, staircases, and the upper part of elevator openings (Figures 6-10). There are also structural damages detected. The main reason for these kinds of structural damages was failure in realization of the detailing of reinforcement according to technical rules such as minimum dimensions of supporting columns and the absence of seismic walls. Improper connections of the infill walls to the RC frame were observed. In some cases, this connection is entirely absent. This is the main reason why large pieces of walls were dislocated and even fallen out of plane.

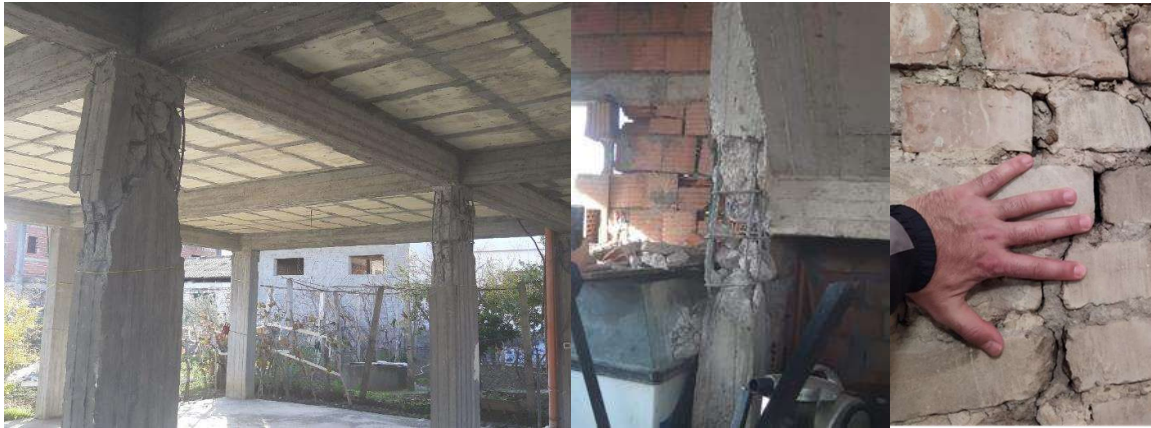
Figure 11. Problems related to poor material quality

Low material quality is one of the main reasons which increase seismic vulnerability, from the inspection (Figure 11). We can say that in URM buildings fired bricks were used in the construction of walls. 3 structures of this typology had heavy structural failures and one of the main causes of collapse is the poor mechanical properties of the bricks and the lack of connections between the slabs and walls. Some of the RC structures had problems with concrete quality and also there are many cases where handmade concrete is used, especially in old buildings, the workmanship was not at the desired level, resulting in a very low quality of material. All these factors, including corroded reinforcing bars, together with the low-quality material of the building, resulted in poor performance during this earthquake.

- The materials used in constructions as well as their implementation should be within the related standards and qualities should be assured through the whole construction process.

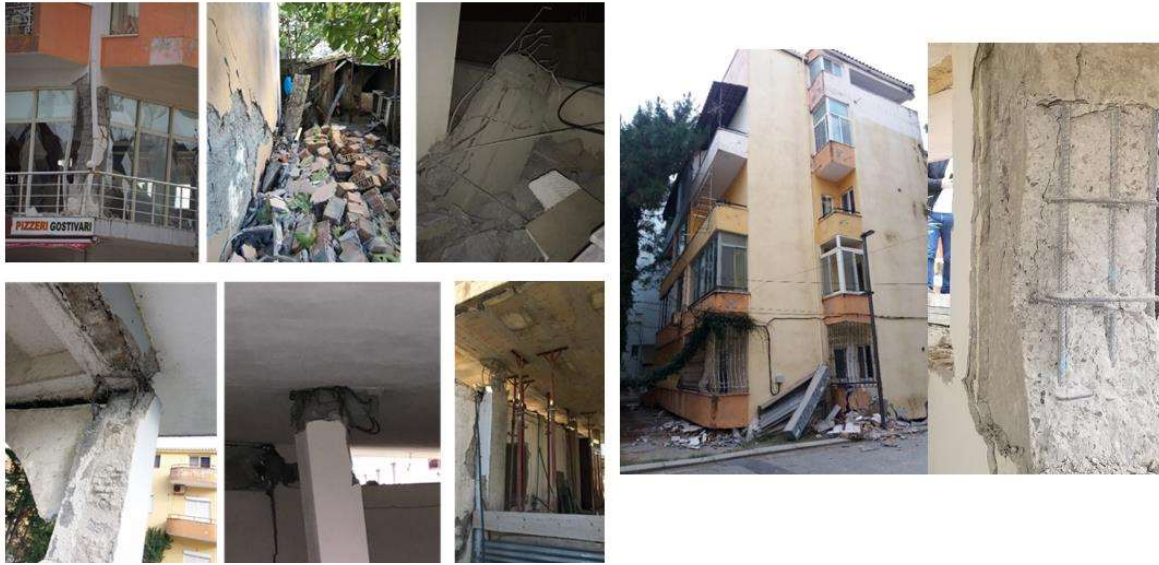
Figure 12. Problems related to poor constructive detailing

During the inspection we found that the minimum depth of required concrete cover was not respected and the details of the reinforcement were not carried out according to the technical conditions (Figure 12). In the old buildings there were cracks in the plaster due to thick layers of plaster, displacement of bricks and damage to the joints between them. Partition walls had out of plane failures and one of the main reasons for this problem is that these walls did not have a good restraint to the RC frames. The detail of stair connection with the floor slab or beam had problems also in some of buildings. There were also frequently observed problems with detailing of beam-column joints, and the diaphragm failures because of problematic connection between the walls and slabs.

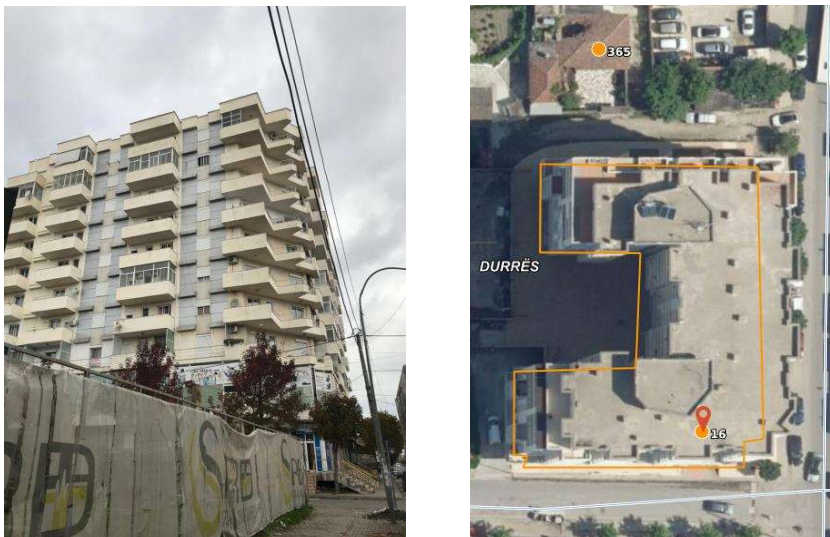
Figure 13. Known phenomena illustrations

In some inspections we observed that the lower story, 1 or 2 stories, had large openings that created the effect of soft stories (Figure 13). Vertical irregularity that affects the load path for seismic loads from the upper stories to the ground. The mechanism of the short columns developed because of the continuous openings located at the top or bottom of the infill walls between the columns.
