Evaluation of Conservation Problems for Restoration of Great Karaosmanoğlu Khan, İzmir, Turkey

**Eltjona Lacaj, Enes Nurkovic, Derya Camuz, Kemal Korkmaz, Aysun Alp,
Başak İpekoğlu, F. Nurşen Kul**

İzmir Institute of Technology, Faculty of Architecture, Department of Architectural Restoration
35430 Urla / İZMİR / TURKEY

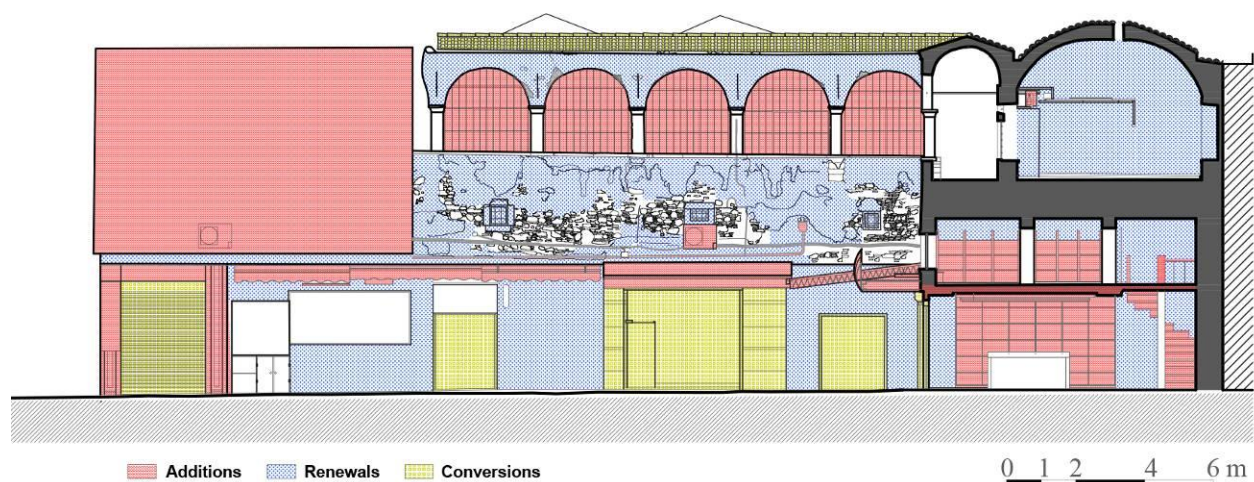
Figure 8: Types of alterations

Alterations: Through time, inappropriate interventions to the building have resulted in loss of historic character of the khan. The major alteration is the missing north part of the building. Moreover; addition of inappropriate masses on the north end; one on the east comprising both floors and one on the west on the first floor and especially on the ground floor; elements such as large glass display windows, mezzanine floors, on the first floor; closing with glazing of the arch openings on the east portico and implementation of inappropriate covering materials on the floors and the walls, inharmonious partition walls, replacement of original lime plasters with incompatible cement plasters, conversion of original doors and windows to different form and material have affected the original architectural quality of the building (Figure 8).

The later incompatible mass additions; one on the east and one on the west in the first floor to the two edges of the U shaped remaining form of the building are to be removed. Instead, new terrace arrangements are proposed. The terrace to the east will serve as a cafe while the terrace to the west will be utilized as a gathering point for the tailors and artists working on the first floor.

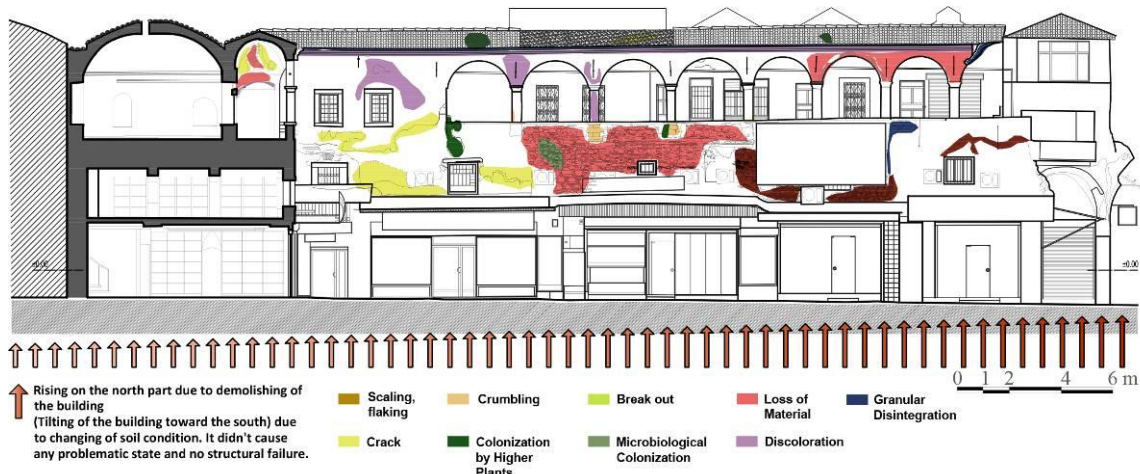
Figure 9: Structural problems and material deterioration

Structural problems and material deterioration: Main structural change observed in the building is rising on the north part due to demolition of the building (Figure 9). It can be explained by tilting of the building toward the south due to changing of soil condition. By demolishing half of the building, the load on the soil was removed and that caused heave (soil expansion) under the demolished portion of the structure. The raise of the structure on northern part 17 cm, corresponding to angle of 0.58° . However, it did not cause any problems and any structural failure.

On the ground floor, due to major recent interventions, no deterioration of materials was observed. Deteriorations are seen on the first floor due to lack of maintenance, rainwater penetrating from the roof and original drainage system that are in poor condition and salt crystallization because of the incompatible material use in clumsy interventions. On stones and brick of portico, scaling is observed mostly because of salt crystallization besides crumbling and granular disintegration of these materials. Falling, cracks, detachment of plaster, microbiological growth, colonization of higher plants growth are observed especially on the walls of the first floor.

Based on the results of visual observations, the structural problems of the building are rather in material scale and the main reason of these material deteriorations is the water penetrating from the roof due to the inappropriately working roof drainage system. Therefore, it is proposed repairing the roof, removing the later added screed layer in some parts and replacing it with the original type of roof covering material, which is half round tile. The lost and deteriorated stone and bricks will be completed or replaced with similar type of material. Lost and powdered mortar and plasters will be completed or renewed with compatible compositions.
