The Archaic Fountain of Agrigento. Results of a New Analysis on the Structures

This paper aims to provide the first results of a new autoptical analysis on the structures of the archaic fountain in Akragas (Agrigento), known as "Santuario rupestre of S. Biagio". The monumental complex, located just outside the city-walls, on the north-eastern slopes of the Rupe Atenea, behind a rock face in which an anthropic cave system has been developed, is made up mainly of two parts: the building of the western basins and, forehead to the east, a fenced yard.

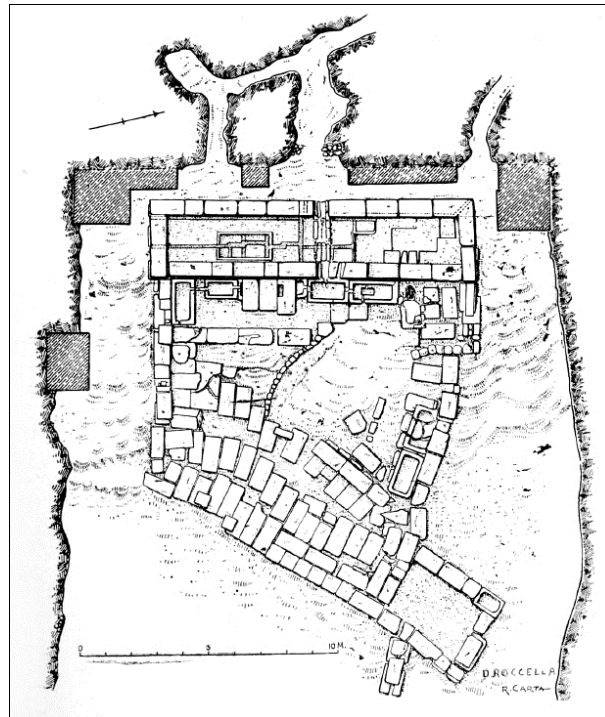
Figure 1: Akragas, St. Biagio's fountain (Plan of the complex (Cultrera 1942, Tav)

So, the monument in question was realized in this natural landscape, leaning on a rock wall, on which there are three anthropogenic caves. The monumental complex consists in a rectangular building, composed of two tanks, and a trapezoidal square that extends eastward. (Figure 1)

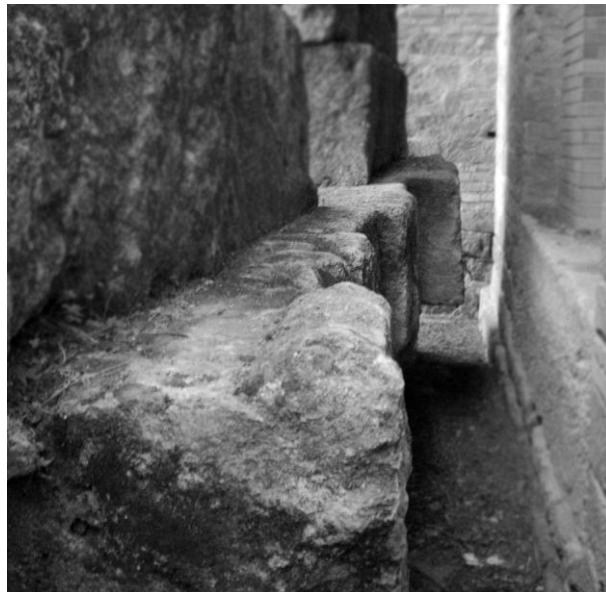
Figure 2: Akragas, St. Biagio's fountain. Detail of the seat for the water supply system (ph. by A. Fino)

The monument and context restoration, repeatedly carried out, led me to read more carefully Pirro Marconi's writings (Marconi, 1926; Marconi, 1929), who certainly noticed some details at the time of the earliest excavation, details that have been inevitably lost with the passing of time. Marconi made the first excavations of the monument, but his work was limited to the building of the tanks and the caves behind. Leaving aside for a moment the religious aspect (*v. infra*), I would begin with the analysis of the structures related to the water-element. Water supply attested in the northern cave, has been based initially in the central one. It is here, in fact, that the digger finds a branch of the main channel, which is northwestern located. According to this, it can be assumed that, at first, the holding tanks were fed by a

bifurcation of the central pipe, resting on the fifth row of the ashlar masonry; in fact, the seat for a root-canal-treatment north southern oriented is visible on the blocks' top surfaces. (Figure 2)

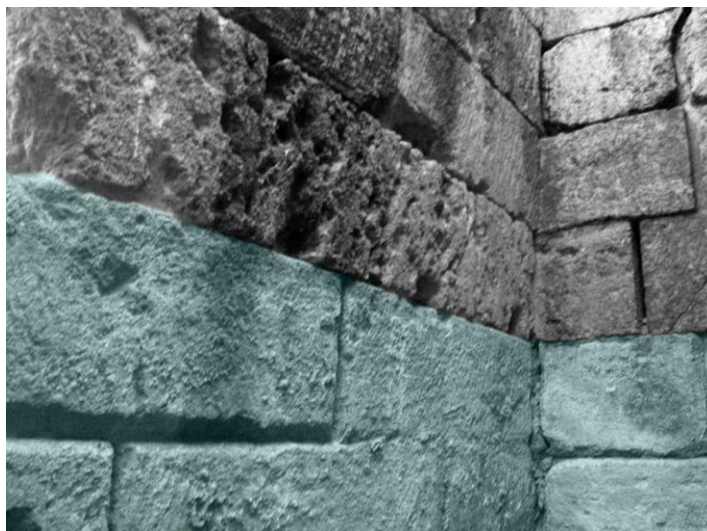
Figure 3: Akragas, St. Biagio's fountain. Detail of the ashler masonry inside the tanks. In blue the water level (ph. and gr. proc. by A. Fino).

However, the two tanks' intake holes are not visible on the bottom; it is likely that those holes were set where other openings have been realized later, after the completion of the wall. The function of the tanks as reservoirs is showed by the presence of two depressions on the floor for decanting, cleaning and maintenance, according to a well attested use (Tölle-Kastenbein 1993, pp. 24-32). From the tanks that are waterproofed up to the fifth row (Figure 3)

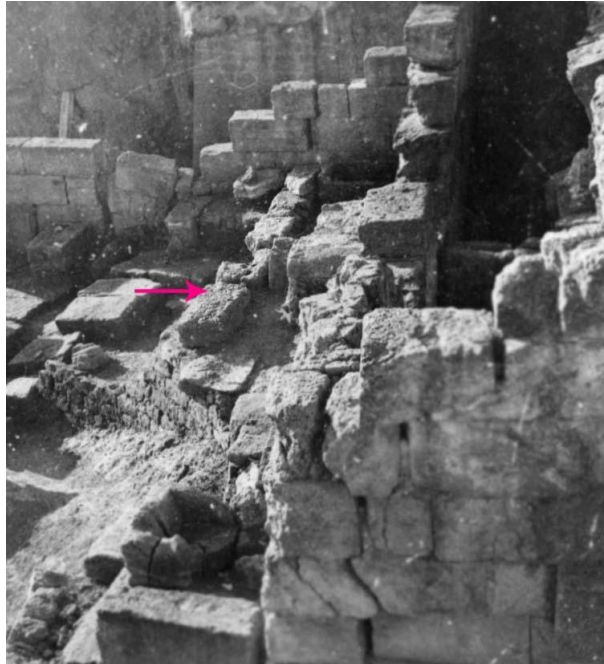
Figure 4: Akragas, St. Biagio's fountain. View from the North; the arrow shows the supposed stylobate (ph. Archive BB. CC. AA. Agrigento).

The water flowed through the drip nose, through which the tanks below could fill up, or under which we can imagine a block shaped to support the hydria. About the location of the drip nose, it should be noted that the two side openings of the main façade have no threshold, which could have hold the blocks whit the nose whether placed above the water's level. In order to protect the fountain originally there could be a basic wooden porch of which we can see a possible stylobate in the excavation's photos (Figure 4)

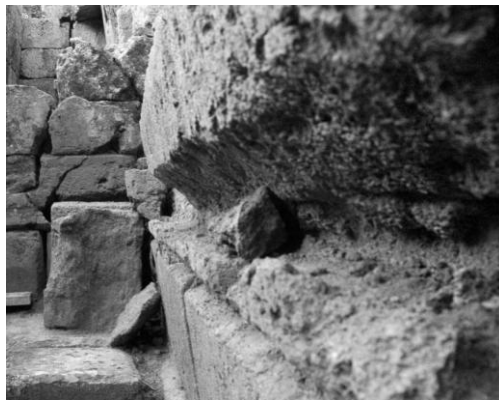
Figure 5: Akragas, St. Biagio's fountain. View from the top of the cliff of the two late tanks (ph. Archive BB. CC. AA. Agrigento).

While it's not sure that even in the first period the fountain was preceded by a paved courtyard. Giuseppe Cultrera, which in addition at the bringing to light of the yard, took care of the first reservoir restorations (v. infra, V. Santoro), highlighted some problems about the static of the soil appeared from the earliest stages of monument's life (Cultrera 1942-43, p. 613). In fact what Marconi reported as a system of ducts on the bottom of the tanks is nothing but the effect of the soil instability. However, because of the detachment, the use of tanks became impossible. Restoration attempts are still visible on the main façade, in connection with the openings. As a consequence of the instability, it was necessary to build another water use system, consisting of interconnected small tanks, located in the forecourt, which was present at least from this moment on (Figure 5).

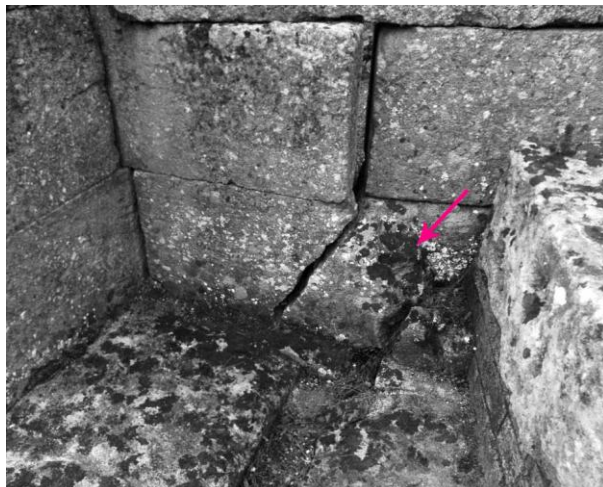
Figure 7: Akragas, St. Biagio's fountain. Detail of the corner block of the first row of the southern wall ashlar masonry (ph. by A. Fino).

There is an important detail present in the square near the south-eastern wall. The corner block of the first row of the southern wall ashlar masonry (Fig. 7) has a protruding rock shaped portion. This naturalistic component, often in connection with the "rock" landscape, would lead up to be more precise in dating the monument later than fourth century. I might add, in support of this statement, that the blocks used in the construction had nearly the same modulus of the nearby walls, destroyed by Carthaginians in 406 BC. It was at that time that the walls were robbed in order to realize buildings such as the St. Biagio's complex.

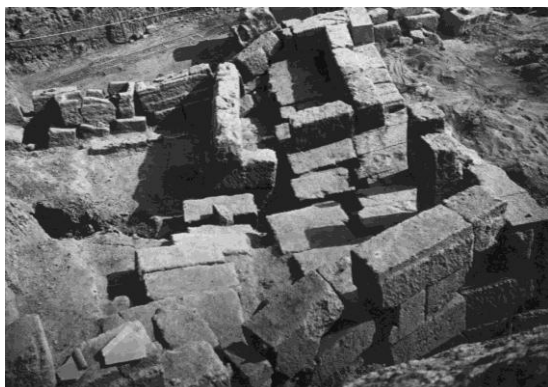
Figure 8: Agrigento, S. Biagio, 1932. The entire monumental complex (Ph. Archive BB.CC.AA Agrigento)

In comparison with the first explorations in 1926-1927 (Marconi, 1926; Marconi, 1929), Giuseppe Cultrera noted a static alteration caused, according to him, by the load of the calcarenitic cliff on the above Rupe Atenea, where the monument leans against. However, although aware of this disruption, he did nothing to change the finding state. In 1932, while the archaeological studies were going on, managed by Cultrera, the architecture of the fountain came to light: it was composed by a forecourt, laterally closed and with a frontal porch (Figure 8).

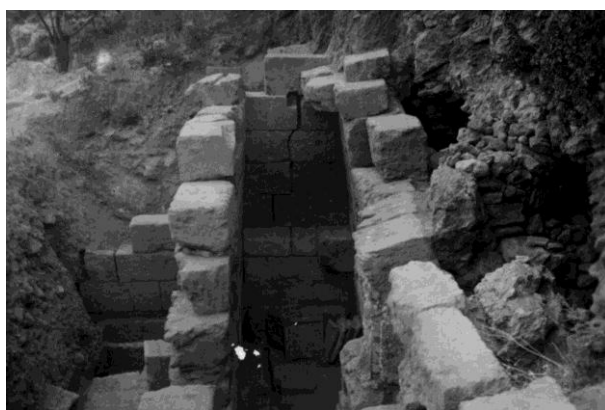
Figure 9: Agrigento, S.Biagio. The connexion between Rupe Atenea and archaic fountain (Marconi 1929, p. 2).

In the same context, Cultrera noticed that, in the West, where the fountain leans against the cliff, calcarenites appeared compact inside and crumbled outside, composed of terrain and mixed size stones. This material, already known by Marconi, seems not to be random arranged, but organized in overlapping blocks, a technique similar to the dry construction's one (Figure 9).

In this case too, it may be a matter of bedrock consolidation, similar to the technique examined previously and used for the foundation. The works went on until 1932, when the entire monumental complex became visible and was strengthened by Cultrera with masonry, composed of ashlar and bricks,

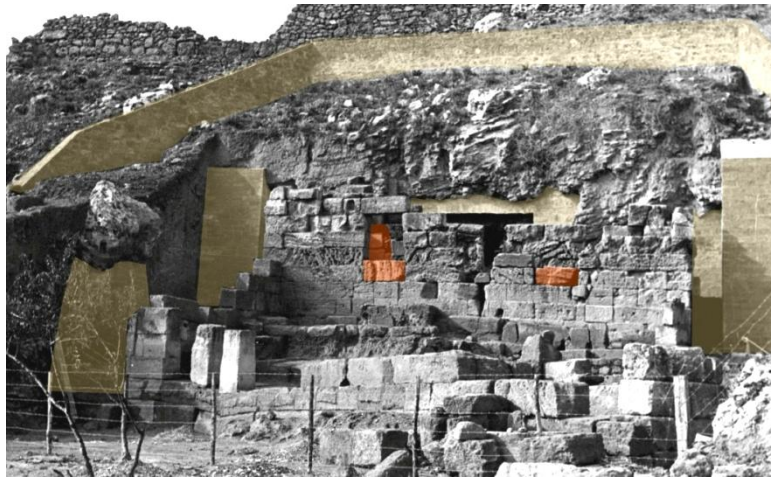
Figure 10: The archaic fountain, after the G. Cultrera Restorations (1932) (in Ph. Archive BB.CC.AA Agrigento).

still recognizable (trapezoidal retaining wall, pillars for the cliff and supports inside the building) in order to make safe the site and the monument (Figure 10) (Cultrera 1942, pp.615-618).

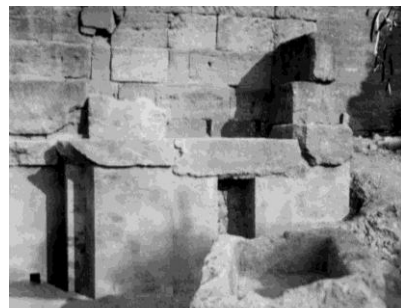
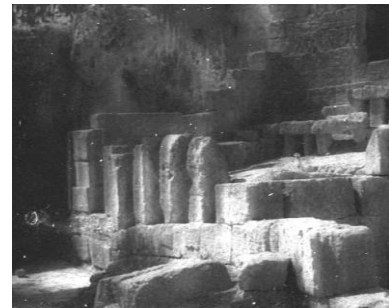
Figures 11, 12: The archaic fountain, 1932-1941. Small interventions of consolidation and *anastylosis* (Ph. Archive BB.CC.AA Agrigento).

Still other interventions were carried out until 1941, supported by Cultrera, also thanks to Jole Bovio Marconi (Figures 11, 12).

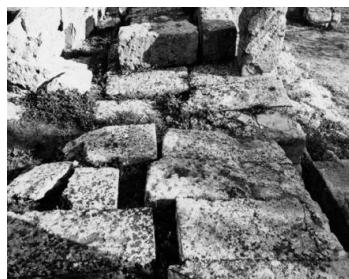
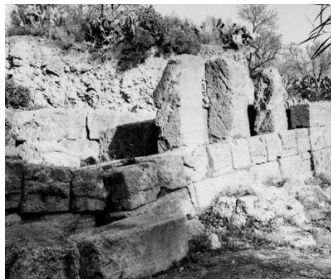
Figures 13, 14: The archaic fountain, 1975-1981. (Ph. Archive BB.CC.AA Agrigento).

The landslides and collapses, already highlighted by Cultrera, are still present (Figures 13, 14);

In particular, we highlight the widening of the joints, the collapse of two of the five pillars replaced in 1940 and the overturn of the north-eastern corner, so that, with the intervention of 1981, there is the installation of steel bars in order to better bind the whole structure. Since 1995, other interventions attempted to solve fountain instability. In this period, resin was used in the stabilization of walls, even if it has now been banned by the scientific community, because of the damages provoked on ancient material, especially on local stone (Bouras, 1994; Zambas, 1994; Karanassos, 2007); the retaining walls introduced by Cultrera have been consolidated using the same material, repositioning the same stones already collapsed. Finally, the beds surfaces have been waterproofed with protective layer made by puteolan mortar, removed during this de-restoration.

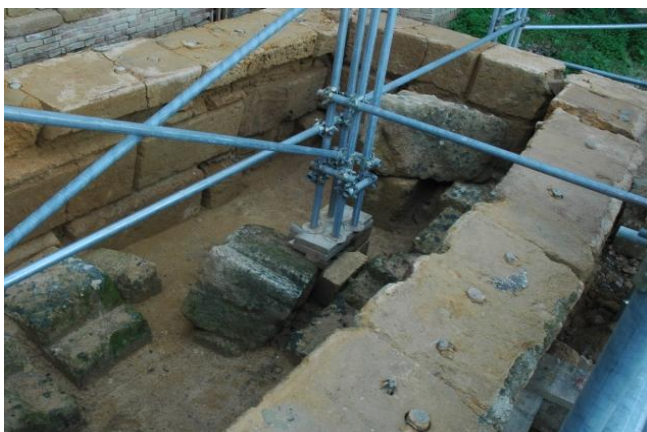
Figure 15: The archaic fountain, 2012. De-restoration the north-eastern corner (Ph. by V. Santoro).

Because of the strong link between architecture and background, the natural dynamics of the site interact on the architectural complex since its inception, insomuch that they affect the several functional changes during the use and they determine, since its discovery, a worsening in the structures preservation. In fact, since 1931, frequent restorations affect the monument and the site, and some of them in the second half of last century were quite invasive. In the Eighties, for instance, a fastening system, which used iron bars and epoxy resin, was inserted in the masonry for static consolidation of the load-bearing system.

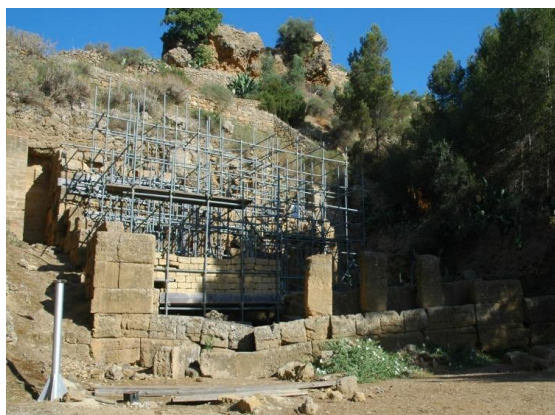
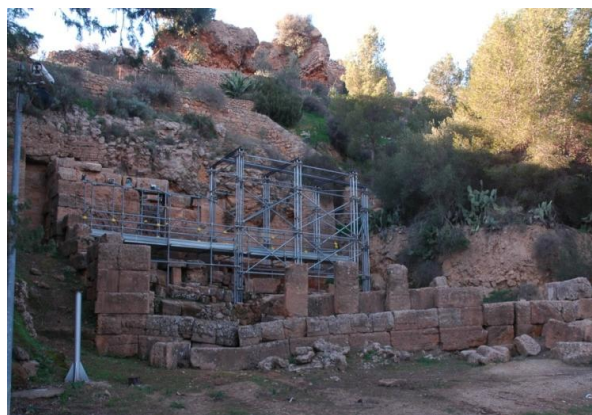
Figures 16, 17: Agrigento. The archaic fountain before and after de-restoration, 2012 (Ph. by V. Santoro).

The original static system showed significant structural tampering, accentuated by the detrital clay-soil and exacerbated, in recent times, by the presence of a large number of metal pivoting. The totally unsuitable system used to shoring up the façade threatened further the structural balance so that, apart from hiding the façade, it was worsening the monument condition because of the excessive weight resting on the structure (Figures 16, 17).

During the last de-restoration in 2012, the disassembly operations focused on 65 blocks belonging to the northern tank. At the end of the works, we can affirm that the totally lost material amounts to about 5%, the partially damaged material to 50%, the fully recovered material amounts to 45%, that is over half of the ancient material has been lost or damaged. The achieved results certainly depend on the nature and the state of the material preservation, on the techniques used in de-restoration and on the works control in course of action, in a logic of government decisions in itinere and specific skills. (Valentina Santoro)
