The Impact Of Disaster On Sustainability Of Civil Cultural Heritage And Authenticity: Case Of Religious Building Sample Of Selami Efendi Tekke In Istanbul

Mehmet ULUKAN¹, Hakan ARSLAN²

ABSTRACT

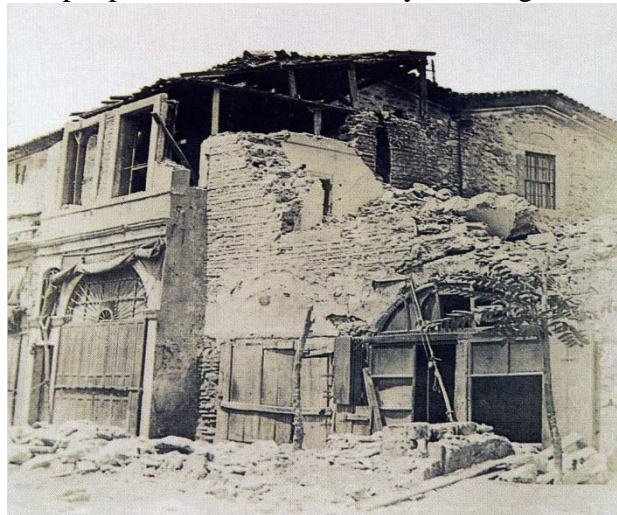
Figure 3 After 1794 Big Earthquake, ruins of stones [8]

Earthquakes had an impact on masonry buildings. They were usually injured and collapsed or very serious damaged (Figure 3) while the timber buildings are stable (Figure 4) Most of deaths and injuries of people occurred in masonry buildings.

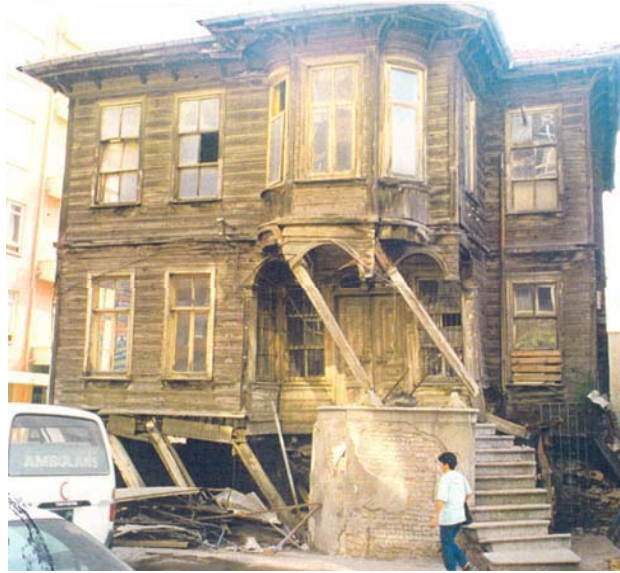
Figure 4 Half demolished timber buildings after Düzce Earthquake [3]

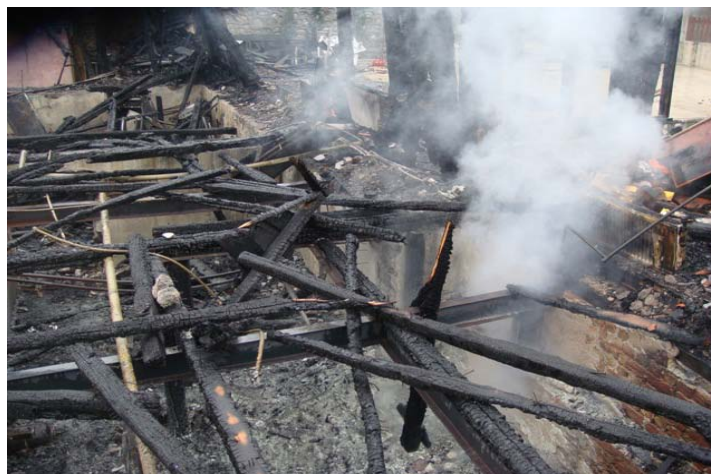
Figure 5 Selami efendi Tekke, the situation of timber structure after fire [11]

The minorities also were gaining money free of taxes while the Muslims were poor and engaged with military service, crafting and agriculture. The Muslims were gaining few money and responsible for many taxes. Istanbul was consisted of high comfortable masonry buildings in Balat, Fener, Pera, Galata and Pangaltı regions which were more expensive than timber buildings. Thus rich minority people were living in these regions [6]. Other regions such as Fatih, Zeytinburnu, Eyüp and Eminönü were consisting of mostly timber buildings which where belong to Muslim peoples. Earthquake behaviors of the buildings were differing between masonry and timber buildings because of their resistance and construction system. While the earthquake was destructive on stone buildings, fire was more destructive on timber buildings (Figure 5).

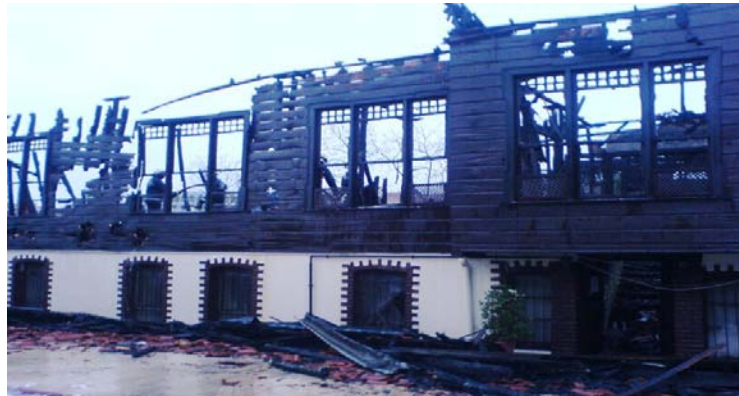
Figure 10 Selami Efendi Tekke right after the fire [11]

Obviously we can not always prevent the damage fire injuries in historical timber buildings like in this case (Figure 10). But, it can be pointed out that malicious intends can be seen in this arsons due to build new building or parking area. Eventually Istanbul has lost civil cultural heritage especially timber frame buildings because of normalization of such events as typical and unpredictable ones.

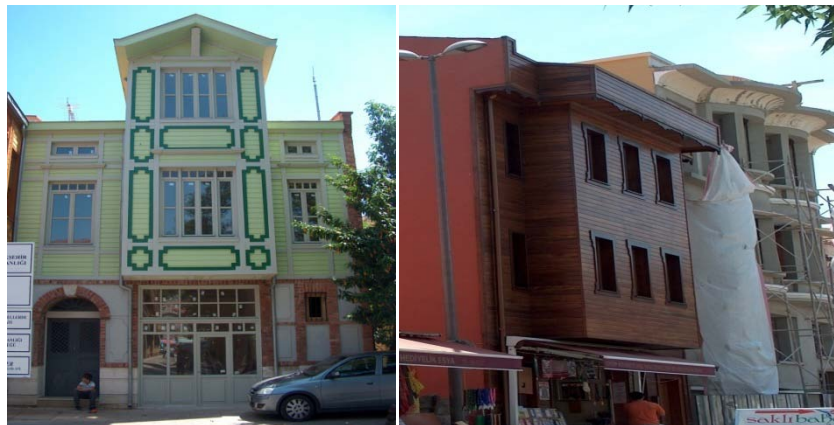
Figure 11 Insides concrete, exteriors seem traditional timber frame buildings, Eyüp (Istanbul)

All throughout historical period, both timber frame and masonry buildings could be repaired up to original situation, because craftiness, techniques, materials of construction were same, so repairing or restoration was convenient for authentic forms. [9] However it is different neither nowadays that nor today's craftiness, techniques, materials, neither today's architecture has a drastic change. Old construction techniques and materials were not still in use with their old practices. Similar applications are used under conservation techniques with limited successes. How handmade timber material can be supplied for restoration of traditional house? Or how traditional paints can be produced? So we can make just their copies or imitations in our factories or ateliers. So the restored buildings became counterfeit and sometime totally fake. Sometimes Interior constructed as concrete but exterior is extremely traditional (Figure 11). Obviously we may discuss the originality of neglected buildings or ruins when we have related them with the terrible restoration activities.
