Seismic assessment of historical masonry structures: The former Italian Embassy

Grigor Angjeliu¹, Markel Baballëku²

Abstract

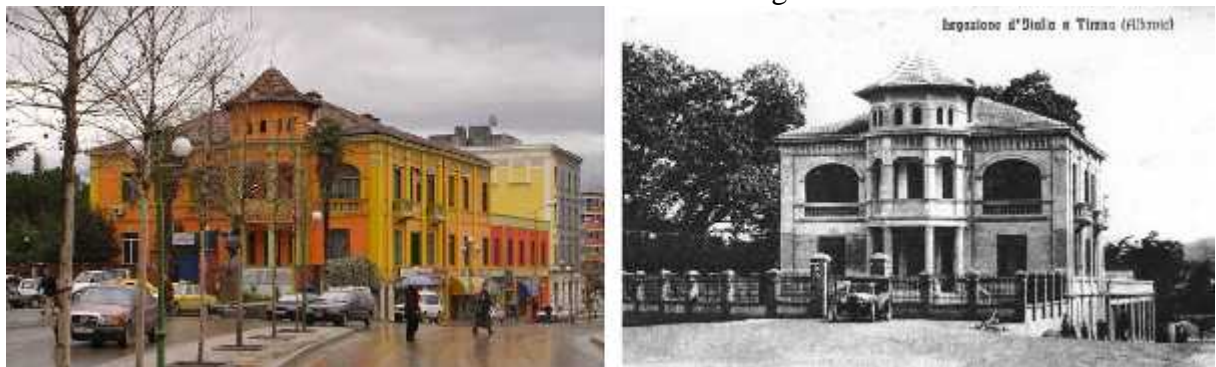
Figure 1 The former Italian Embassy

The building is located in the center of Tirana city, next to the Albanian Parliament. It was built in two phases. The first phase comprises the central building, built in the 20th, whereas the second one was an addition in the left and back side of the building in the 30th.

After its construction it was used as the Italian Embassy (legazione Italiana) and today is used by the Institute of the former Politically Persecuted and by some retail units (basement floor). The building architecture represents the Fascism architecture of the time. It has artistic values and thus it is a monument of the second category and protected by the state. When the works started the terrain was plain in different to what we can see today. Later during the communistic regime was built the road next to the building (on the east side). During these 80 years of its history it was subject to several interventions mostly in the first floor that intended to transform its function as a basement to retail units. The most frequent intervention is switching the windows to doors. In the second and third floor the building was not subject to any structural change.

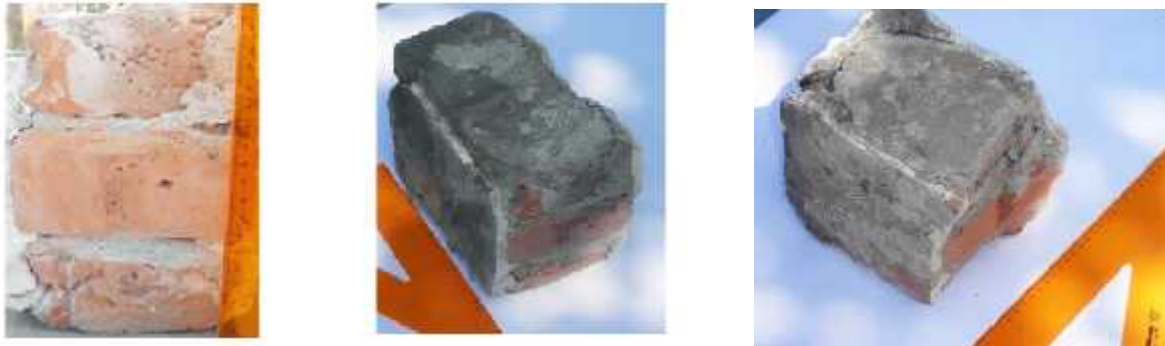
Figure 4 Masonry wall specimens

Tests were carried on brick masonry wall specimens extracted from the wall to evaluate its strength. For stone masonry the strength and deformability characteristics were evaluated considering the Technical recommendations and results from literature [1, 5, 8, 11].
