Restoration Effects on the Experimental Dynamic Behavior of Historical Molla Siyah Mosque

Ismet Çalik¹, Alemdar Bayraktar², Temel Türker², Ali Osman Ayan¹

¹Directorate General of Foundations, Trabzon, Turkey

²Department of Civil Engineering, Karadeniz Technical University, Trabzon, Turkey

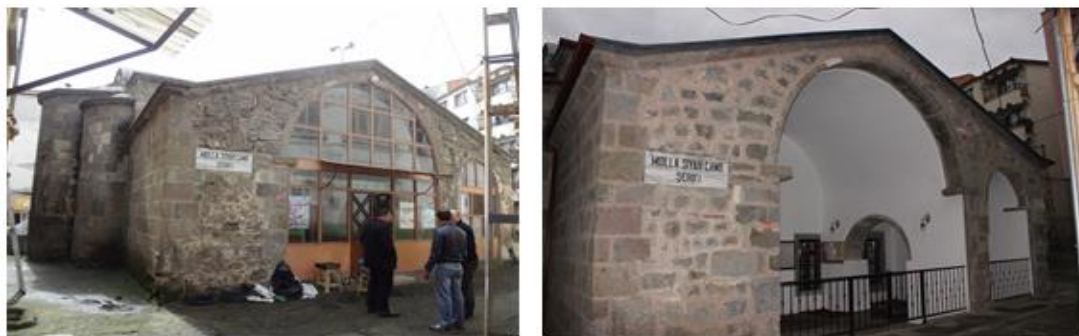
Fig. 2. Images of Trabzon Molla Siyah Mosque before and after the restoration

The structure of the mosque was built as a church in the XI Century initially. It was converted into a mosque before the 1557 [18]. The owner of the structure is Foundation of Fatih Sultan Mehmet, the administration and the representation is carried out by the General Directorate of Foundations. The mosque was restored and strengthened by the Trabzon Regional Directorate of Foundations in 2015. The photographs of the mosque before and after restoration are presented in Fig. 2.

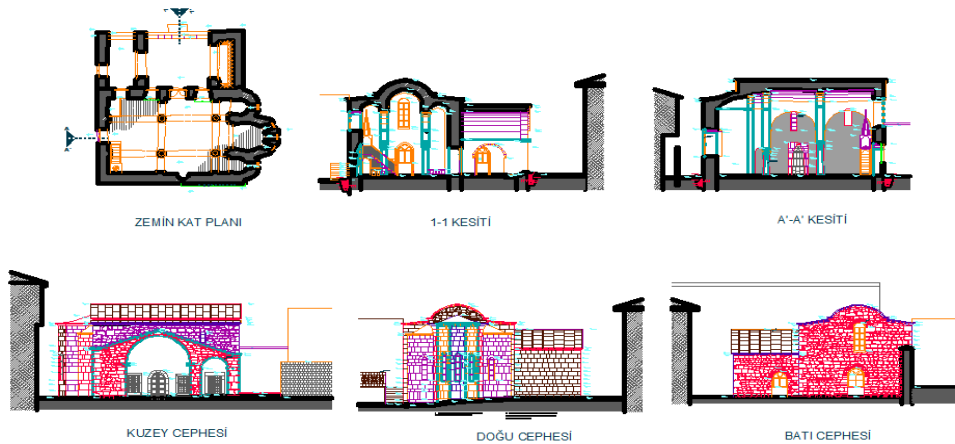
Fig. 4. Layout, inside and outside of the restoration project of Molla Siyah Mosque [20]

layout, inside and outside of the survey project, and Fig. 4 shows images of the layout, inside and outside of the restoration project of Molla Siyah Mosque. The artifact, which was restored by the Trabzon Directorate of Foundations in 2015, is presently open for worship and is actively being used.

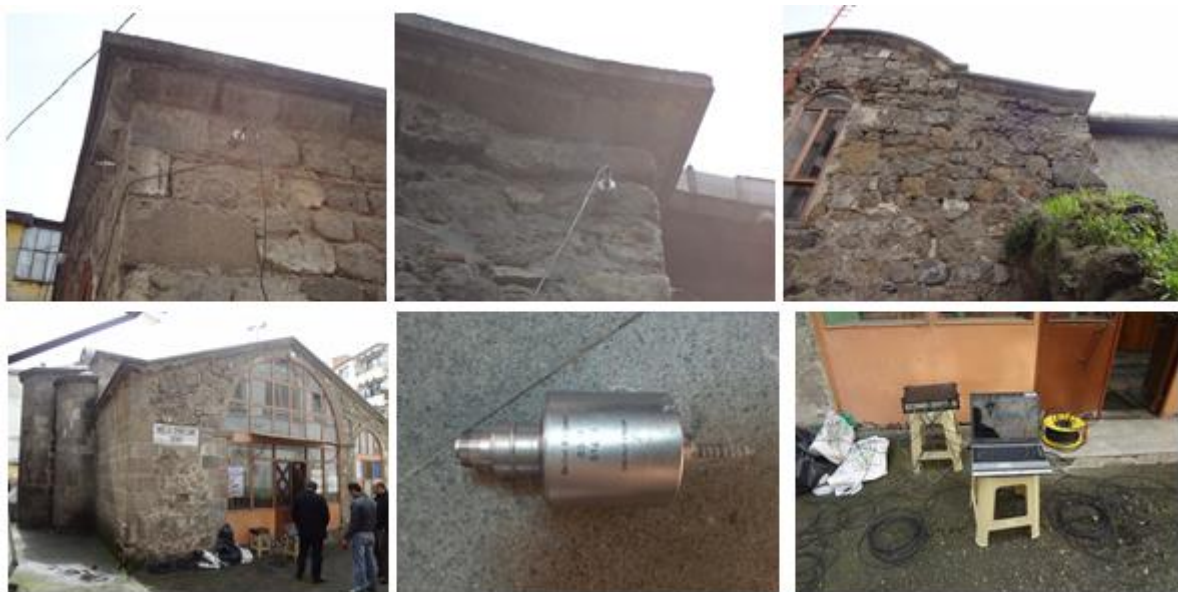
A total of 12 accelerometers were used in the measurements performed on the Molla Siyah Mosque before and after the restoration. The accelerometers were attached to the corner points of the mosque in the transverse and longitudinal directions. Some images of the accelerometer placements and the data acquisition system are given in Fig. 10.

Fig. 10. The images of measurements of Molla Siyah Mosque before the restoration
