**ROCK FALL AND RISK ASSISSMENT  
IN URBAN AREA OF BERATI TOWN  
(MANGALEM)**

**MASTER OF SECOND LEVEL  
EPOKA UNIVERSITY  
2014**

**Thesis Submitted to the Graduate Studies  
Coordination, Epoka University, in Fulfilment of  
the Requirement for the Degree of Master of  
Second Level**

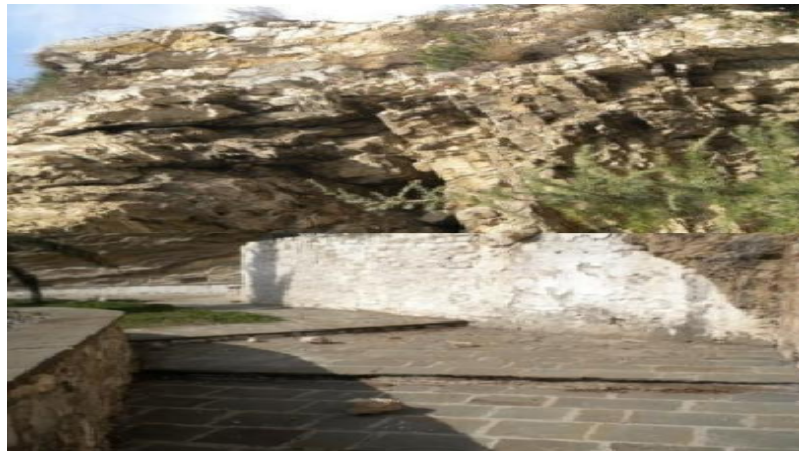
Figure 5. Root growth on the mountain near to Mangalem

One of the problems that might cause the rock fall was also root growth or moving in high wind, if we see the (Figure 4), we may arrive to these conclusion and we may also add that really it is a big problem and that the people and the state should take the needed preoccupation that is granted by law (Figure 5).

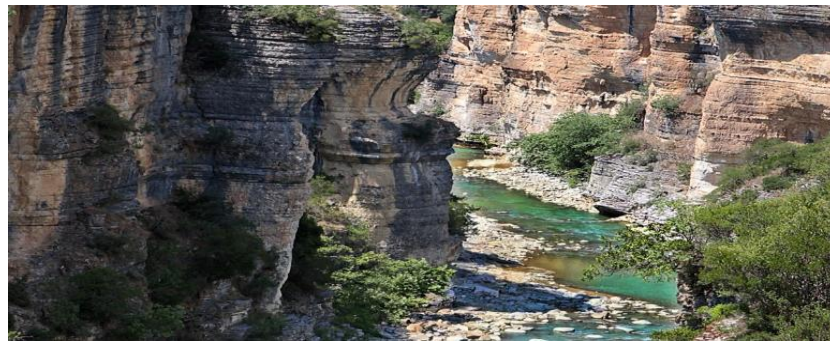
Figure 6. Erosion and poor drainage system in the mountains of Berati

Erosion on the rocks happens for the only reason of the heavy rains that fall in Berat (Mangalem) us we saw upstairs at the table given for the areal raining, also the other thing that causes erosion is even the poor drainage system that the mountain near to the area has, and this is shown even in the (Figure 6) below.

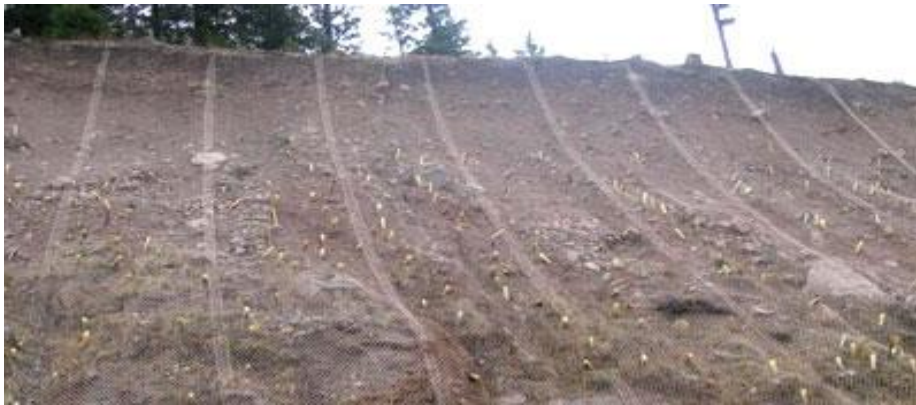
Figure 7.Simple Drapery Fence

If we use the fences for the protection that prevent the falling of the rocks from the mountain, that is something simple. This protection may occur in different

ways like, fences etc. One of the ways is the, simple drapery fence, barrier catch fence (Figure 7, 8).

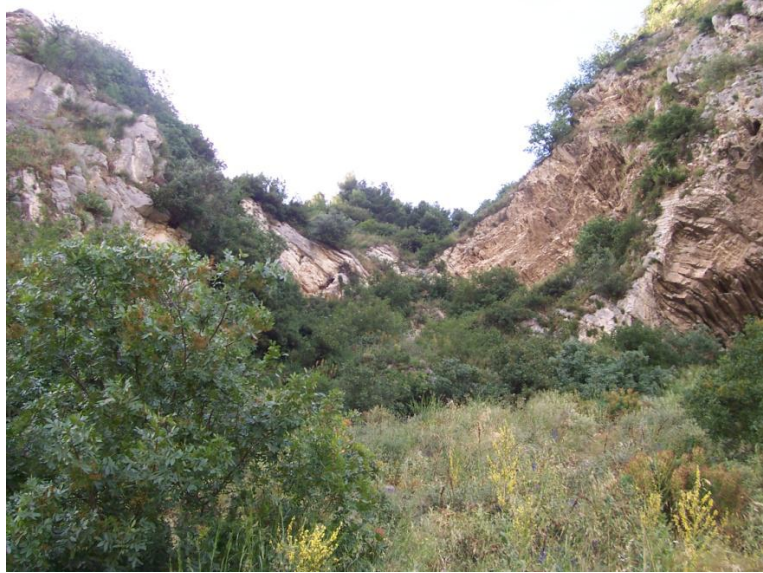
Figure 15. Torrent bed that separates the two parts of morphological unit

No morphological unit. 1 traversed across from a ravine, which has its origins from down the walls of the castle and after permeates the three morphological units, the Osumi River flows into the ravine. Water regime of this ravine appears more ambiguous and unstable. Dry time without precipitation, in total groundwater flow lacks surface and the opposite happens in time of rainfall, where it collects water that have great power to transport material copepod.

Direction of flow waters of this ravine is south - southeast. This morphological unit's ravine divides into two parts: the eastern and the western part (Figure 15).

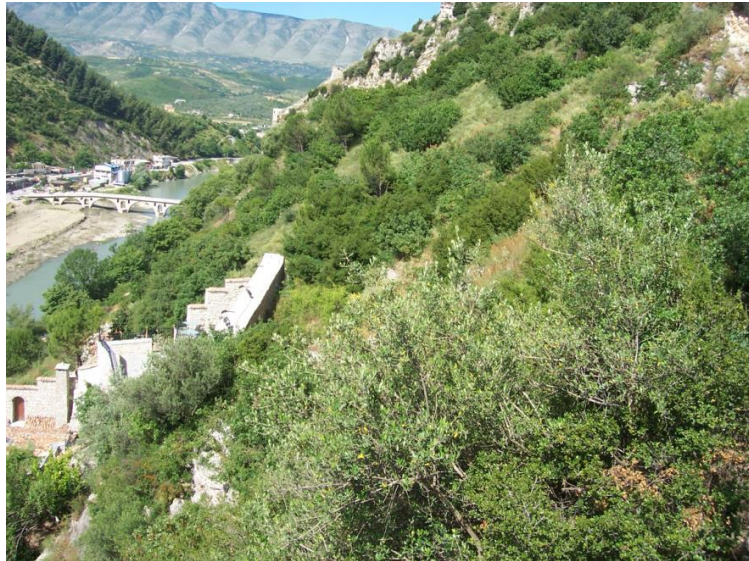
Figure 16. Images from the eastern part of the morphological unit

The eastern part of the morphological unit No.1, is more complicated, as a result of the presence in the form of a nose lifter, which is located about 20 m from the bed of the stream eastward. This morphological increase in this part of the morphological unit No.1, has decline toward the north for the south and near the housing decline slope from 40 to 50<sup>0</sup>, has decreased by vertical. The rest of this slope has decreased mainly south - southeast at angles from 40 to 50<sup>0</sup> (Figure 16).

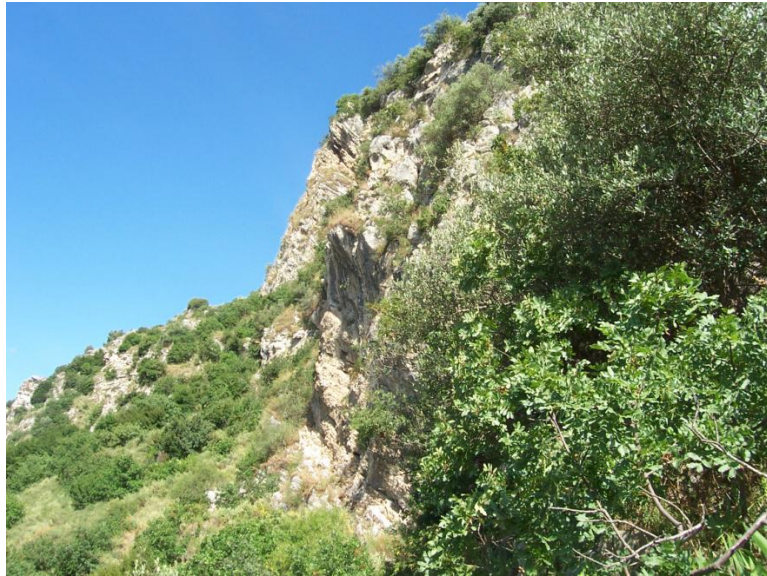
Figure 17. Morphological transition from unit to unit no.1 morphological

The western part of the morphological unit No. 1, is developing uniform and smaller dwellings. Fall is mainly its southern angles from 40 to 550, then the steep eastern portion of this morphological unit. The entire slope that constitutes morphological No.1 unit is forested, mostly with bushes with fruit trees planted by residents. Morphological relations unit No.2 No.1 with morphological unit, are the immediate cutting. Terrain from declines with angles from 40 to 550, passes immediately to falling angles over 85<sup>0</sup> (Figure 17).

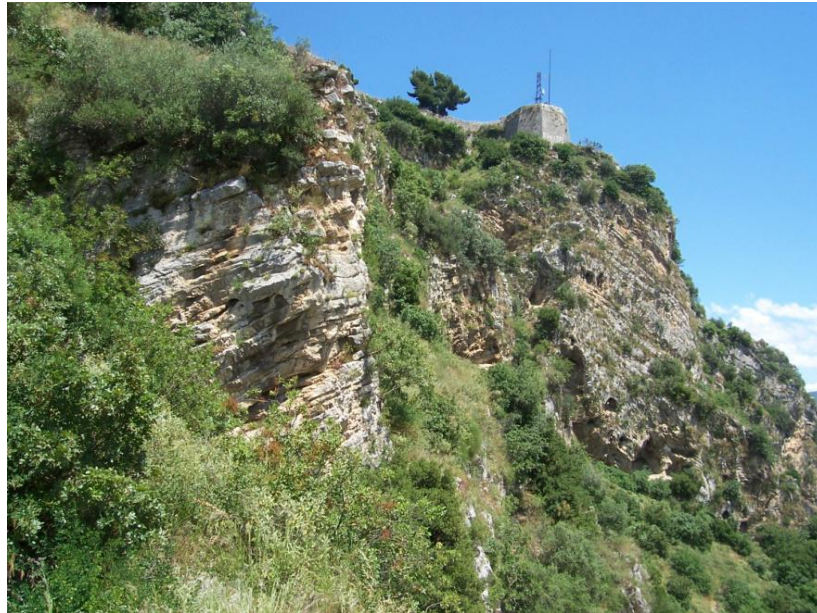
Figure 18. View of the eastern portion of the morphological unit

Morphological Unit No. 2 is located between two other units represented by morphological and slopes to slopes with decline. This unit has the form of a half arch, which is divided into two parts by the dry coulee mentioned above, in the eastern part of the western part. The eastern part of the morphological unit, starts from the middle of the neighborhood Mangalem and continues west to the stream bed. This part has decreased toward the south - southwest and elevation units from contact with morphological unit no. 1 to ridge ranges from 20 m to 55 m (Figure 18).

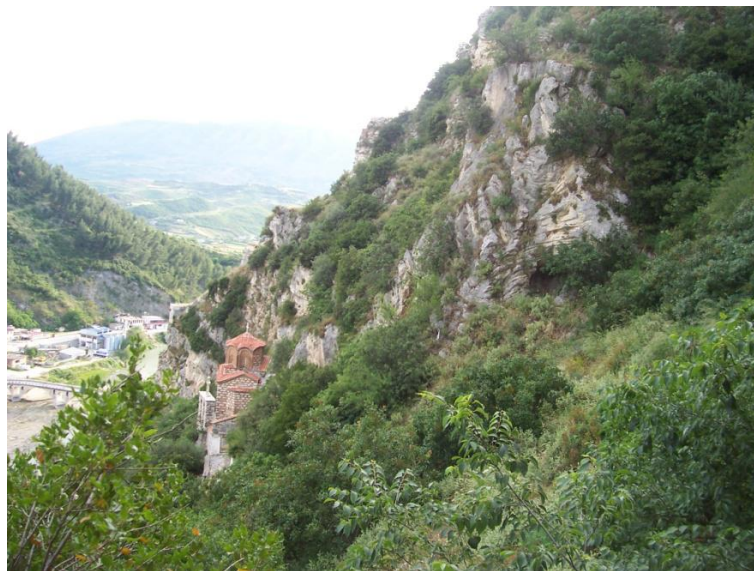
Figure 19. View of the western part of the morphological unit

The western part of the morphological unit No. 2, starts from the bed of the stream and continues up to the national road, near the tunnels. This part has stretch northeast - southwest and southeast toward decline. Its quota elevation is 20-40 m (Figure 19).

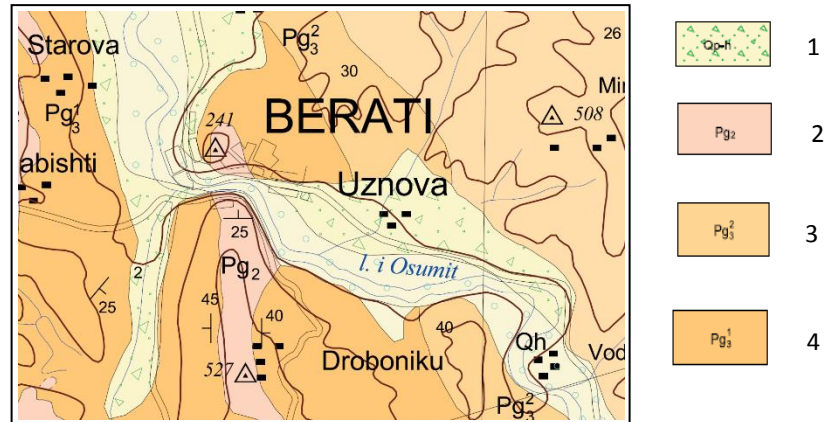
The region which is studied is included in the Adriatic tectonic zone. It is strange but, the Adriatic tectonic zone is very large. They spread in the northwest-southeast direction. The peak creation is determined by anticline structures from hilly ranges. Also an abrasive marine line is created too. The following rocky formations participate in the geological construction of the territory (Figure 11):

Figure 20. Quaternary deposits, alluvial and diluvium soils, 2. Eocene deposits-limestone, 3 and 4. Lower-Medium Oligocene deposits-Flysch rocks, [24]

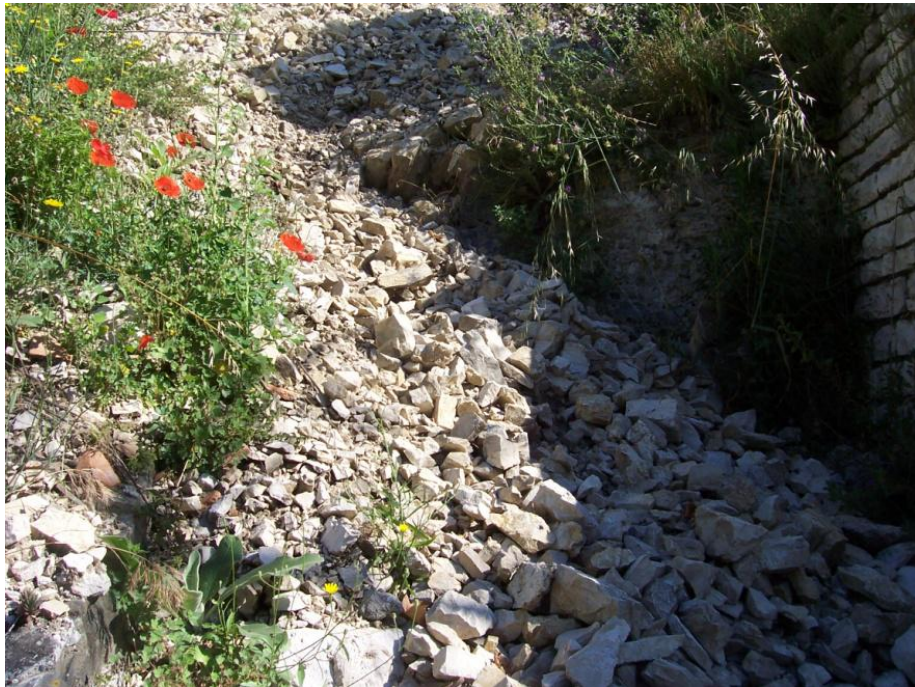
Figure 22. Quaternary colluvial deposits

cm to 2 m. All this sector appears more fragmentary and distorted. In most of the space you occupy geomorphological units No. 1 and No. 2, the spread find the slope Quaternary deposits, which are mostly colluvial type of less proluvial. We koluvionet slopes, or brekçiet limestone slope, have a thickness from 0.2 m to 1.5 m. Near the stream bed, koluvionet joining with proluvionet , reach up to 2.0 m thick . The composition of these deposits is the limestone slope. They are unrelated kohezionale, or about kohezionale very weak, if we are found inside the soil suargjilore (usually in developing countries where the vegetation) (Figure 22)

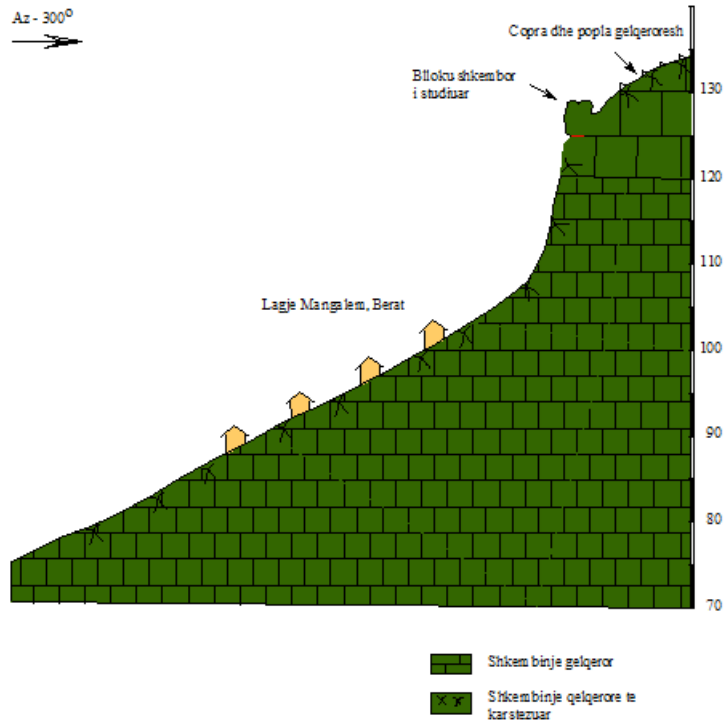
Figure 23. Lithological profile of Berat, Mangalem

During the field work carried out in the studied area, deposits represented by terrigenous and continental formations were encountered. They have been subject of physical and geological processes in various stages of geodynamic evolution of this region. As we have undertaken to provide solutions to many dilemmas, we are going to treat this chapter on the basis of lithological concept. So we come across the following elements in the area we are going to perform studies:

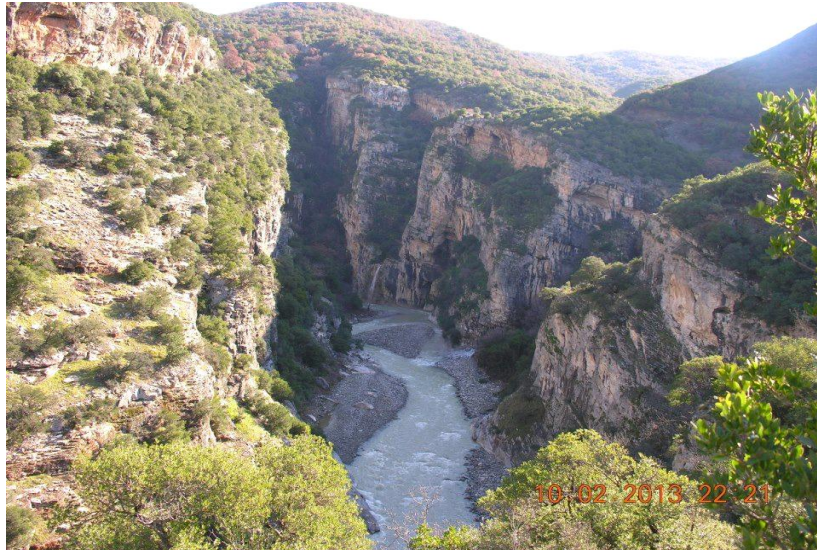
Figure 26. View from the mountain and the hills

180.0-250.0 m identified in hilly morphological unit of Berat, the slope inclination and continental winds that trigger rainfall, the climate with relatively abundant and rainfall and other factors are causes of the powerful development of water erosion. Erosion is generally being developed in the whole of elevated surface in hilly morphological unit, wherever an imbalance in the relief is created, but it mostly conspicuous in molasses soft rocks and also in moderately strong rocks, in water outflows just like torrents, brooks, streams and rivers (Figure 26).

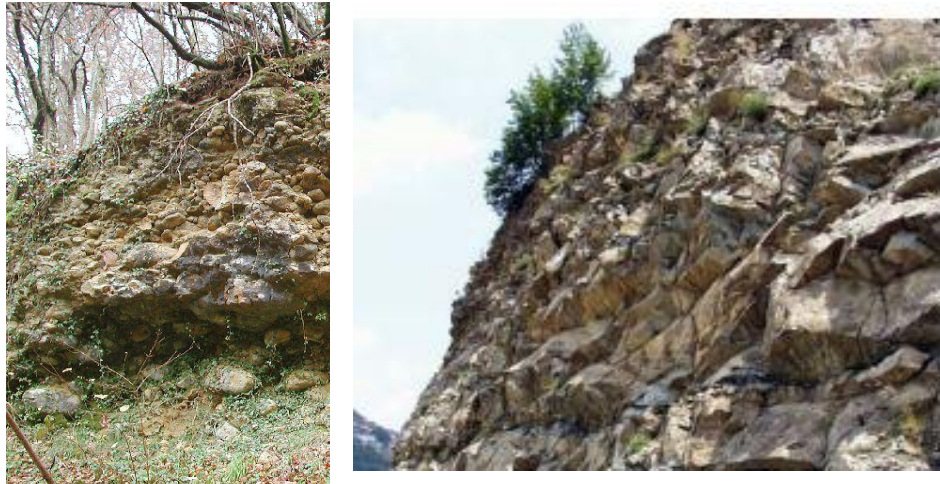
Figure 27. Conglomerate rock and flysch rock

The conglomerate area it is a zone that have even five other types like, marine, fluvialite, estuarine, lacustrine and glacial. In area of study I is found only fluvialite (Figure 27).

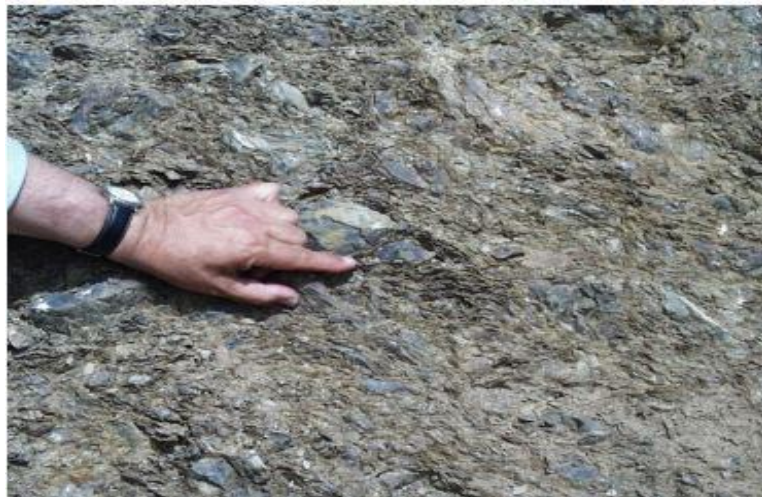
Figure 28. View from siltstone mountain

It is slightly weathered, it has a blue-grey color and it is extremely (Figure 28).

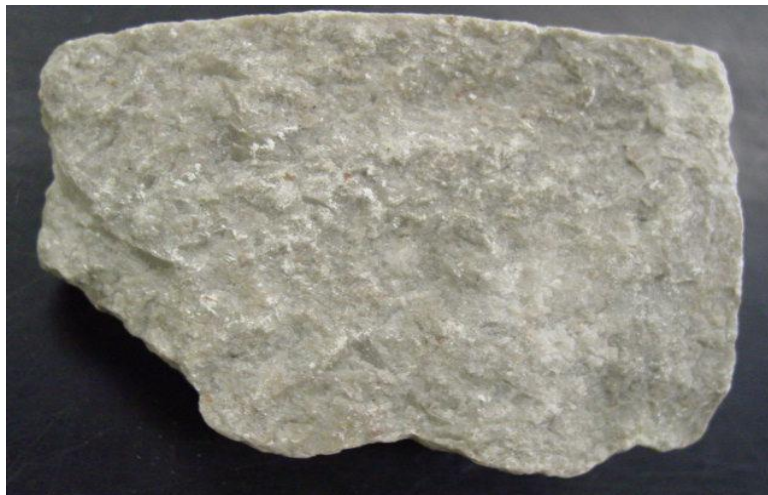
Figure 29. Dolomite limestone

Limestone is an organic, sedimentary rock. This means it was formed from the remains of tiny shells and micro-skeletons deposited on the sea bed. They were compressed to form solid rock. Limestone is made up of calcium carbonate and reacts with diluted hydrochloric acid. Limestone is formed in layers - called bedding planes. These bedding planes contain vertical cracks called joints. Joints and bedding planes make the rock permeable. In area of studding we have mostly dolomite limestone (Figure 29).
