Towards a Disaster Risk Management Plan of Historical Centers: Case Study of The Historical Center of Gjirokastra

Julinda Keçi¹, Endrita Mulleti²

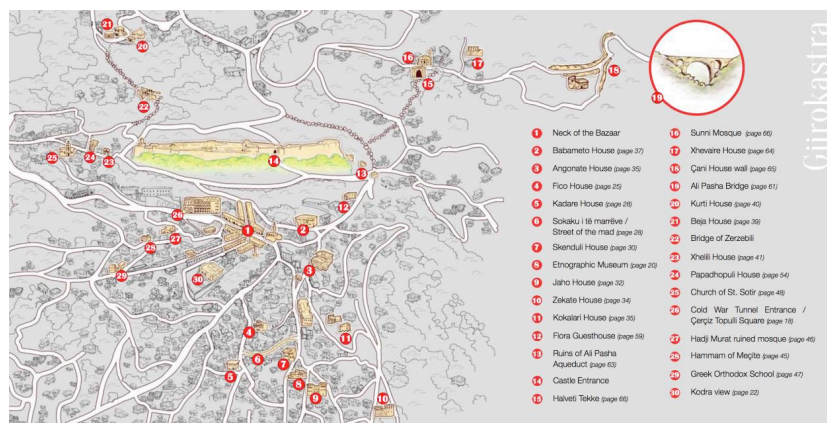
Figure 1. The Historic Center of Gjirokastra and key monuments

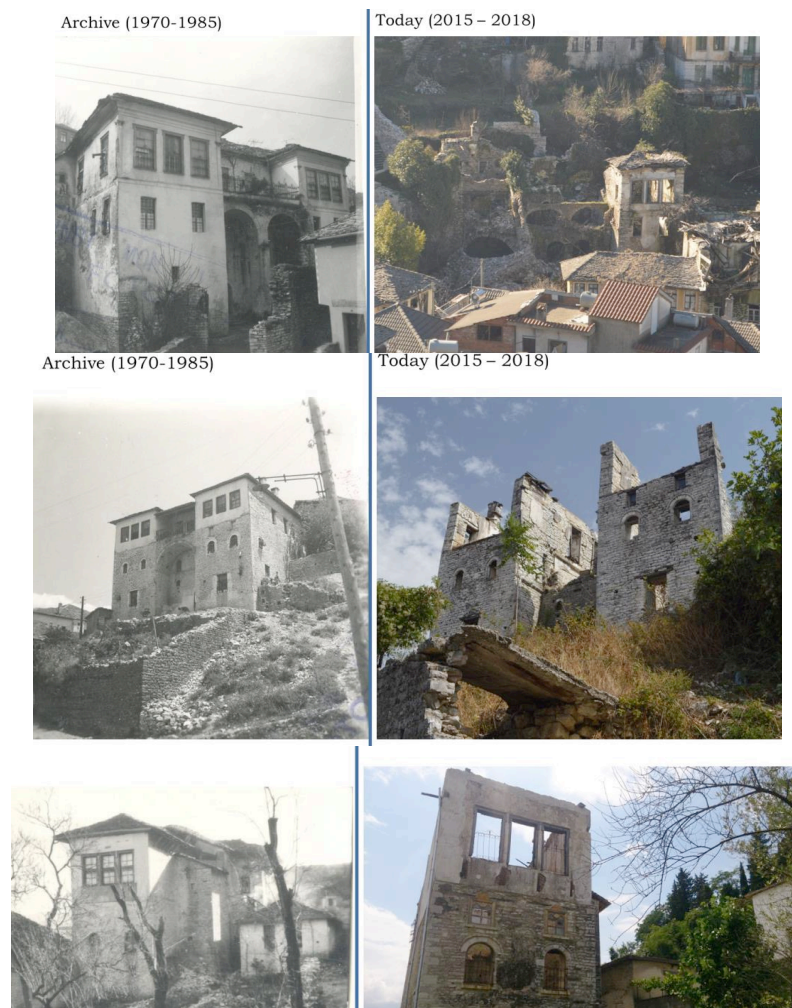
Figure 2. Degradation of dwellings in Gjirokastra [8]

Figure 2 represents some typical degradation of dwellings in Gjirokastra, Archive recordings of Institute of Cultural Monuments.

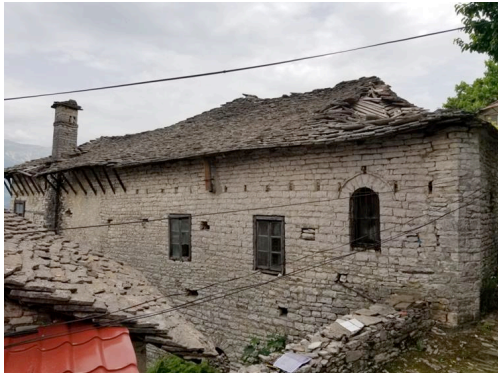
Figure 3. Roof degradation

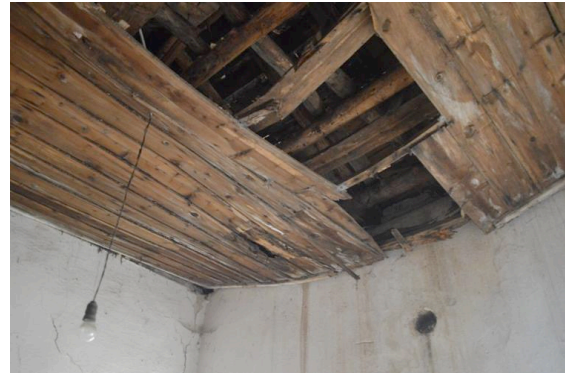
Figure 4. Presence of Humidity and degradation of wooden ceiling

- field survey for the collection of preliminary data on the state of conservation of the historic buildings;
- the methodology used was based on clear photographic data collection, technical schedules and identification of needs for interventions, leading to compilation of a preliminary list of interventions with cost list for each building (Figure 5);
- the results consisted of determining the nature of potential threats to the building:
 - i. the ROOF, its condition is imperative to the state of conservation of the structure. If humidity infiltrates through and reaches the wooden structure, this is the starting point of degradation of the roof, leading to the wooden floors and the walls; the process is accelerated if the building is abandoned (Figure 3)
 - ii. presence of HUMIDITY (capillary), LANDSLIDES, ELECTRICAL SYSTEM (Figure 4).

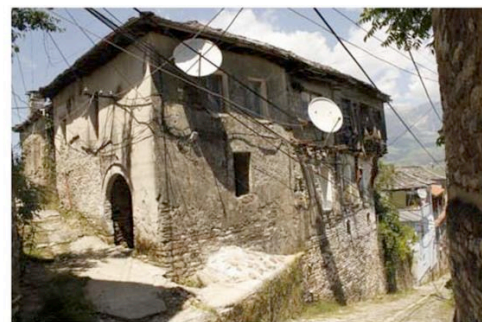
GJINDJA AKTUALE
 Gjendet ne kushte te rëndura si ne eksterier edhe ne interior. Catisa ehtë e rremuar dhe degradimi po perparon. Tavani jane pothuajse te shkaterruara nderkohë qe ehtë e braktisur nga pronaret dhe banohet nga familje te ndryshme. Mierkaset ne presentme te ma dhe jane te dekomponuar dhe mbiturime lera brenda baneses e rëndojne situatën me peshten dhe lagështine qe mbajne. Tregji i vjeqe-dhe-ut dhe karrahimëve qe perdoruesi kane vendosur ka probleme dhe rrjedhe lagështia nga keto tregje deperton ne strukturen e monumentit duke e vene ate ne një rrezik te perherbem. Rreziku nga zjarri gjitha këtu ehtë present. Banoret e tarashem e perdorin monumentin pa kenter duke nderhyre me forma brutale.

RISKU KRYESOR :
 Risku kryesor ehtë zjarri. Nderhyrjet pa kriter jane një rrezik permanent. Gjithashtu kolapsi i catisë dhe nderkatese hyn ne risqet e MEDHA qe ky monument po per ballat.

Figure 5. Example of the Risk Identification file [8]

NEVOJJA PER NDERHYRJE
 Nevojat te menjshmerhane ne pastrimin e monumentit, plotesimin e catisë dhe muraturës. Perforcime te nevojshme per sa i perket nderkatese etj.
