## **SEISMIC STUDY OF HISTORICAL CASTLES AND THE EFFECT OF SOIL-STRUCTURE INTERACTION : CASE STUDY OF THE CASTLE OF BASHTOVA**

### **ABSTRACT**

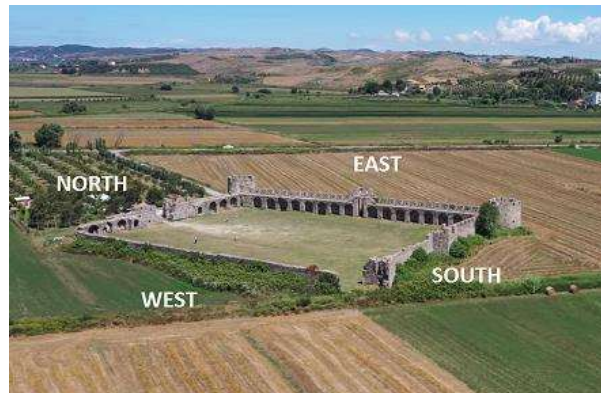
Figure 35: Areal view (orientation) of the castle.

The shallow rigid foundations of the building are built of irregular massive stones, bonded with lime mortar. The masonry built on the foundations is also built with stone blocks connected with lime mortar, having a thickness of 140 cm in the towers, while the walls between the towers having a thickness of 70 cm. Arches that serve as buttresses support the longitudinal walls; they are 70 cm wide and 140 cm thick. The current height of the towers is 8.3m, while that of the walls is 6.3m. The shape of the castle is quadrangular, but not a regular rectangle, however its western wall is totally detached from the rest of the castle due to the lack of two corner towers. This wall belongs to another phase of construction / reconstruction; the construction technique is distinct from the original. Even half of the north wall is built with the same later technique; there is even a quite distinct crack that corresponds to the interface of two different techniques.

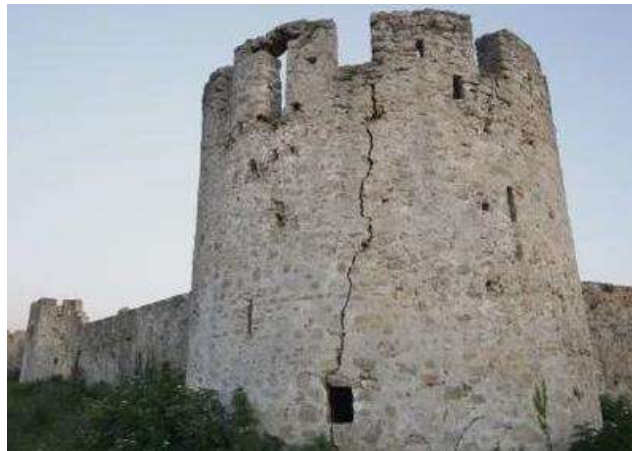
**Figure 9: Existing crack of the north-eastern tower.**

The above values and the location of the concentration of tensile/shear stresses in the tower, clearly show that the settlement has caused the loss of shear / tensile strength of the masonry and explains the cause of the cracks that appear in this tower.

- At the local level: improving the bearing capacity of the soil in the north-east tower area, in order to eliminate non-uniform settlements. The proposed method is to install piles in the area around the tower.
