SEISMIC PERFORMANCE EVALUATION OF RESIDENTIAL RC TEMPLATE
BUILDINGS USING NON-LINEAR ANALYSES PROCEDURES

A THESIS SUBMITTED TO
THE FACULTY OF ARCHITECTURE AND ENGINEERING
OF
EPOKA UNIVERSITY

MARSED LETI

JUNE, 2022

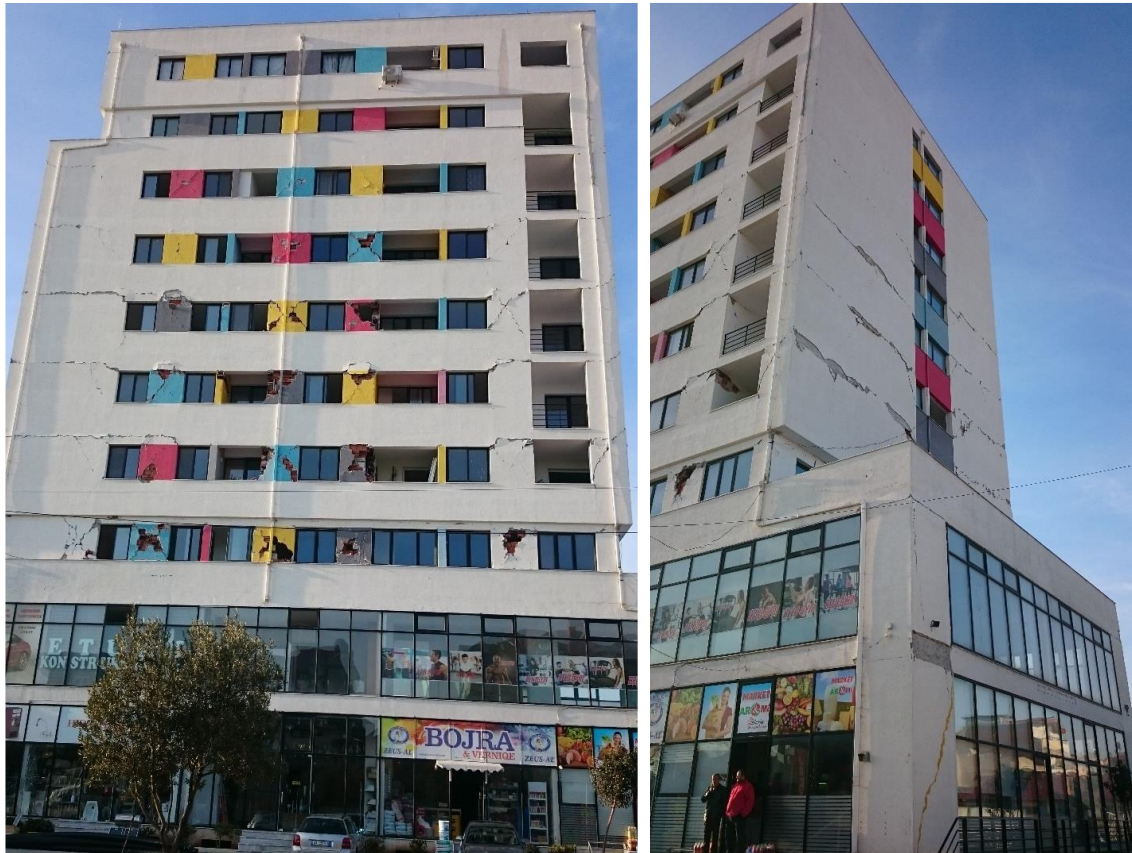
Figure 12: Heavily damaged high story Reinforced Concrete building

Such factors as: poor concrete quality, steel corrosion, inadequate reinforcement detailing in structural elements, steel corrosion due to insufficient concrete cover were a few of the deficiencies that led to heavy damages in the buildings hit by 6.4 Mw earthquake in Albania.

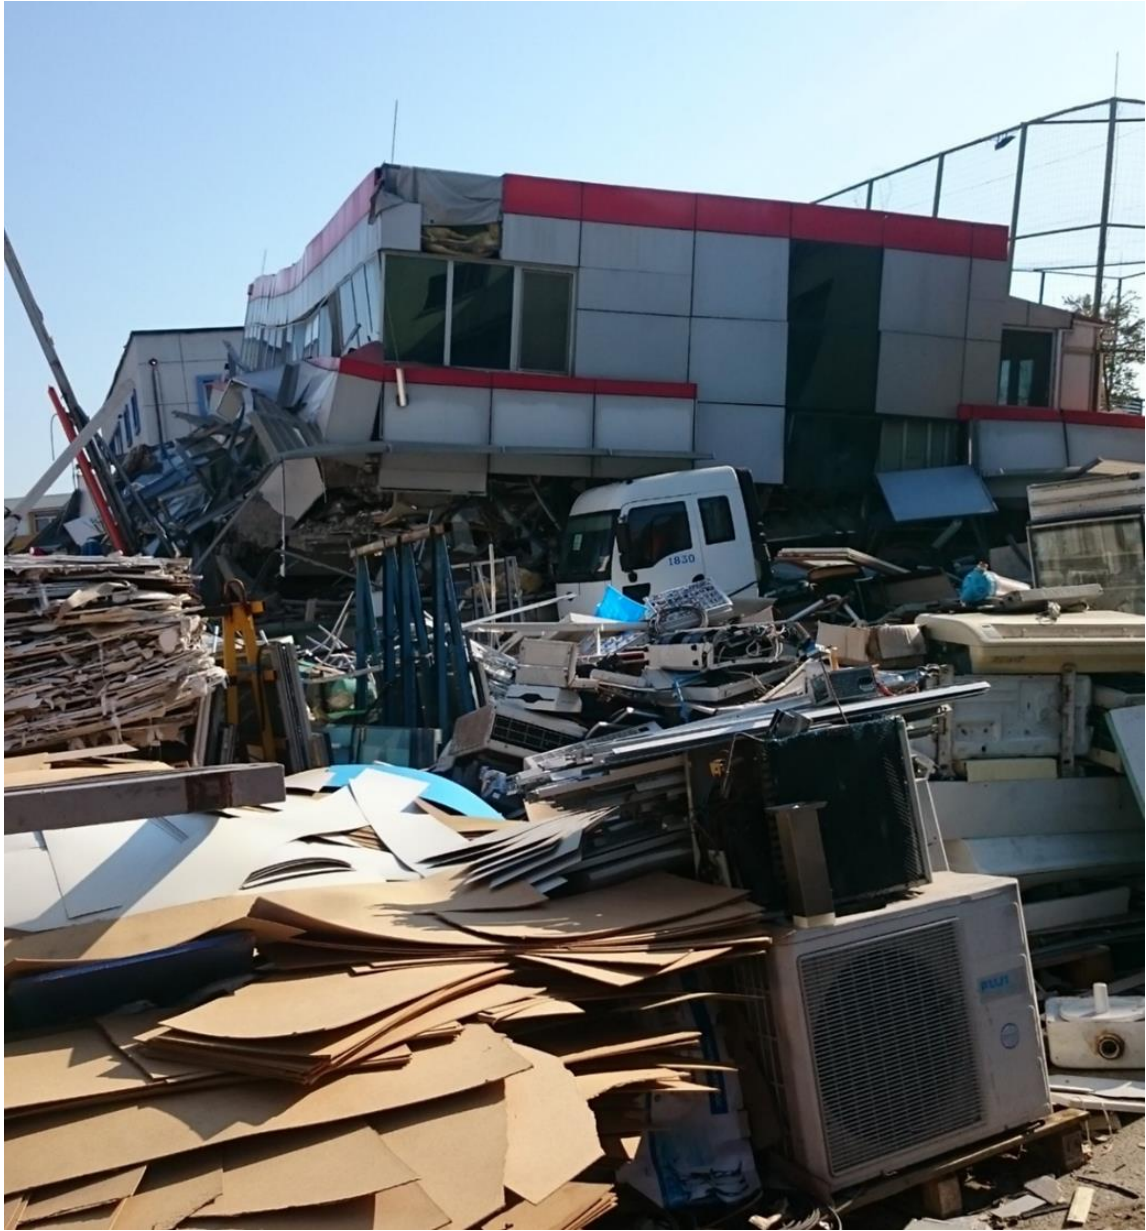
Figure 13: Building collapsed completely

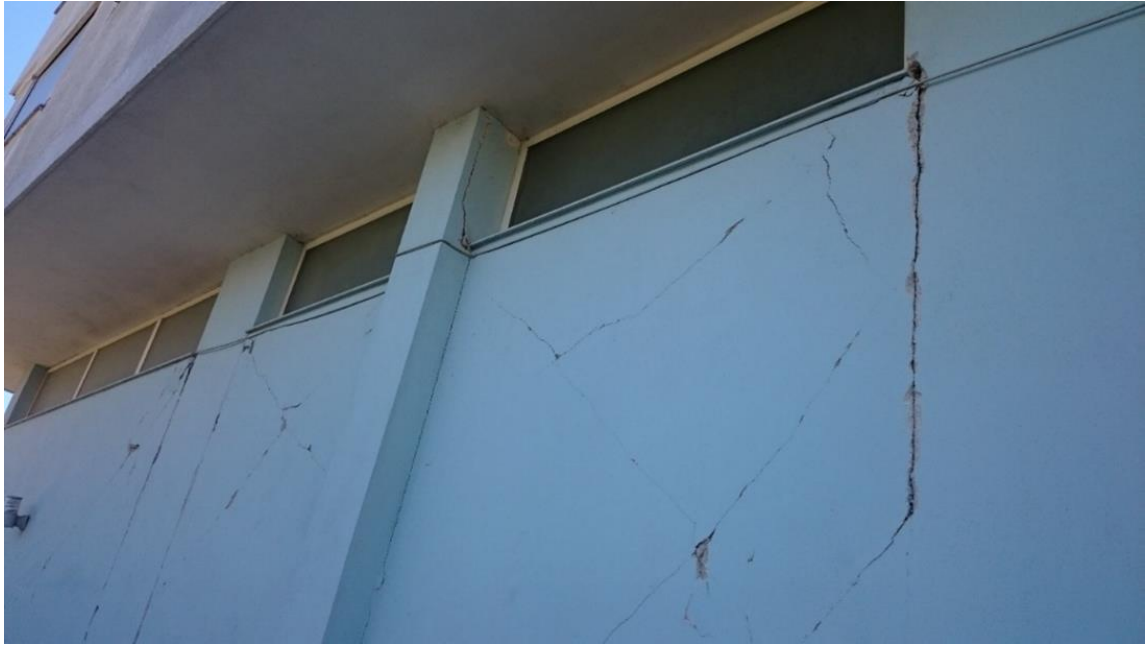
Figure 16: Short column formation and in plane failure of partition walls

Due to the openings in the infill walls of these buildings, the short column mechanism is formed resulting in accumulation of large shear forces. Usually, the damage in these short columns is in the form of X-shaped cracking as shown in the **Figure 15a** and **Figure 15b**.

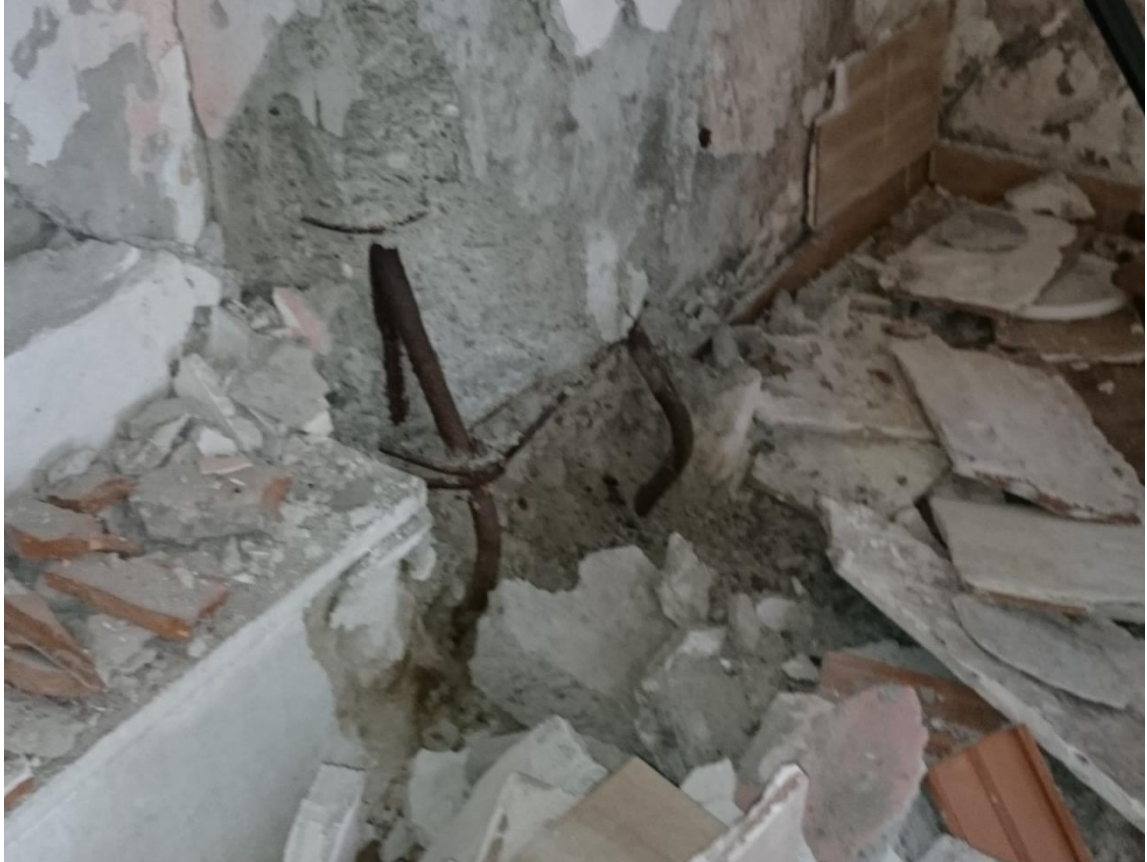
Figure 19: Buckled rebars on a reinforced concrete column base

Reinforced concrete buildings suffered heavy damages and buckling of rebars occurred as shown in (**Figure 18 - Figure 22**). It was observed that stirrup detailing was insufficient. Similar effects are also seen massively in the damaged buildings investigated during the November 26, 2019 earthquake. **Figure 22** a,b,c shows the inadequate application of stirrups in the structural elements. Some cases the stirrups space goes over 25 cm from each other. On the other hand, due to insufficient concrete cover and lack of maintenance, rebars were corroded completely.

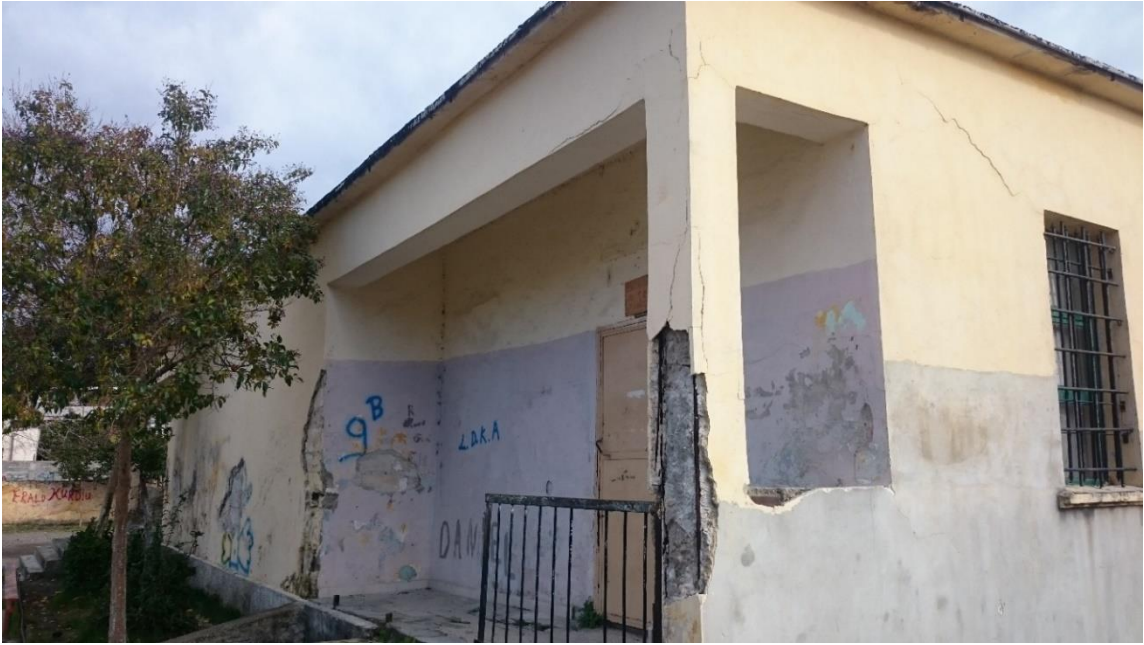
Figure 20: Reinforced concrete column with no stirrups

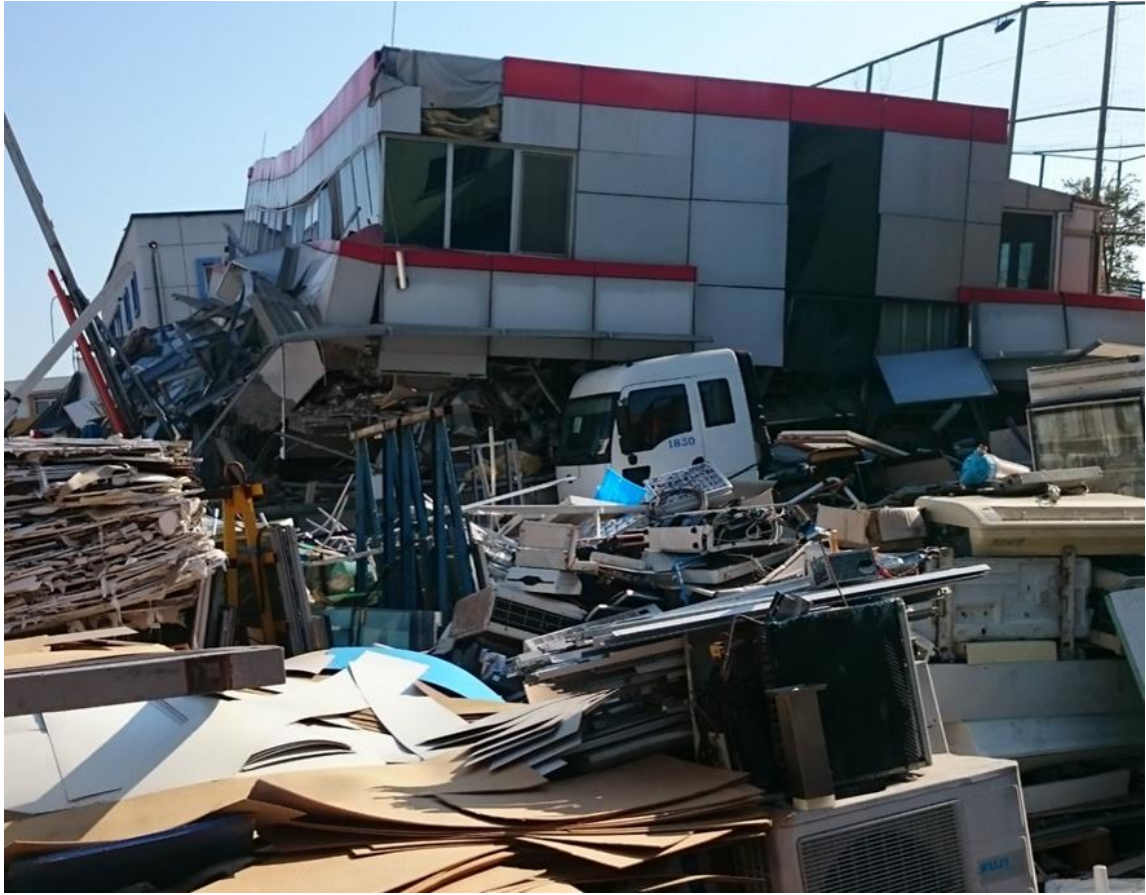
Figure 23: Reinforced concrete industrial building collapsed completely

Concrete quality plays a significant role on the structural performance against earthquakes. In Albania there are many cases where handmade concrete is used, especially in the old buildings. On the other hand, workmanship service was not at the desired level resulting thus in a very low material quality. As seen in **Figure 24** the homogenic mixing was not achieved properly therefore the compressive strength of the concrete is not at the required level.

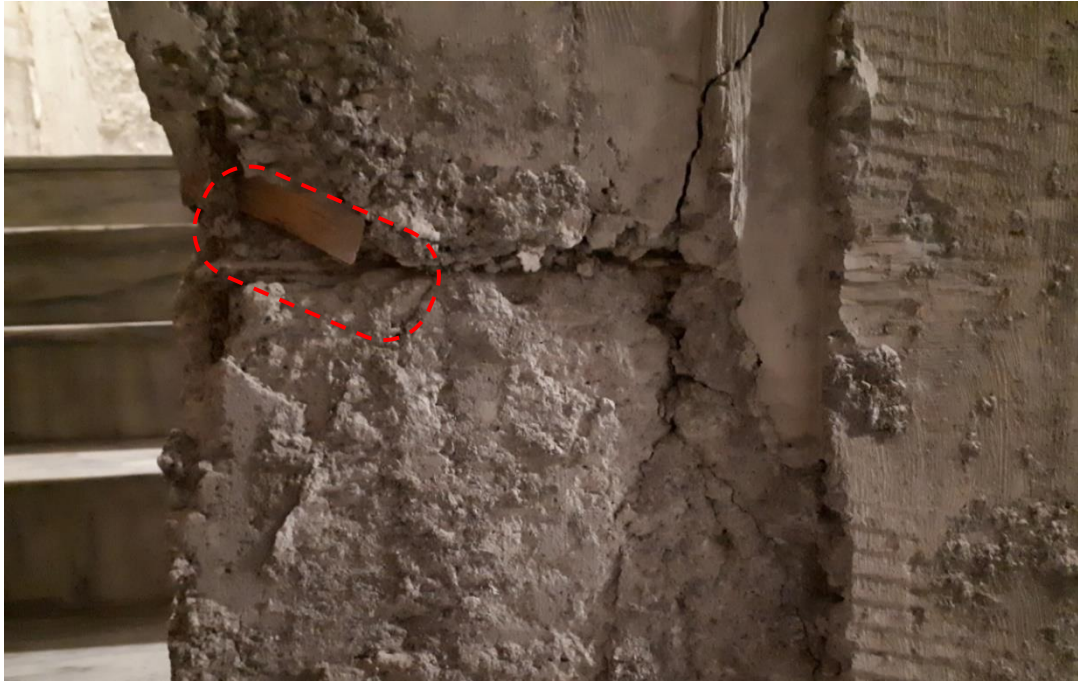
Figure 24: Poor quality of concrete, part of formwork found inside the concrete

Moreover, the concrete looks to be not bounded properly with reinforcement as indicated (**Figure 24** and **Figure 25**) with deep cracks and corroded stirrups. Besides the low quality of the concrete, the vibration process must have been not controlled accordingly. In addition, if it is observed carefully, it is seen that a piece of wood is found inside the concrete columns. All these factors conclude in a poor-quality material of the building as well as low workmanship.

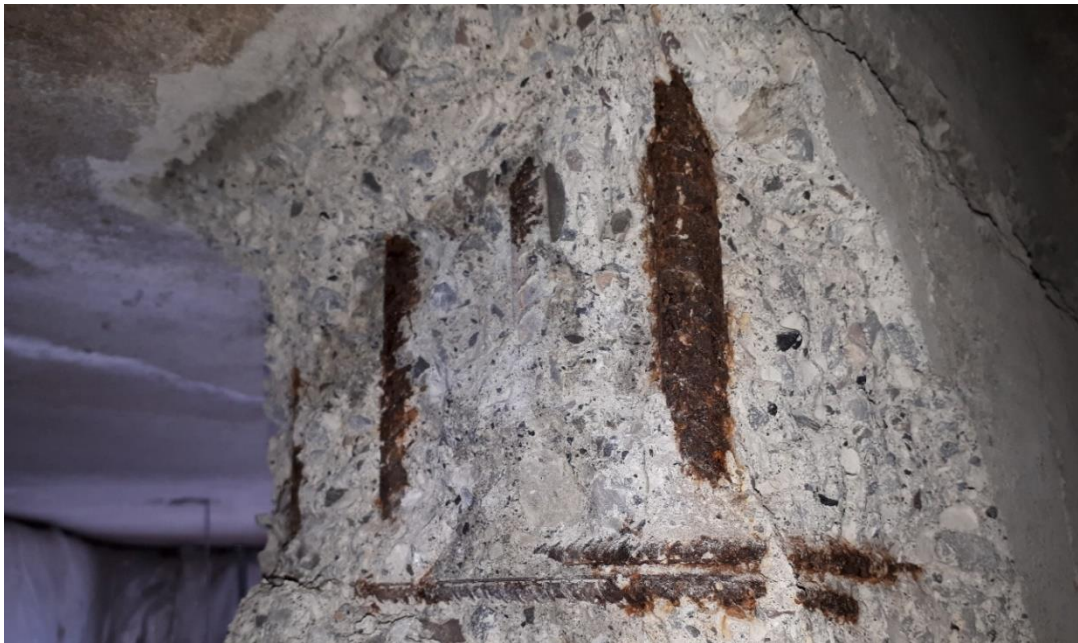
Figure 25: Corroded rebars and damaged column

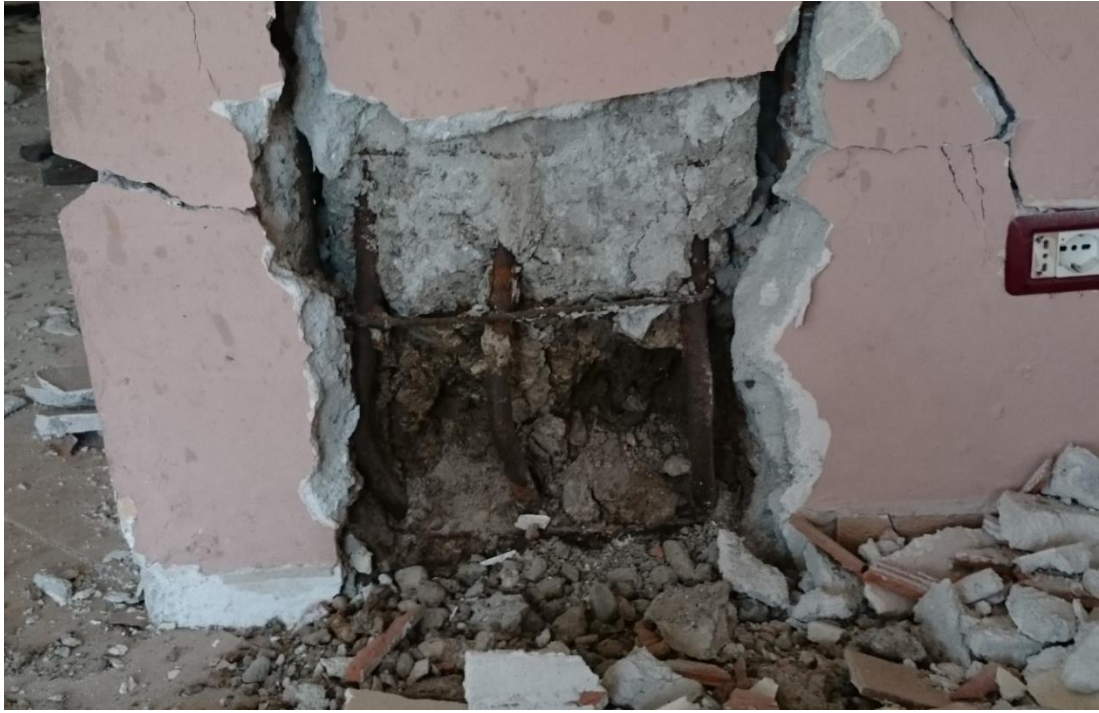
Figure 26: Column failure, corroded rebars, poor concrete

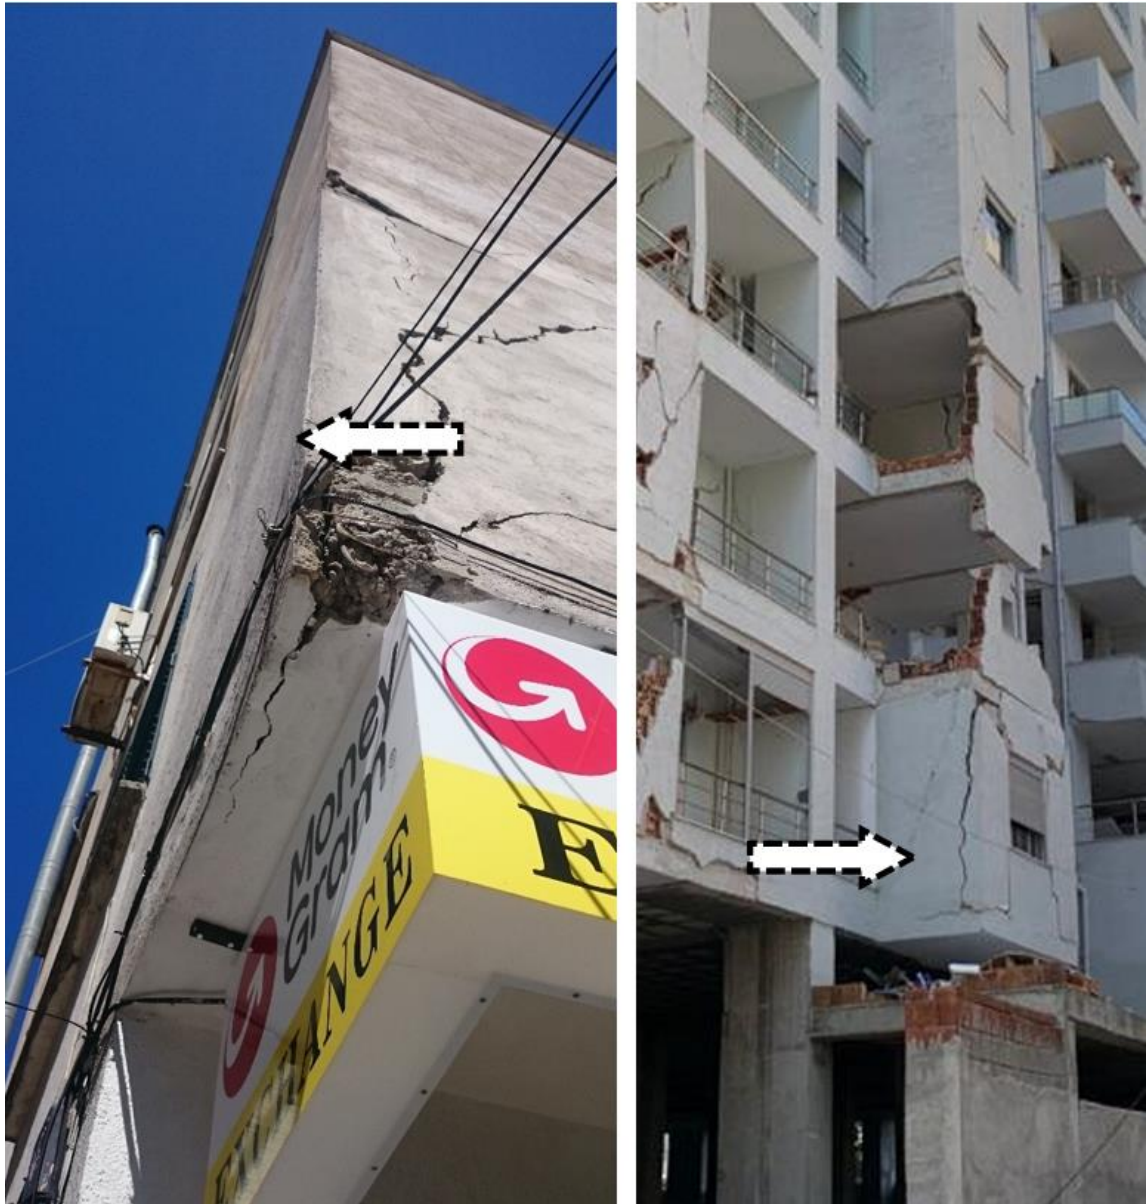
Figure 30: Heavy overhang and failure at the corner

Another damage pattern has been observed at the corners of reinforced concrete buildings during November earthquake. As shown in the figure below, the corner of the wall is heavily damaged. From the observations, seems that the overhanging beam has failed to withstand cantilever loads during the earthquake.

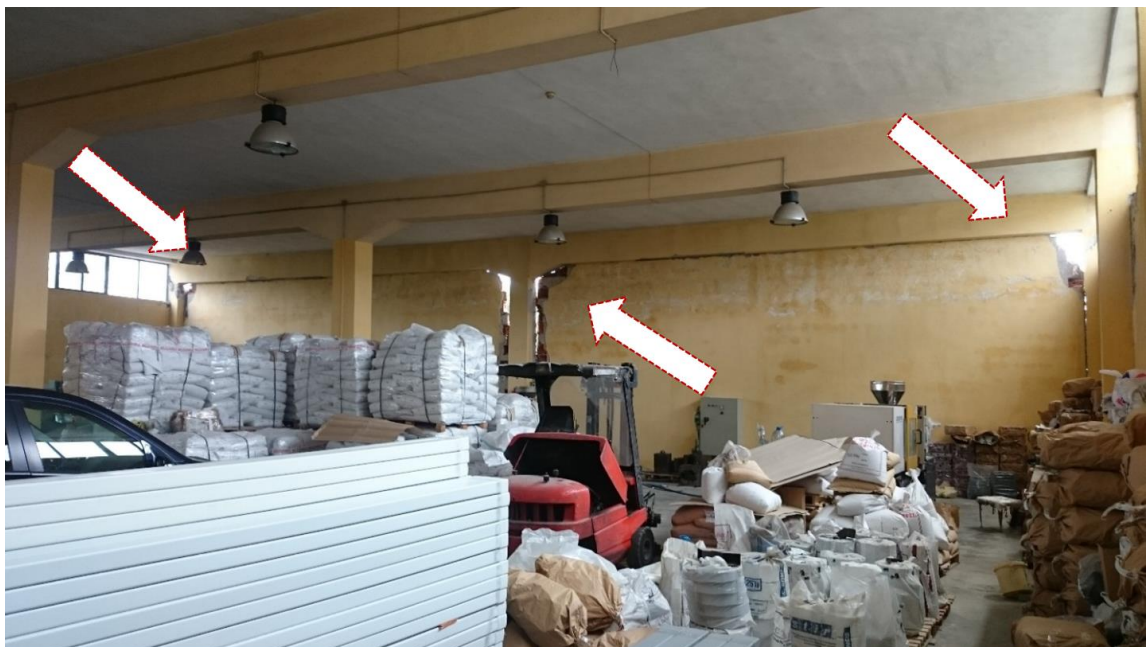
Figure 33: Out of plane failure of partition walls

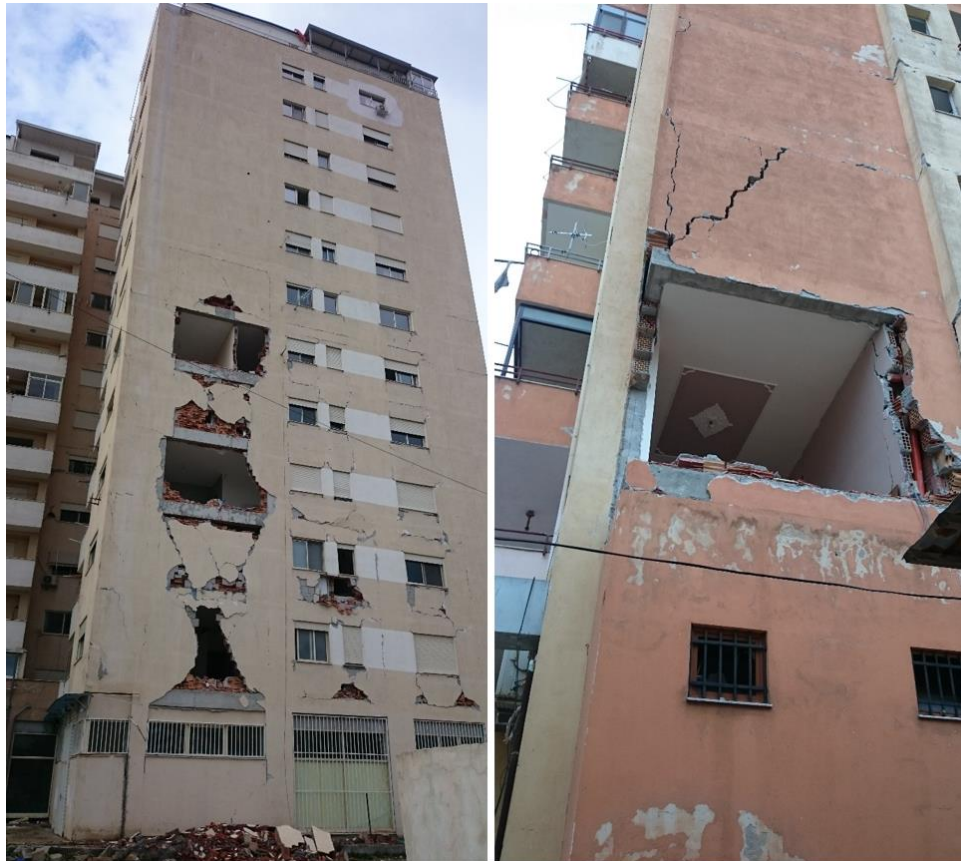
Figure 35: Heavily damaged high-rise RC building

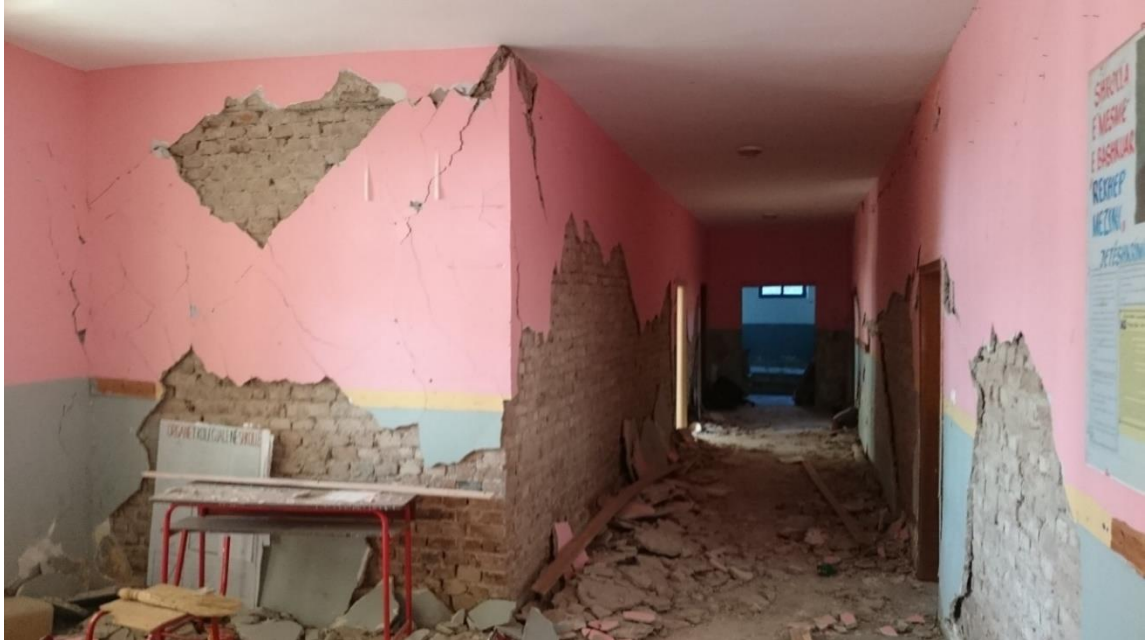
Figure 36: Heavily damaged walls on a masonry building

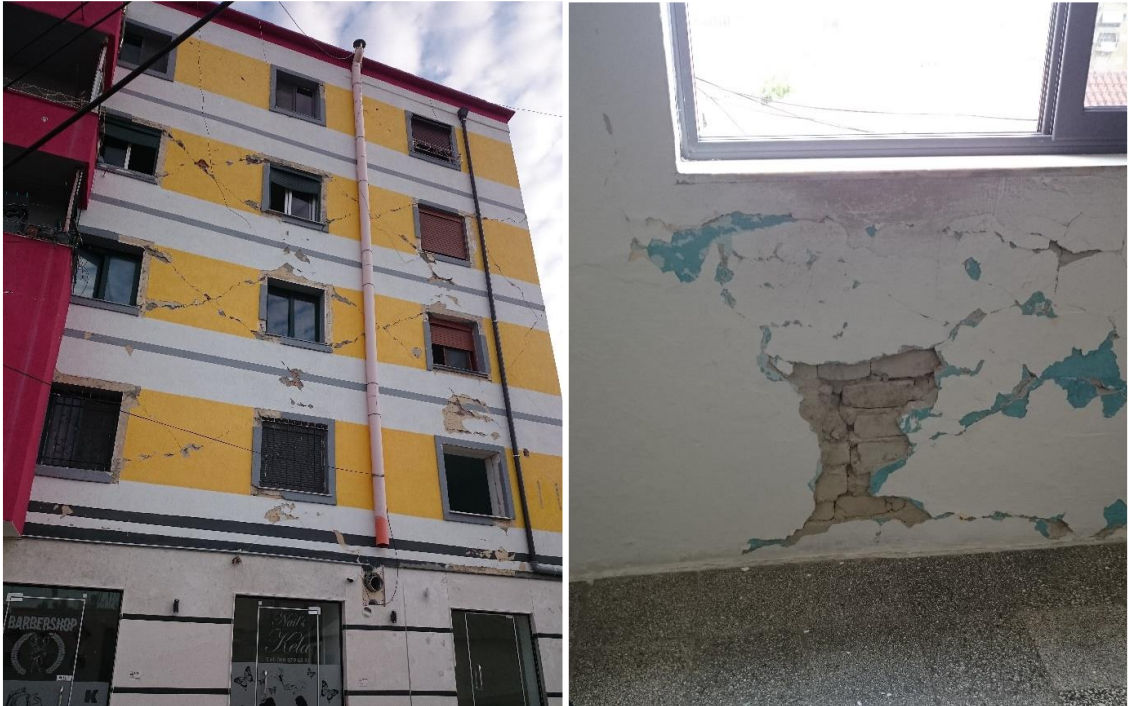
Figure 39: Shear cracks on the front façade of a masonry building

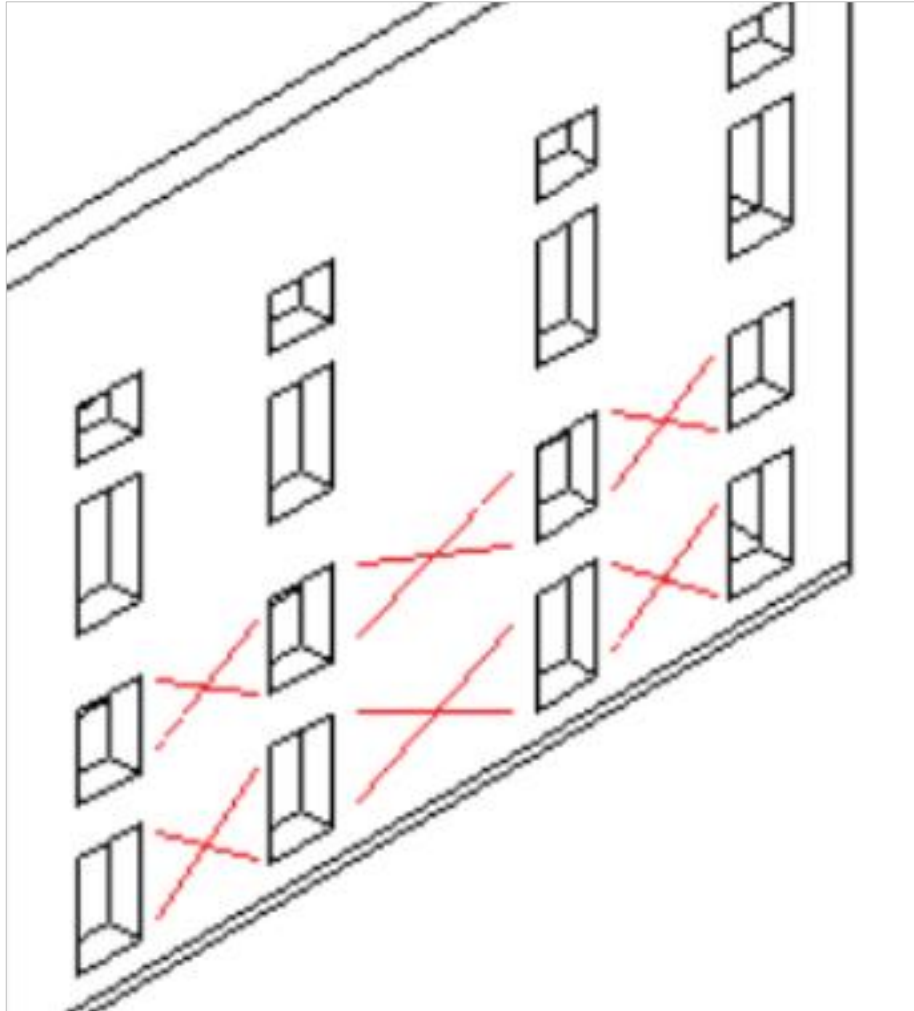
Figure 40: Schematic representation of diagonal shear cracking of piers

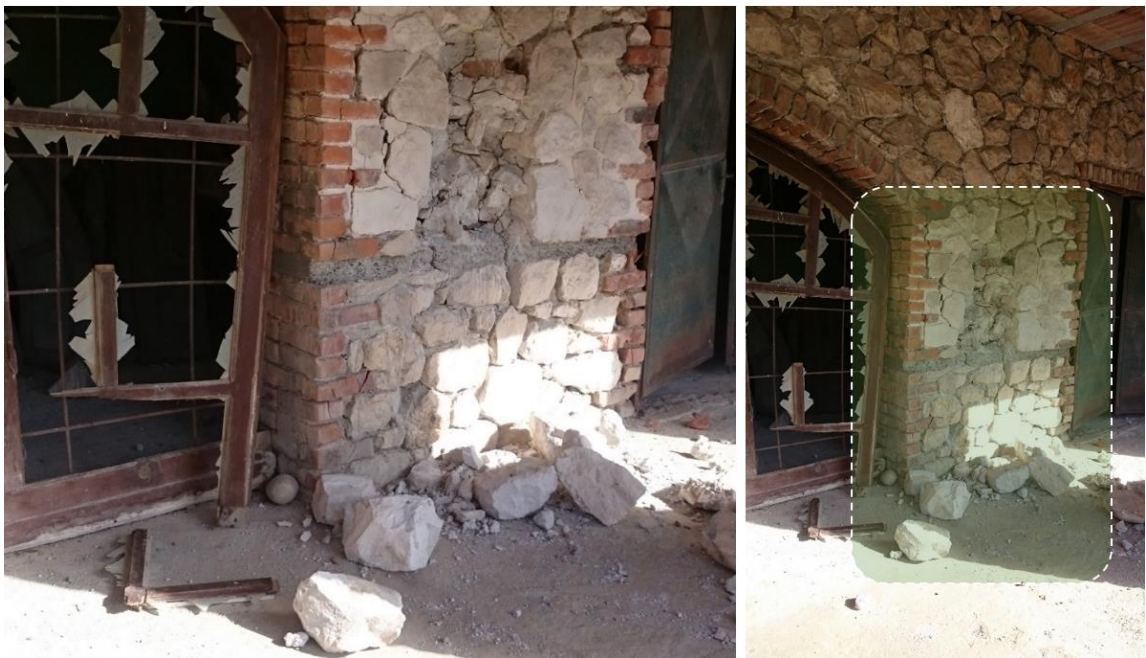
Figure 45: Pier damage on a stone masonry building

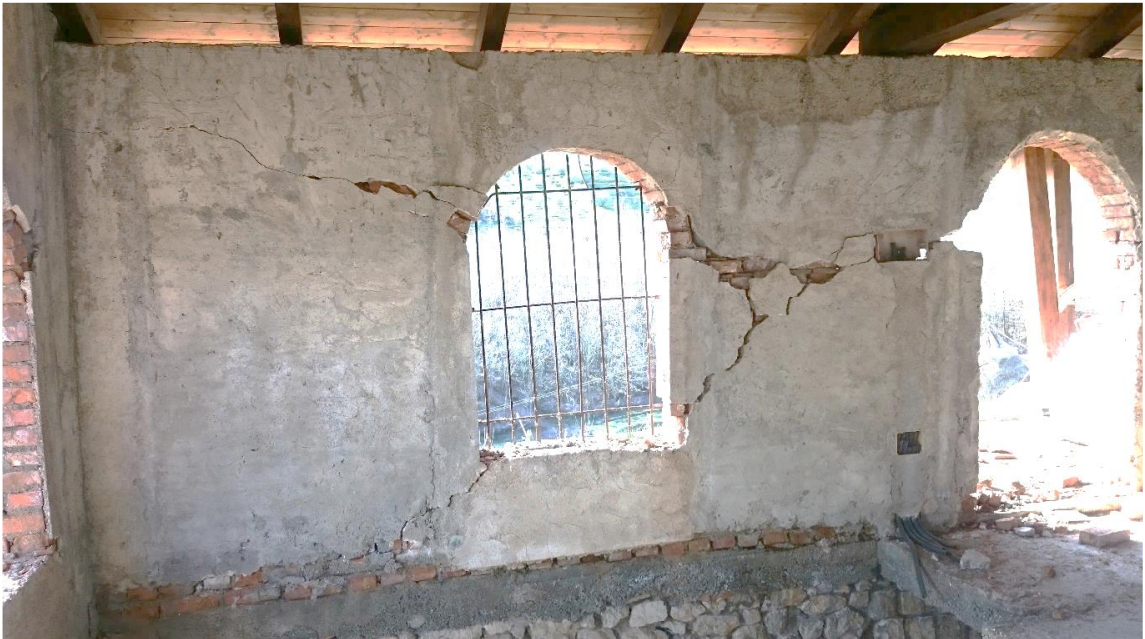
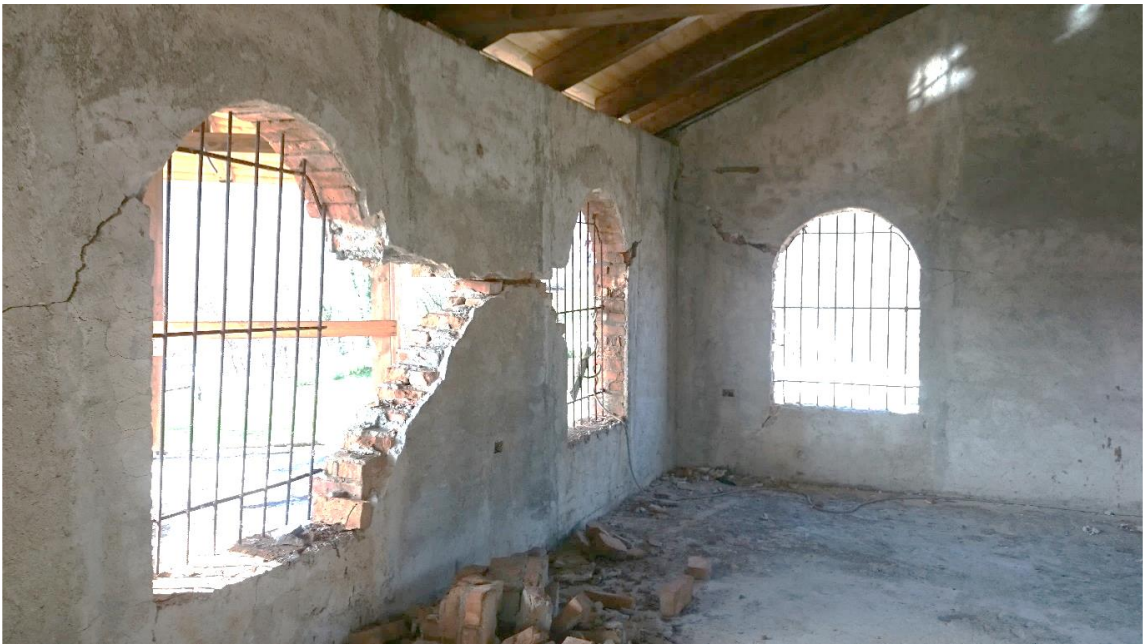
Figure 46: Heavily damaged pier of masonry building

poor material quality used, insufficient detailing, were some of the reasons led these elements to undergo deep cracks until the complete failure.

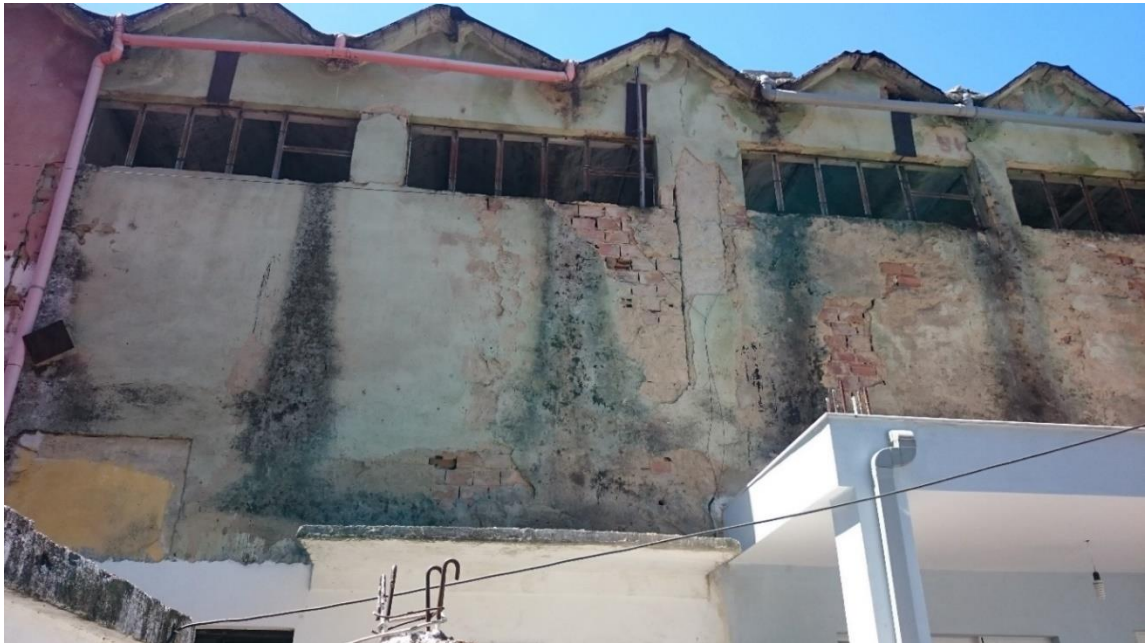
Figure 47: Damage due to short column and lack of maintenance

Moreover, it is seen that a major part of the shear failure of piers in masonry buildings were attributed to the short column effect.

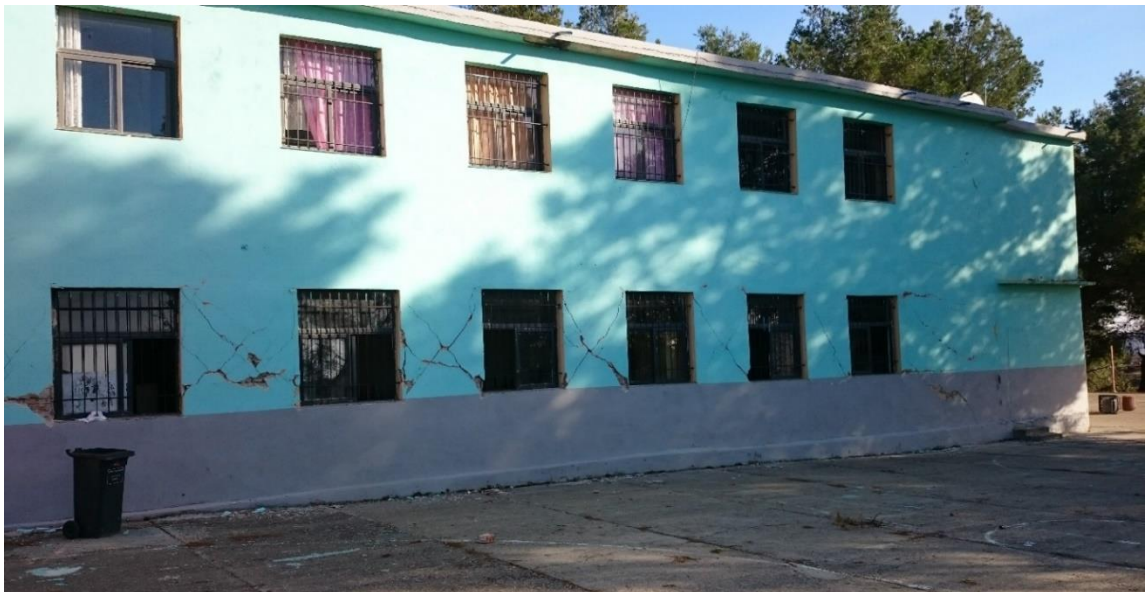
Figure 48: Shear crack on piers of a masonry school building

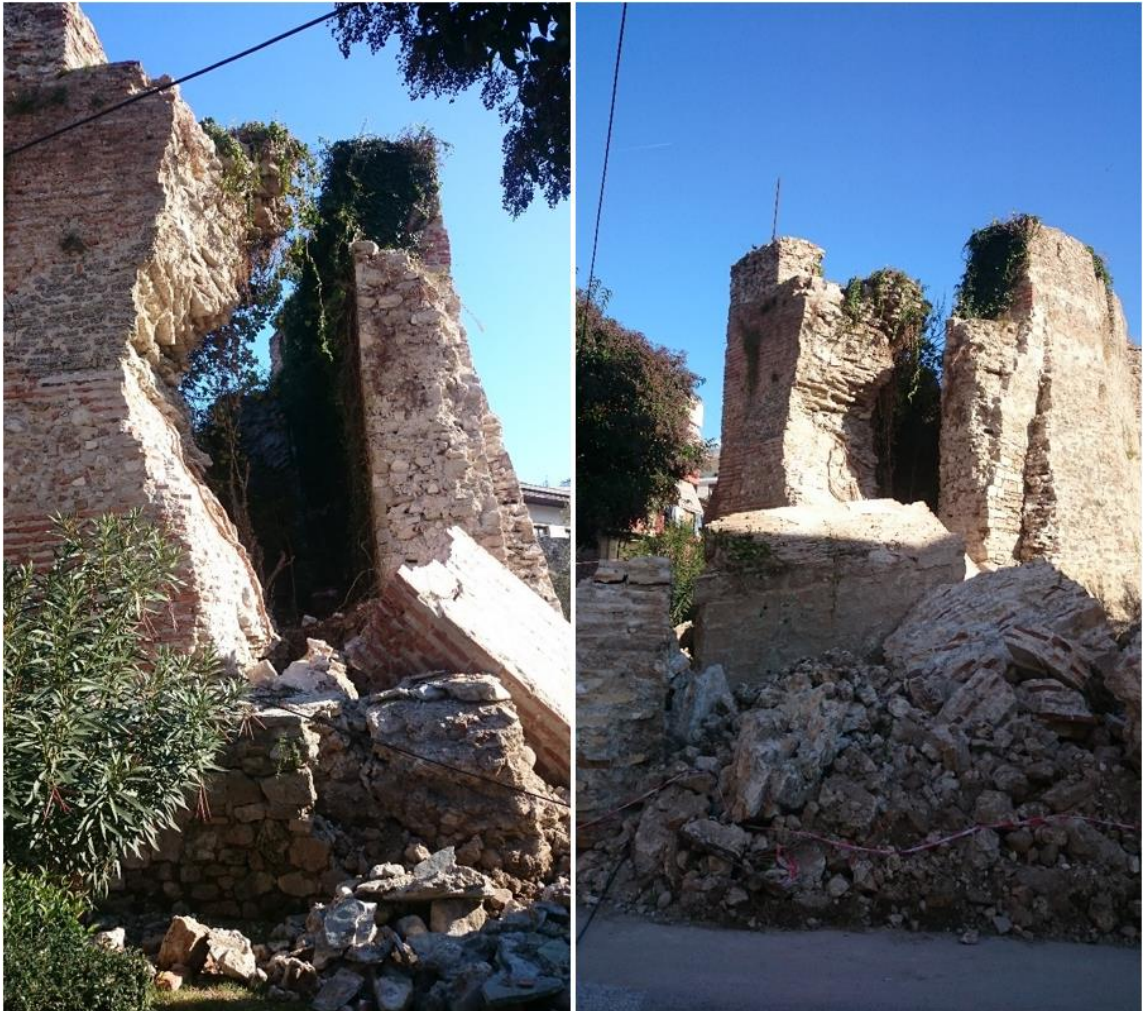
Figure 52: Heavy damages in the fortified walls of Durrës Castle

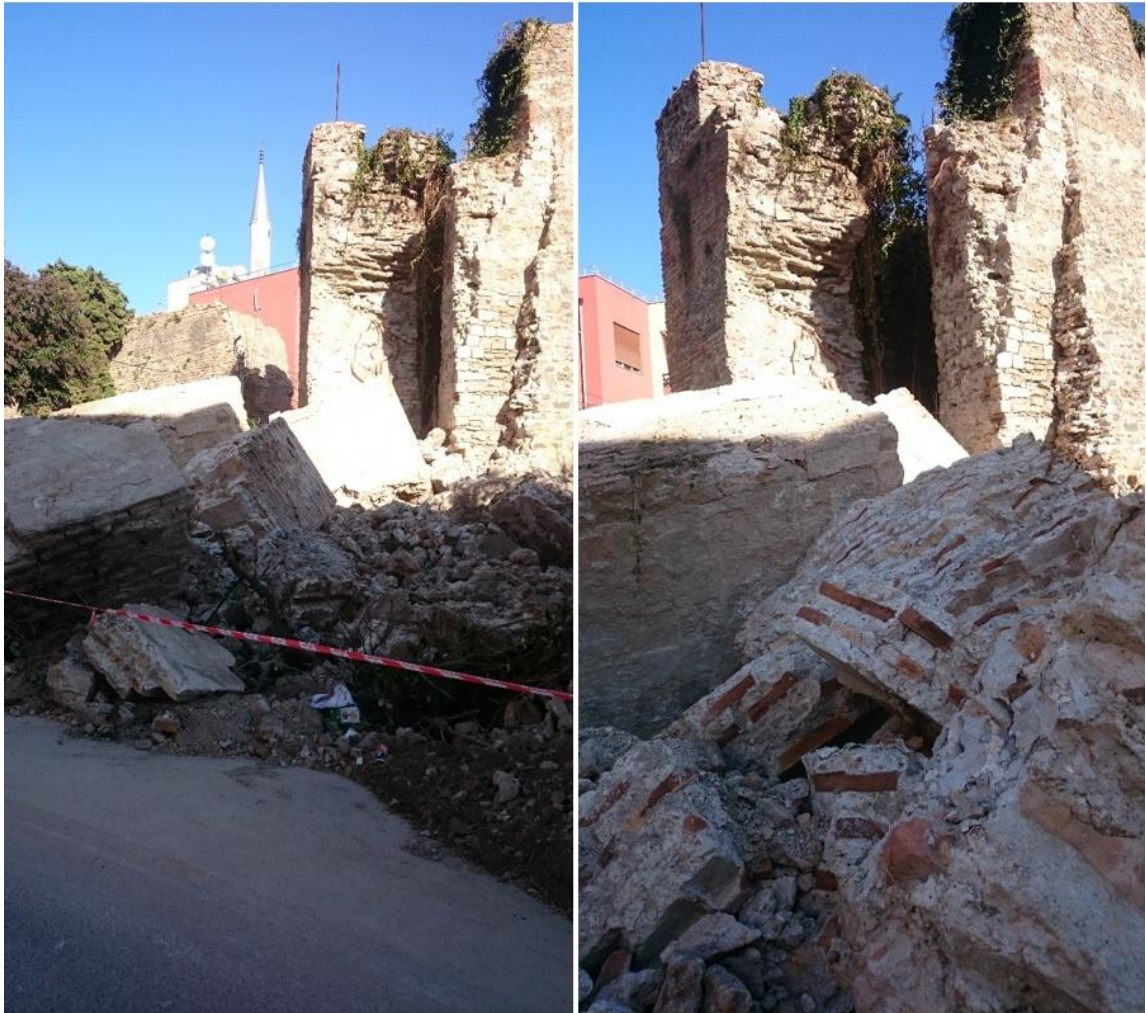
Figure 53: Massive destruction of the outer walls of the ancient castle

repaired again. Many earthquakes hit our country from that period, however the castle was strong enough to maintain its sustainability. After 750 years from its last damage, on November 26, the ancient castle suffered severe damages during the earthquake due to lack of maintenance and aging. In the figures below are shown most of the partial collapse of Durrës castle tower exposing the wall cross-section and internal construction.

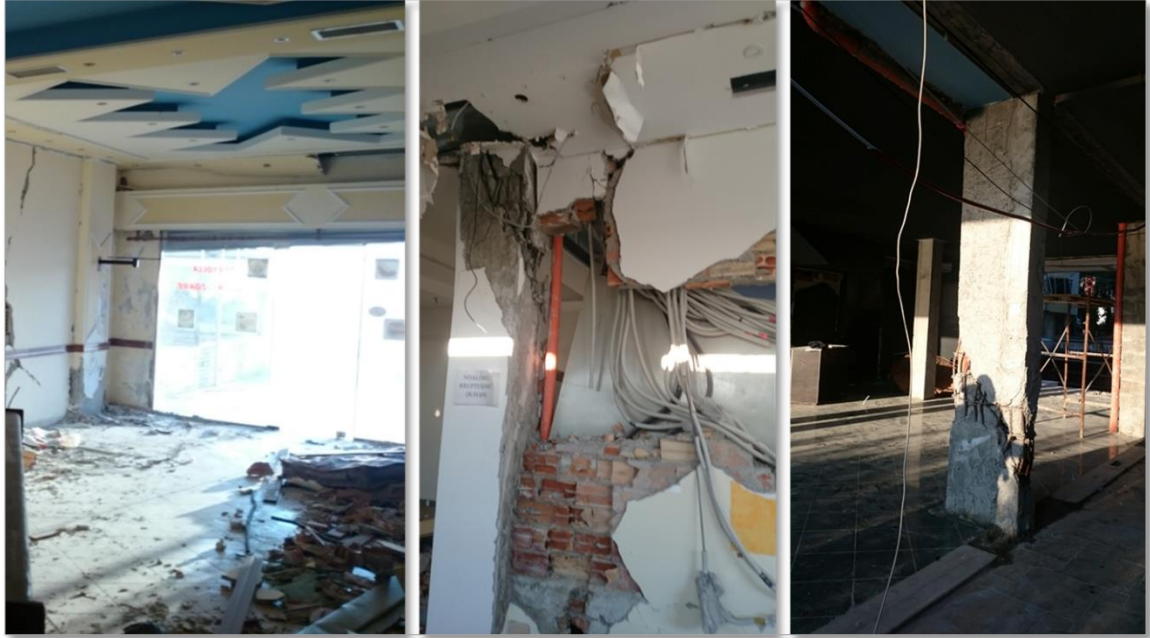
Figure 80: Damages of the E Template building during November 26, 2019 earthquake

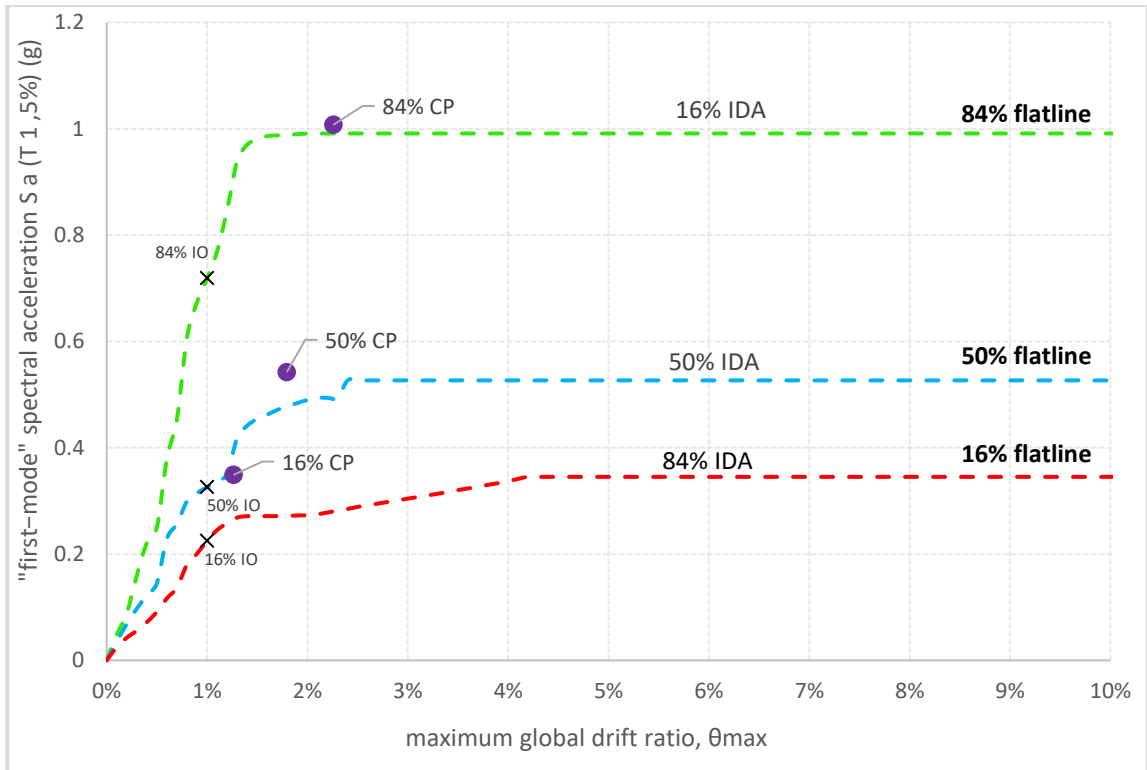
Figure 247: 16%, 50%, 84% IDA fractiles for C Template with concrete C16 in X-direction
