SEISMIC ASSESSMENT AND RETROFITTING STRATEGIES FOR A
PROMINENT MASONRY STRUCTURE AFFECTED BY EARTHQUAKE

A THESIS SUBMITTED TO
THE FACULTY OF ARCHITECTURE AND ENGINEERING
OF
EPOKA UNIVERSITY

JOZEFINA STERKAJ

MARCH, 2024

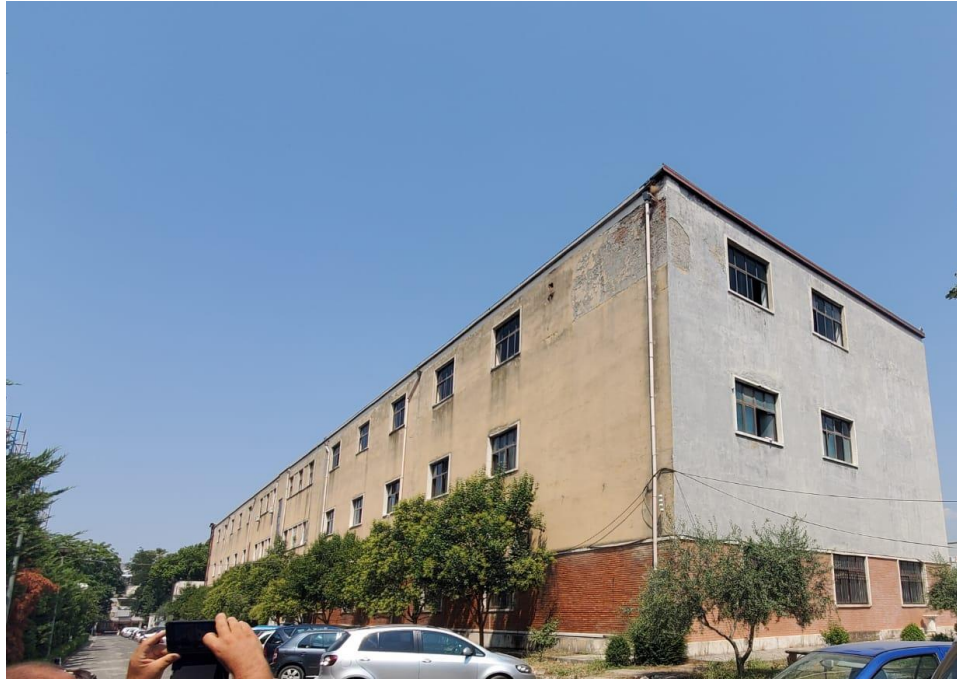
Figure 10. The inspected object on the field

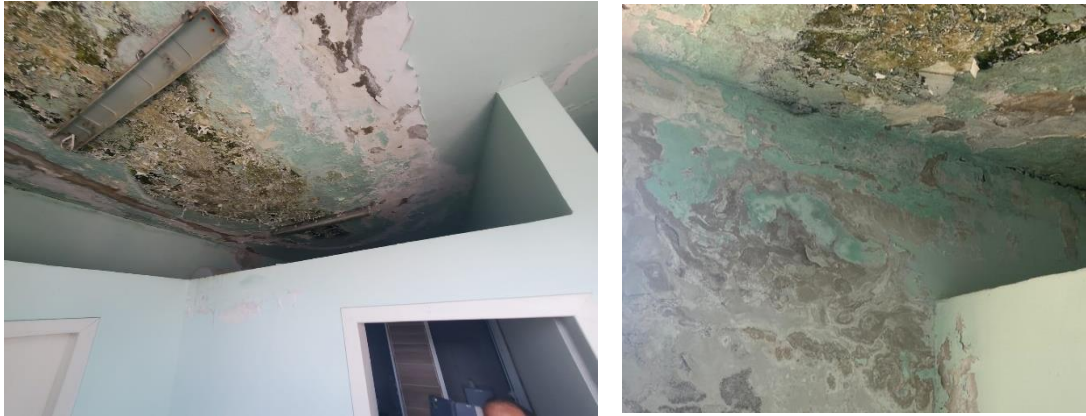
Generally, no significant damage is observed in these slabs, except for the ceiling slab of the second floor, where the presence of moisture has caused not only minor damages but also material degradation in some parts.

Figure 14. Damage to floor slabs and perimeter walls on the top floor due to the presence of moisture.

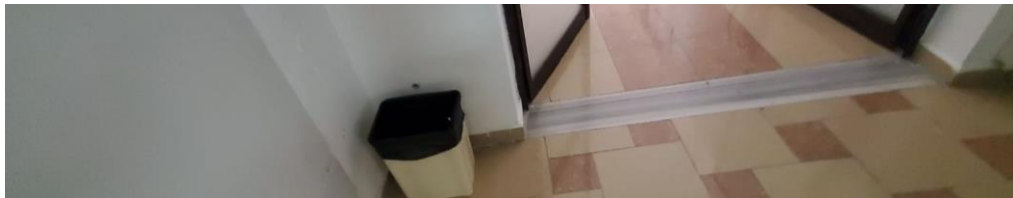
Figure 15. Division of masonry from other load-bearing elements and its loading near the joint.

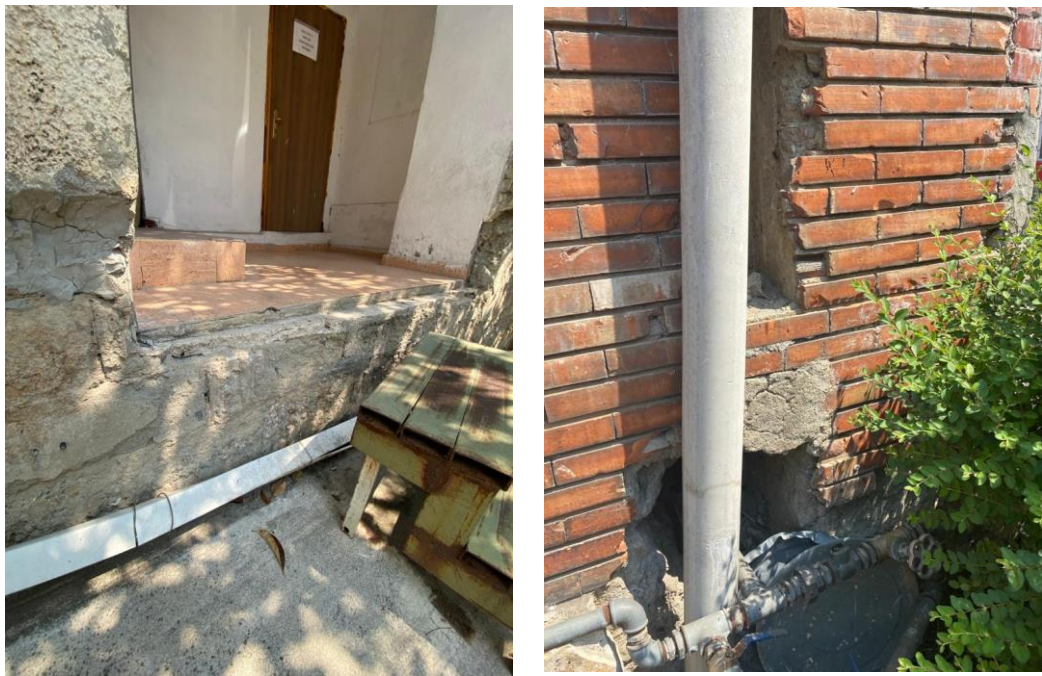
Figure 14. Observation of the masonry on the ground floor where concrete blocks are visible.

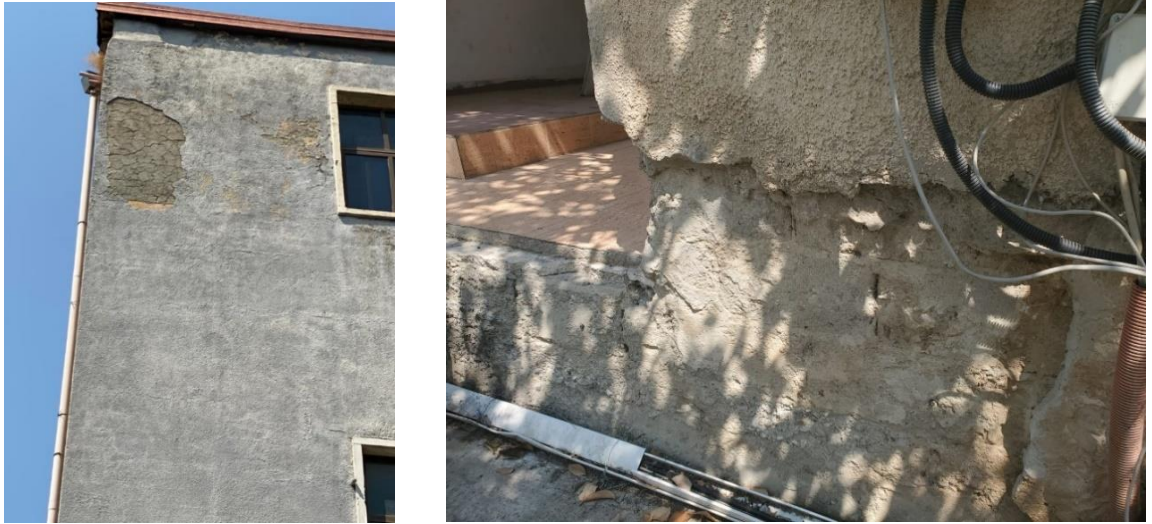
Several damages are present in this building. Damages consist of cracks and small to medium sized openings. They are limited in corners, especially in the connections between the walls and between slab wall

Figure 16. Damage to perimeter walls on the top and ground floor.

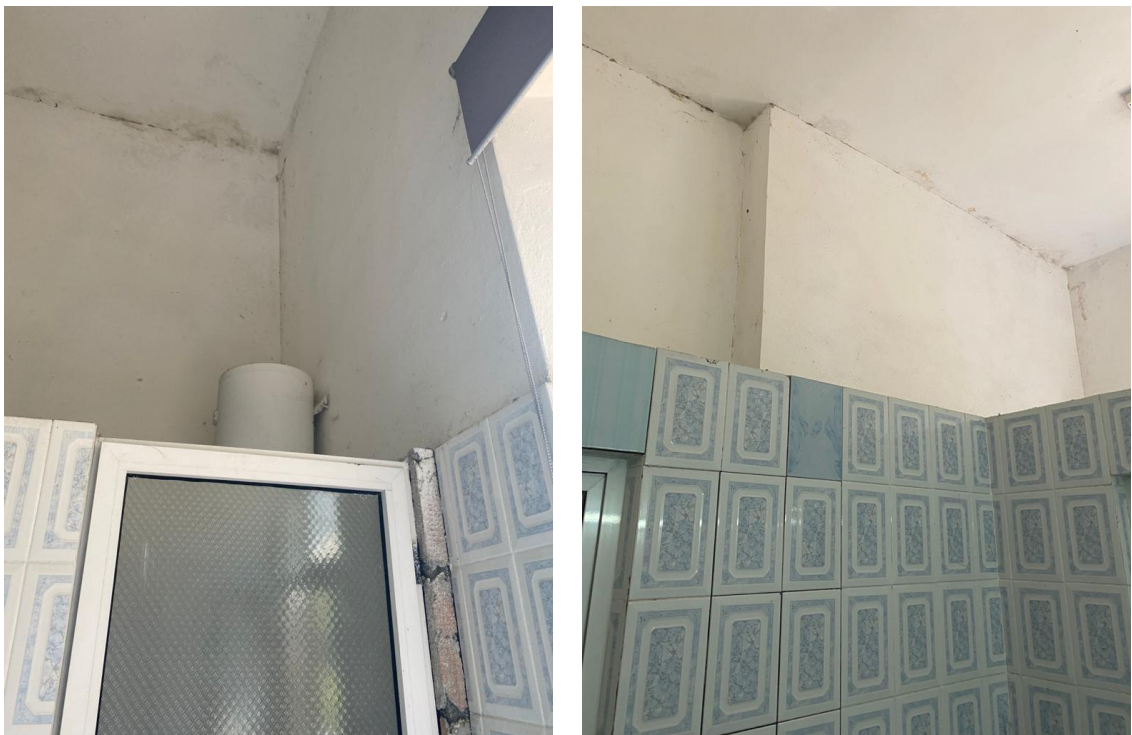
Figure 15. Separation of load-bearing structural elements from non-load-bearing walls.

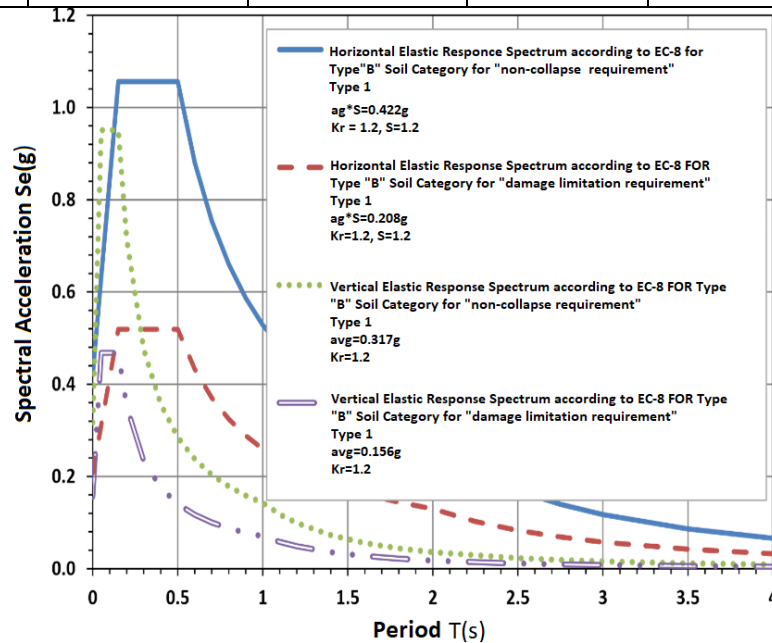
Soil Factor	Max. Ground Acceleration	Desing Acceleration	Corner Periods		
			T _B	T _C	T _D
1.2	0.173g	0.208g	0.15s	0.5s	2.0s

Figure 18. Elastic spectra for both horizontal and vertical response at both performance levels according to EC8 for the structure

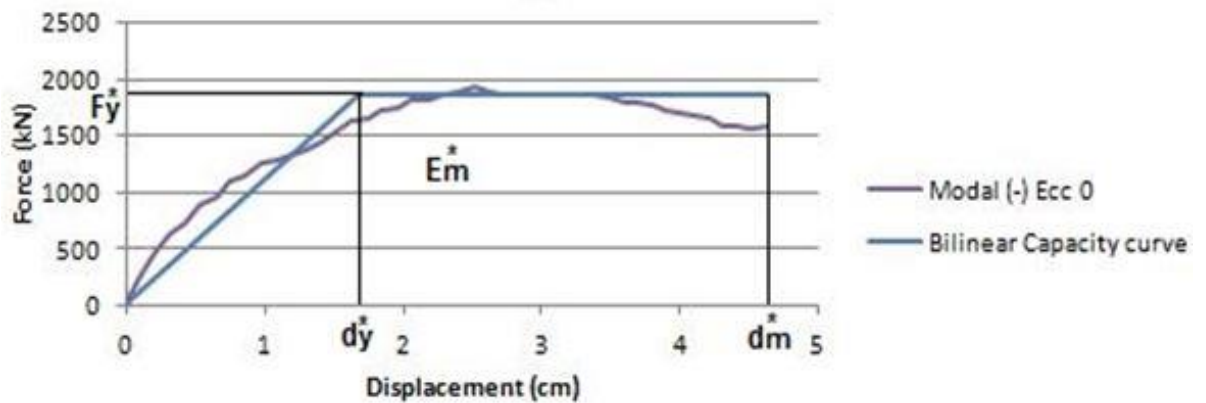
In the N2 method, two mathematical models and three analysis steps are employed. In the initial step, stiffness, strength, and supplied ductility are determined through non-linear static analysis of the MDOF system under a gradually increasing lateral load. In the second step, an equivalent SDOF system is defined, assuming that the deflected shape remains constant during an earthquake. The non-linear characteristics of the equivalent system are based on the base shear vs. top displacement relationship obtained in the first step. In the third step of N2, the maximum displacement is determined through non-linear dynamic analysis of the equivalent SDOF system.

Figure 21. Curve Bi-linearization [22]

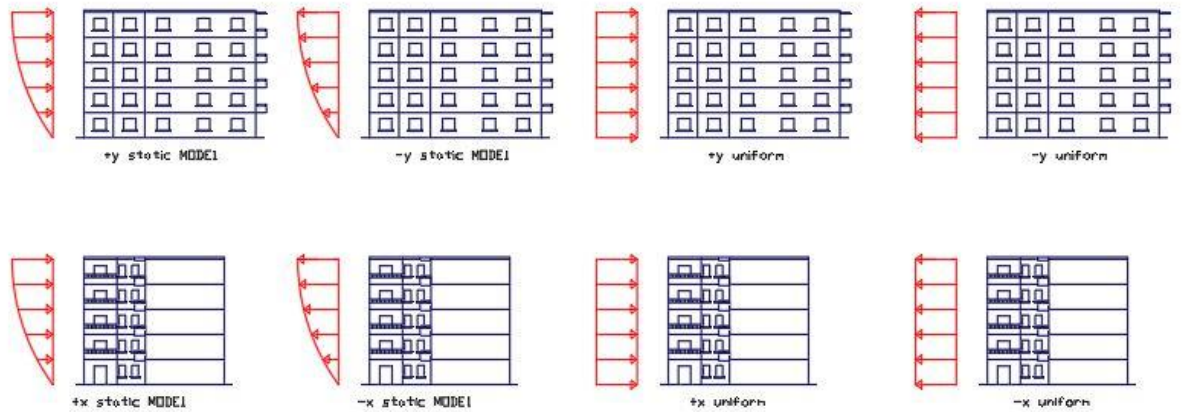
The 24 pushover scenarios for the building study are depicted in the figure above.

Figure 23. Load patterns and different cases of pushover analysis

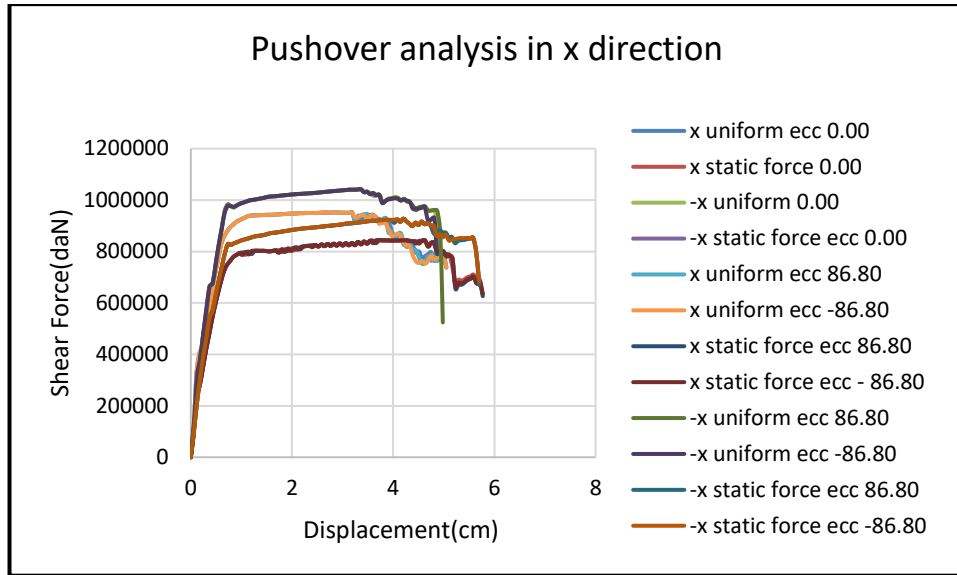
Figure 25. Pushover analysis for x-dir, 12 load patterns of case-study building

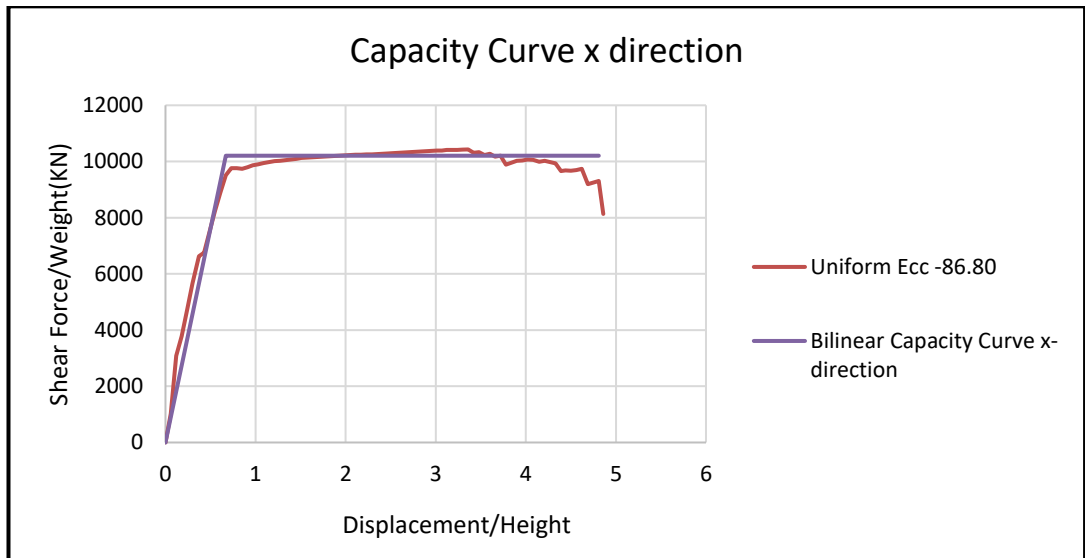
Figure 28. Normalized bilinear capacity curve in x-direction

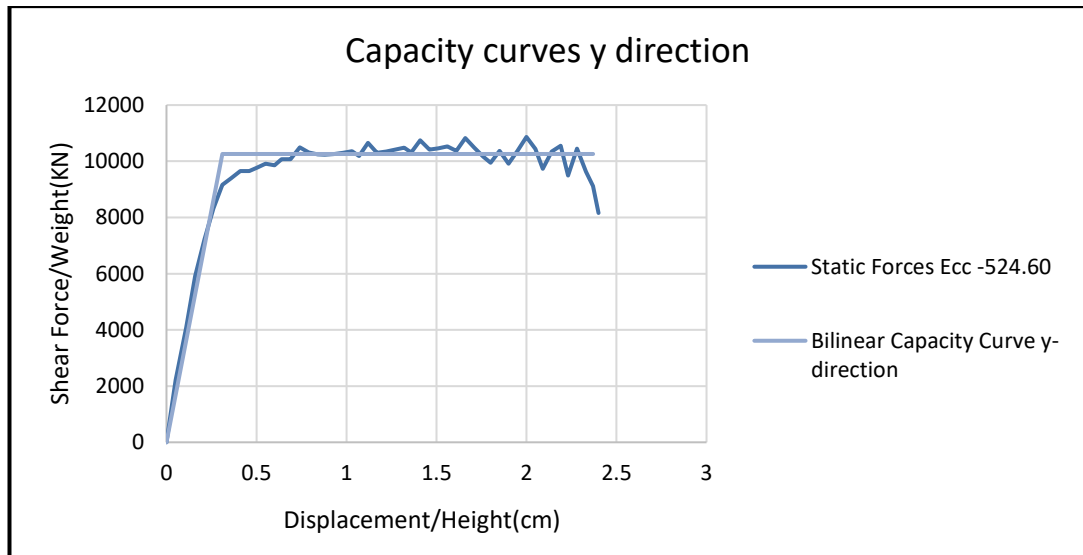
Figure 29. Normalized bilinear capacity curve in y-direction

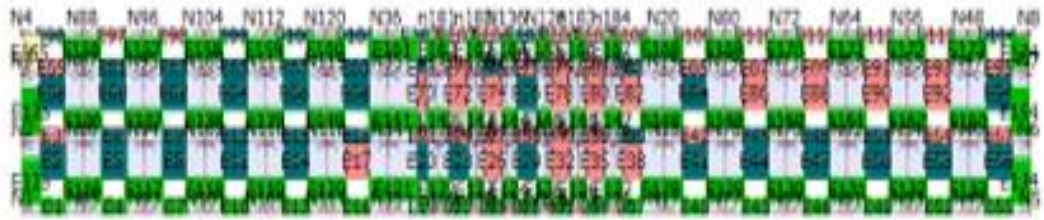
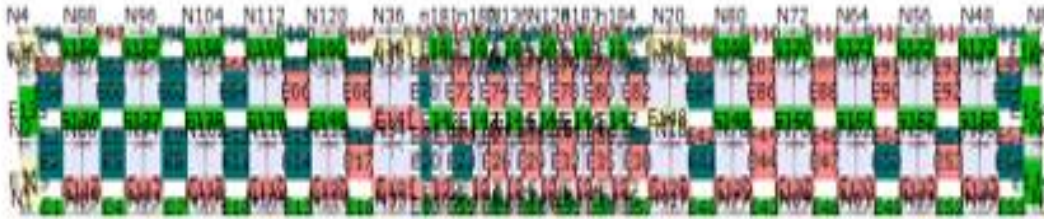
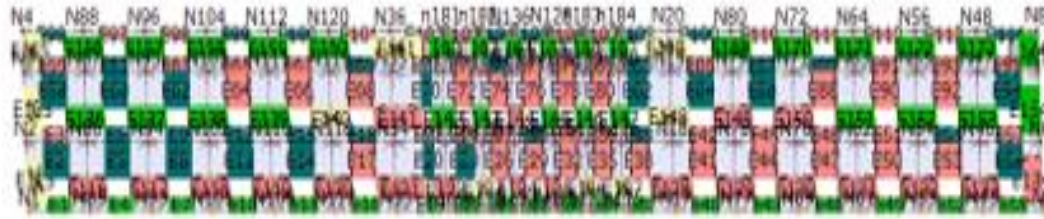
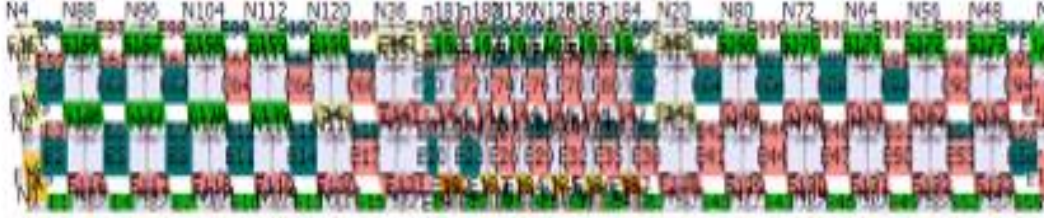
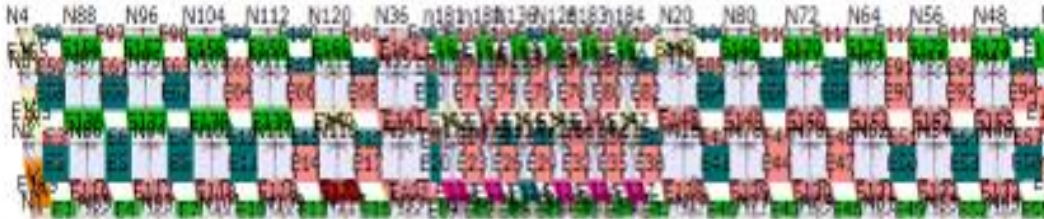
Figure 31. Failure mechanism

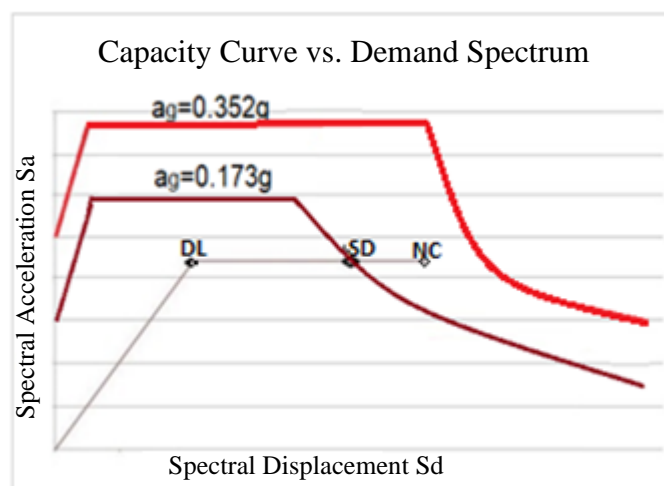
After this analysis, a comparison is made between the structure's capacity and the seismic design spectrum for the conditions of non-collapse and limited damage. According to EC-8, for the structure to guarantee proper seismic performance, it must perform at the DL (Damage Limitation) level for the earthquake with a return period of 95 years, corresponding to an acceleration level $a_g=0.173g$ in our case. Similarly, for the earthquake with a return period of 475 years, with an acceleration level $a_g=0.352g$ in our case, it should perform at the SD (Significant Damage) level. The procedure followed in this case is in accordance with EC-8, comparing the capacity and earthquake in the Sa-Sd spectral format. The structure's capacity is assessed based on y , as it indicates weaker performance. In the figure below, this comparison is illustrated, showing that the structure has surpassed the DL performance level and is in the SD phase for the earthquake with a return period of 95 years, corresponding to an acceleration level $a_g=0.173g$. This implies that the structure does not meet the damage limitation condition according to EC-8. Making the same comparison, this time for the earthquake with a return period of 475 years, with an acceleration level $a_g=0.352g$, it is observed that the structure has exceeded the NC (Near Collapse) performance level, indicating it is on the brink of collapse. This means that even the non-collapse condition is not satisfied, and the structure is at risk for an earthquake with a return period of 475 years.

Figure 33. Capacity Curve vs. Demand Spectrum for the unreinforced object

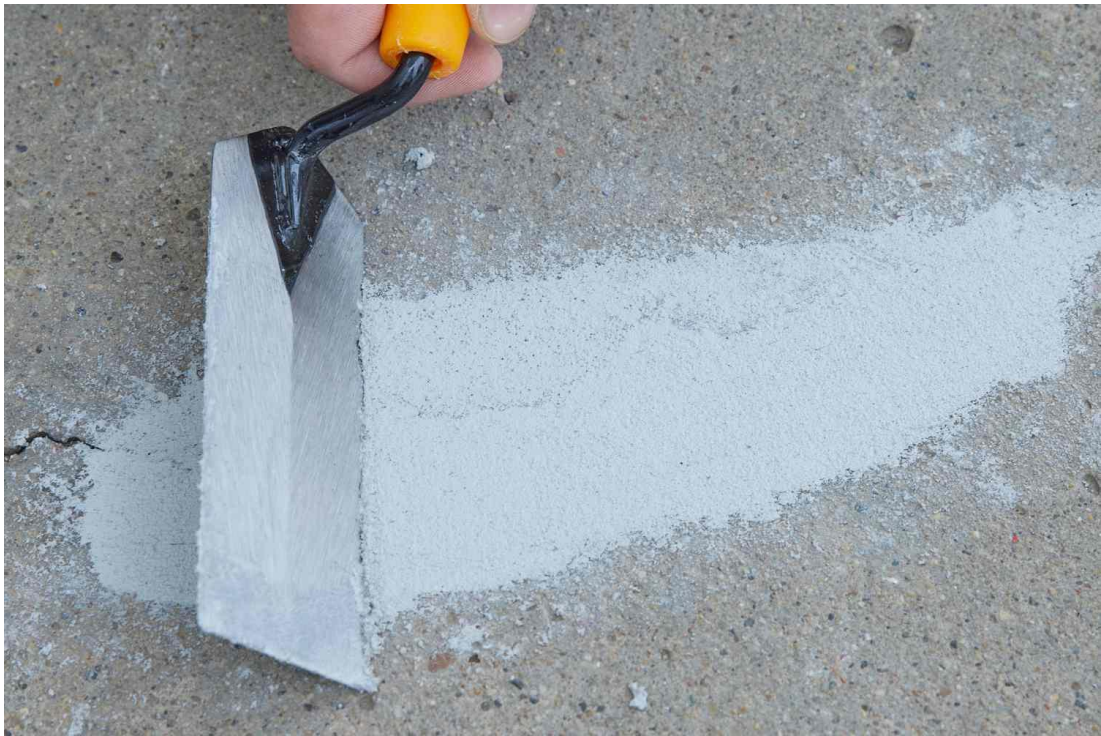
For the reinforcement of walls using the Textile Reinforcement Mortar (TRM) method, the cleaning and repair process of the existing surface should involve removing plaster and all impurities until reaching a clean brick surface. Pre-wetting spray is then applied to the entire wall surface. The first layer of plaster is applied, followed by the placement of textile mesh. Finally, the second layer of plaster is applied. The reinforcement of the internal concrete of the walls (brick + concrete) will be done by injection from the sides with low-dispersion resins. The type of resins is different for masonry and concrete injections. Concrete injections will be pressure-controlled to avoid damage to degraded concrete. The characteristics and technology of the injection resins will be applied based on the specifications provided by the manufacturer.

Figure 35. *The cleaning and repair of existing surface cracks on the floor slab.*

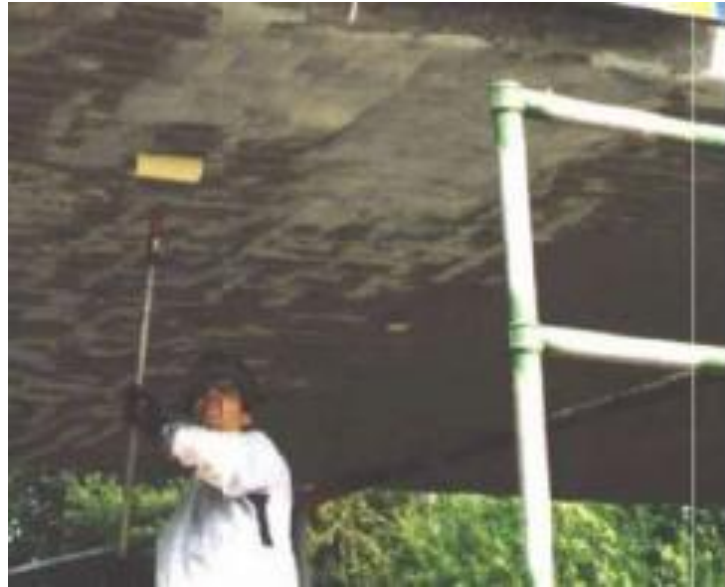
layer is applied to create a suitable layer for bonding carbon fibers. After necessary checks, carbon fibers with a weight of $\geq 400 \text{ g/m}^2$ are applied, taking special care to avoid creating air bubbles.

Figure 36. The application of primer according to the manufacturer's specifications,

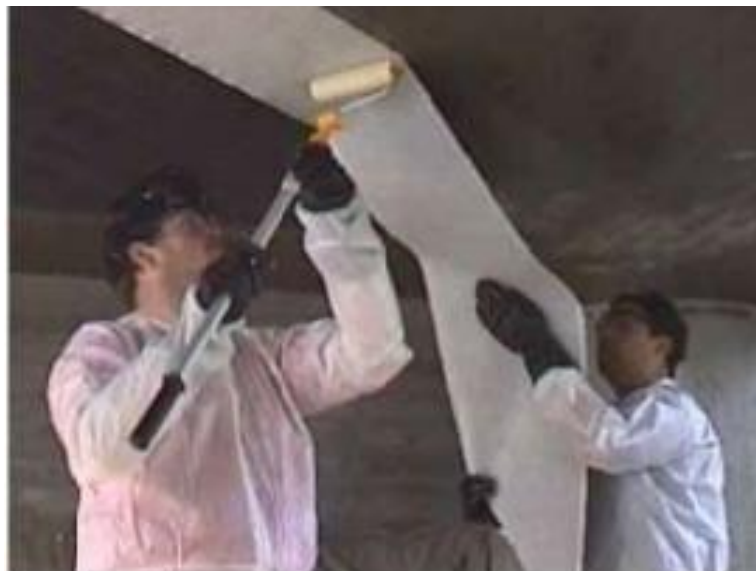
Figure 37. The placement of carbon fibers.

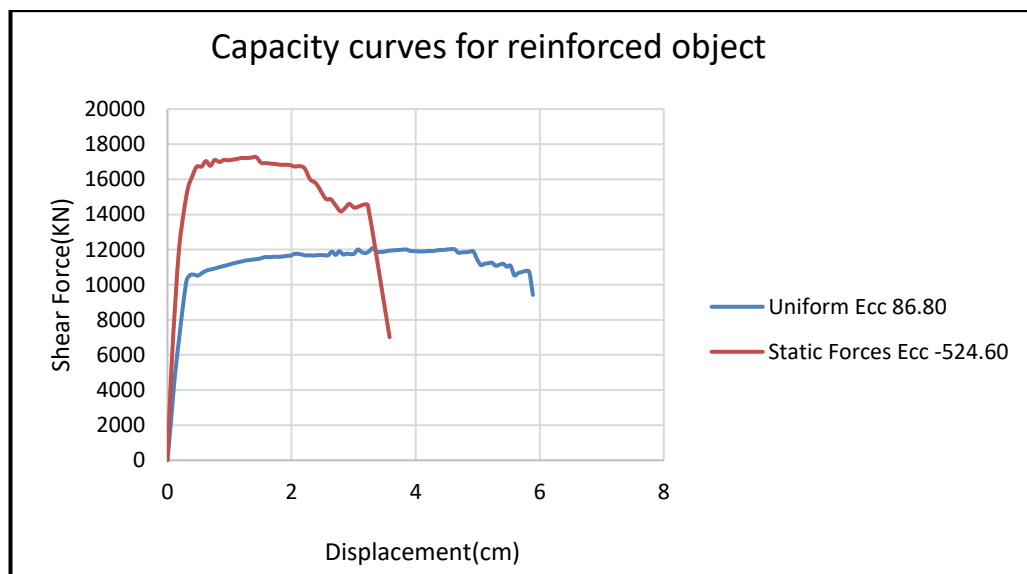
Figure 45. *Capacity curve in x and y-direction, worst scenario*

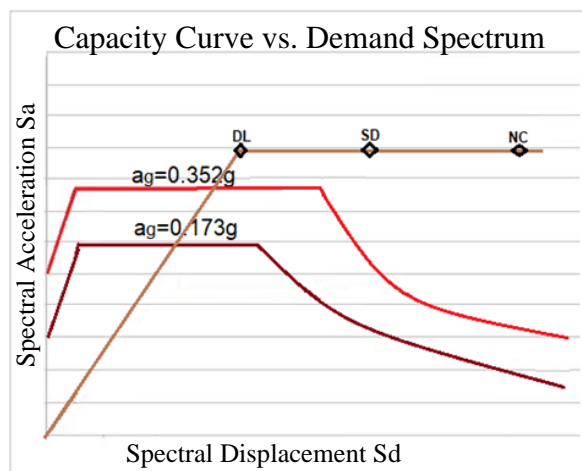
In seismic terms, as shown earlier, the structure was in the NC phase according to EC-8 after the earthquake. After the intervention, for a seismic event with a return period of 475 years, the building is guaranteed not to reach the SD state. Moreover, the condition of limited damage is ensured for the building, given that it is in the DL phase, for a seismic event with a return period of 95 years.

Figure 48. Comparison of structure capacity with earthquake spectrum

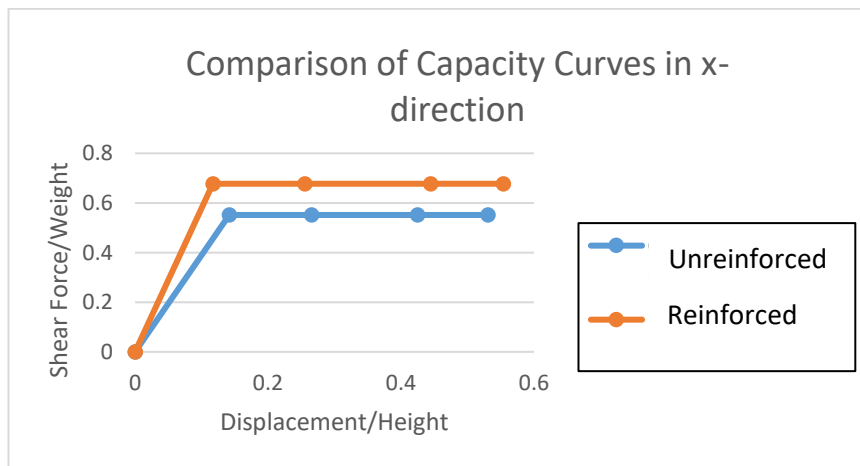
In terms of maximum horizontal load-bearing force, the structure's capacity has increased by over 100% (from 0.25 to 0.53) in the Y direction, which was initially more problematic. Additionally, stiffness has significantly increased, with values rising by around 70% (from 7830 to 12914) in both directions.

Figure 49. Comparison of capacity curves in the X direction
