RC BUILDING TYPOLOGIES AND FAILURE MODES OBSERVED DURING
THE 2019 ALBANIA EARTHQUAKE

A THESIS SUBMITTED TO
THE FACULTY OF ARCHITECTURE AND ENGINEERING
OF
EPOKA UNIVERSITY

IN PARTIAL FULFILLMENT OF THE REQUIREMENTS
FOR
THE DEGREE OF MASTER OF SCIENCE
IN
CIVIL ENGINEERING

JULY, 2023

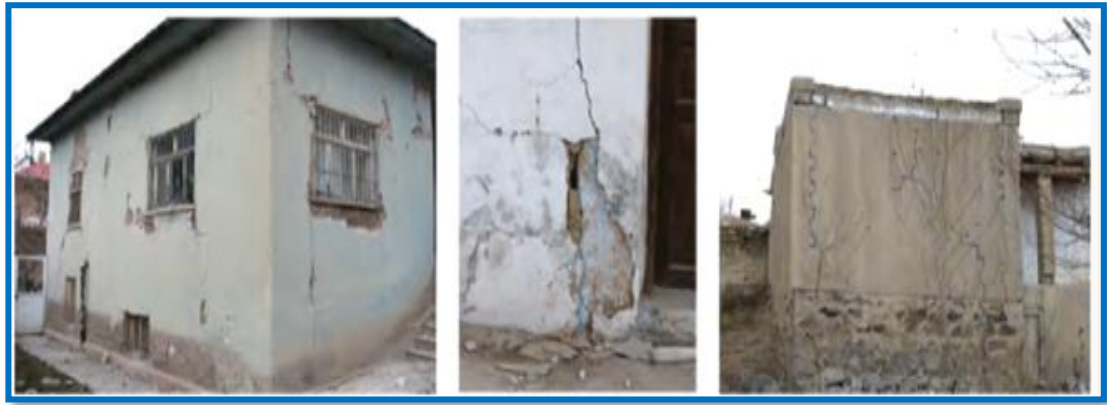
This structure had showed a poor seismic response despite no causalities but was caused by flaws that result from bad seismic design, abnormalities brought on by unapproved interventions, inadequate reinforcing detailing, poor material quality, and subpar construction quality.

Figure 3. Unreinforced brick building with damage

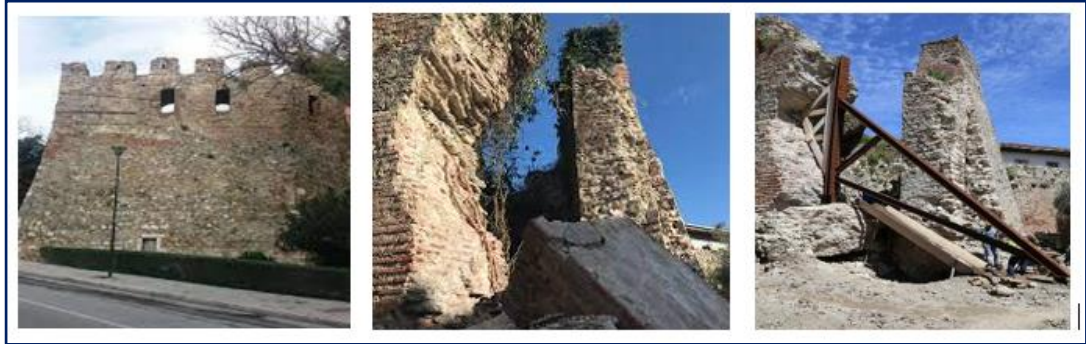
Figure 6. Durrës Castle-Tower 'C' and fortification walls (a)before earthquake , (b) collapse wall , (c) the structure of steel reinforced

Clay brick walls adorned by multiple leaves and external leaf collapses are evident. The Durrës Castle and some collapsed sections are still visible., the structure of steel reinforced.

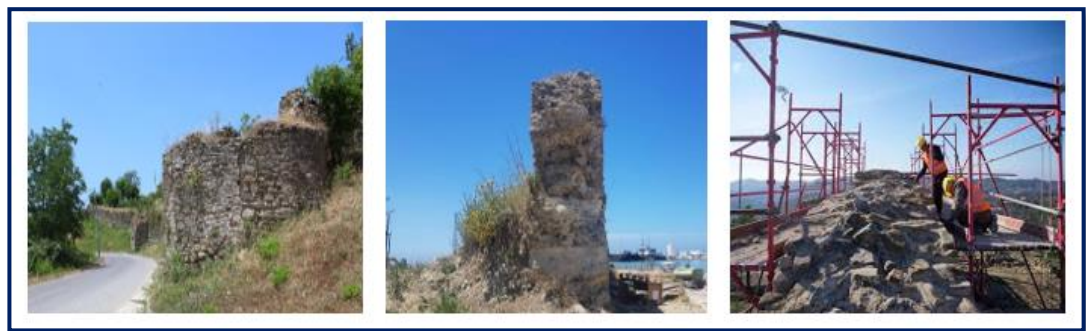
Figure 7. Gate walls at Porto Romano; (a) the wall before earthquake , (b) the gate wall damaged (c) the wall under reconstruction

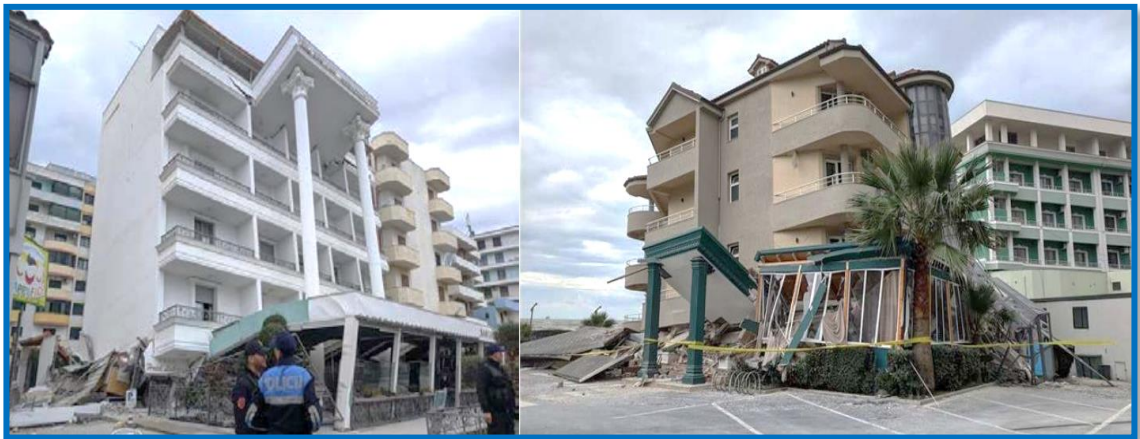
The seismic demand in the RC columns at the ground floor level was significantly raised because of the masonry infills and the increased stiffness at the upper floors, which led to damage and collapse of these structures.

Figure 11. Collapsed buildings in Durrës, Albania due to the “soft storey” irregularity (McKenney, 2019)

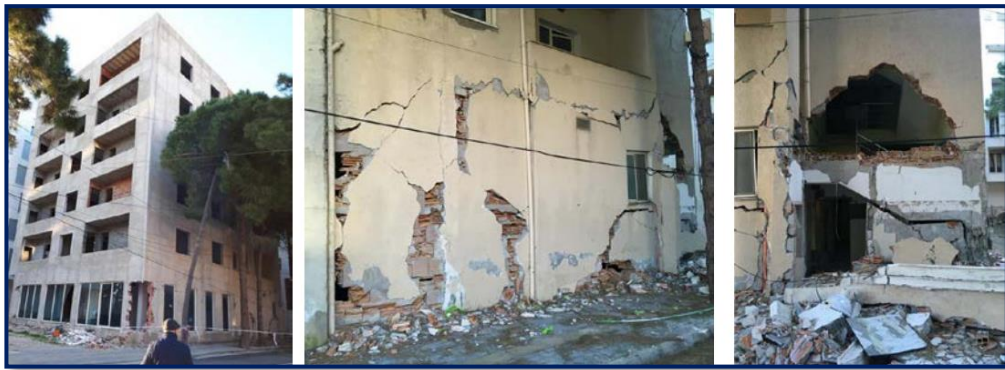
Those two figures illustrate significant damage of an RC frame structure due to torsional effects caused by masonry infills and a staircase, which were likely neglected in seismic design. The building has an open ground floor and additional five floors (Figure 11-a).

An eccentric position of the staircase, with regards to the building's centre of mass, caused eccentricity of the centre of stiffness in relation to the centre of mass and the corresponding torsional effects.

High torsional demand contributed to excessive damage of an exterior masonry infill adjacent to the staircase, as seen in Figure 11-b. Seismic vulnerability of the staircase was compounded by the “short column” effect at the abutment of the staircase.

Figure 12. Damage to RC building in Durrës, Albania due to torsional effects: a) a view of the building after the earthquake; b) damaged masonry infill at the ground floor level (adjacent to the staircase) and c) damaged staircase area

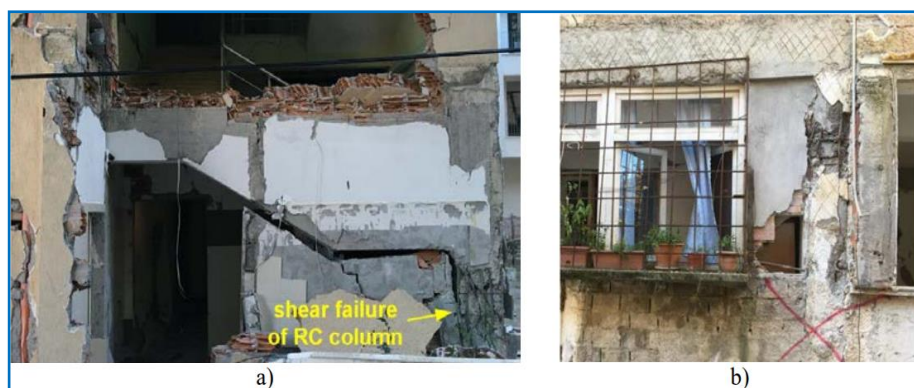
Figure 13. Damage of RC buildings due to the "short column" effect in the November 2019 Albania earthquake: a) impact of the stair support on supporting columns and b) impact of partial masonry infill due to the openings

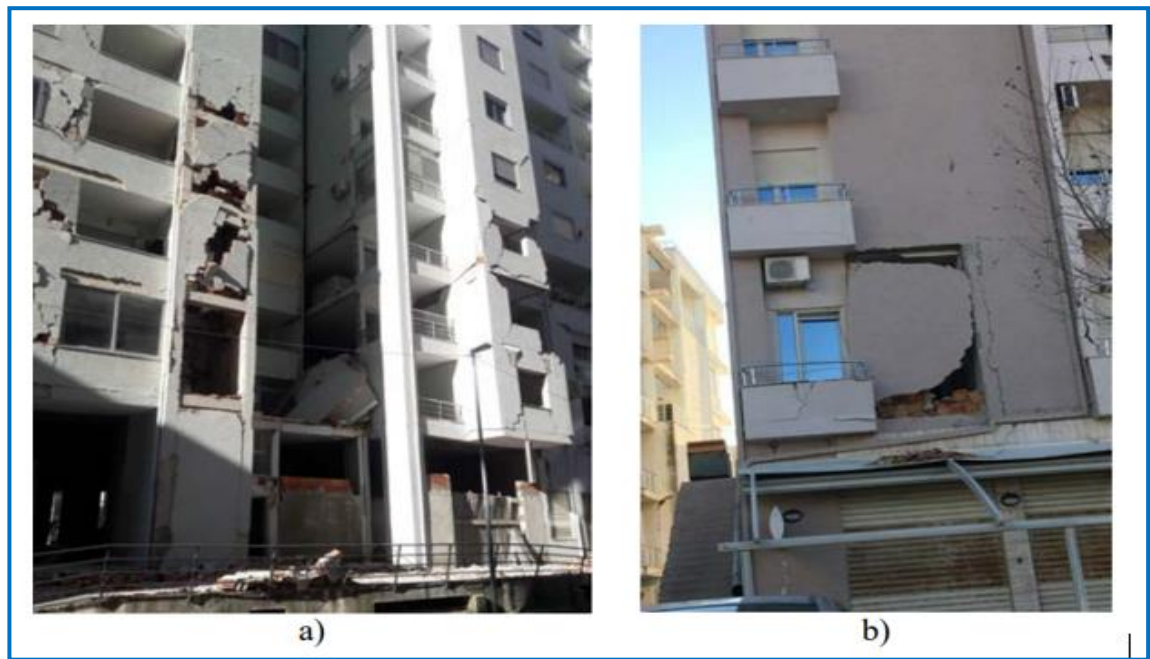
Figure 14. Severe damage and failure of masonry infills in RC frame buildings in Durrës, Albania due to the November 2019 earthquake

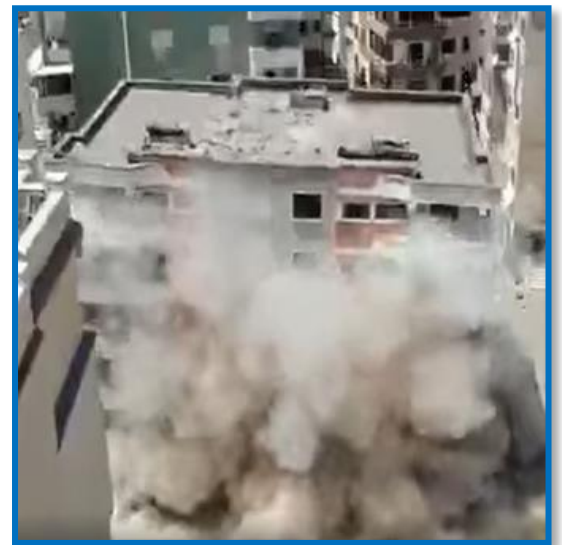
Figure 18. Vip building collapse

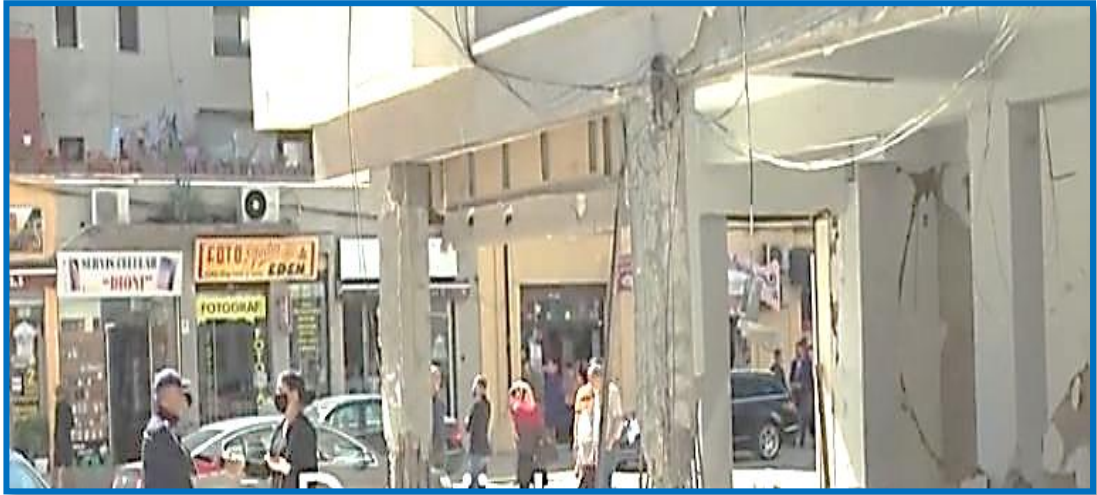
Figure 19. Damages made in the building by the earthquake

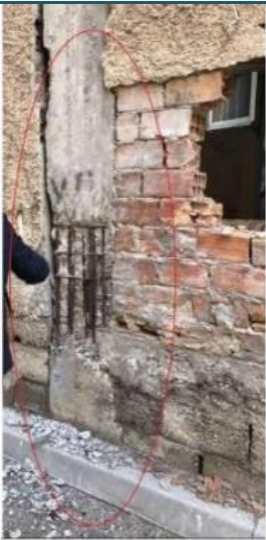
<p>Figure 43. Spalling of concrete</p>	<p>Figure 44. Longitudinal reinforcement not fastened by stirrup</p>	<p>Figure 45. Out-of-plane wall failure</p>

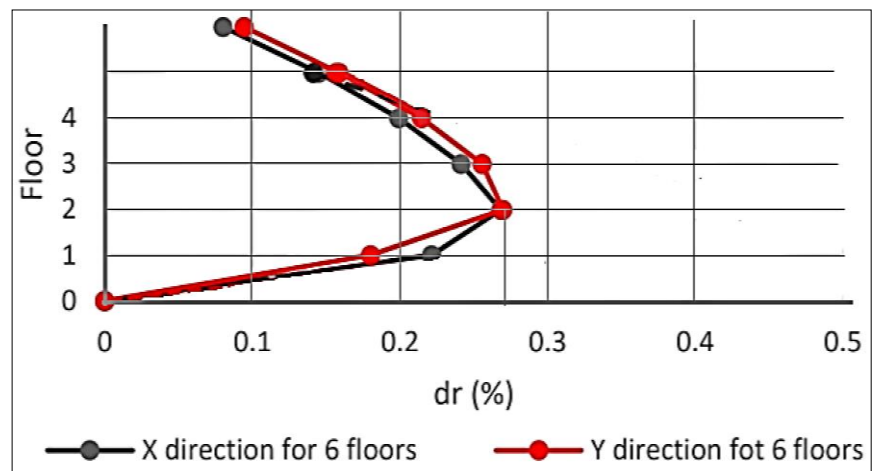
The results of the two methods analysis, such as non-linear static analysis and response spectrum analysis (Pushover), are displayed below. The interstorey drift is a crucial factor to consider when estimating the damage caused by aspects both structural and non-structural during earthquake activity

Figure 47. Maximal drifts for the 82/2 type of building

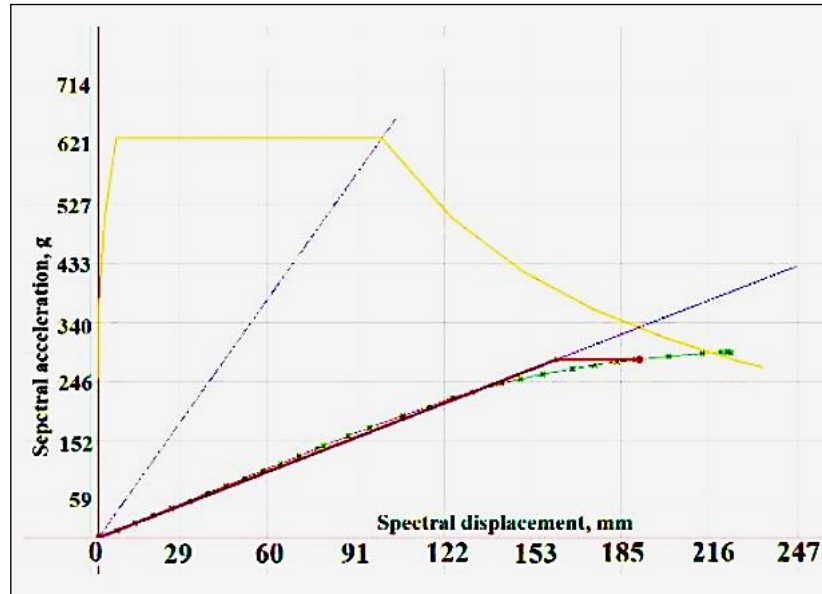
The six-story building exhibits a seismic capacity that is insufficient to meet the seismic demand (for y-direction) according to the nonlinear static analysis (Pushover)

Figure 49. Capacity diagrams for 6-storey building X direction

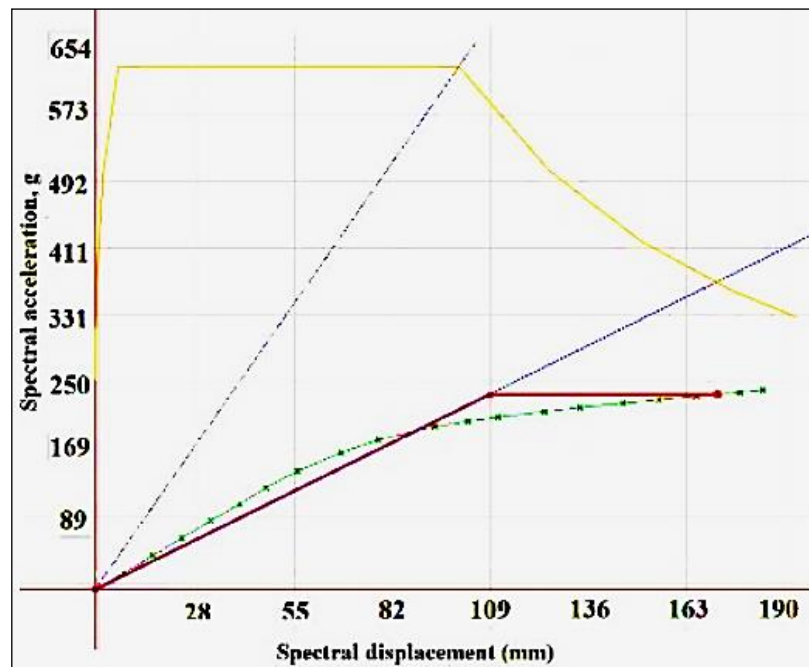
Figure 50. Capacity diagrams for 6-storey building Y direction

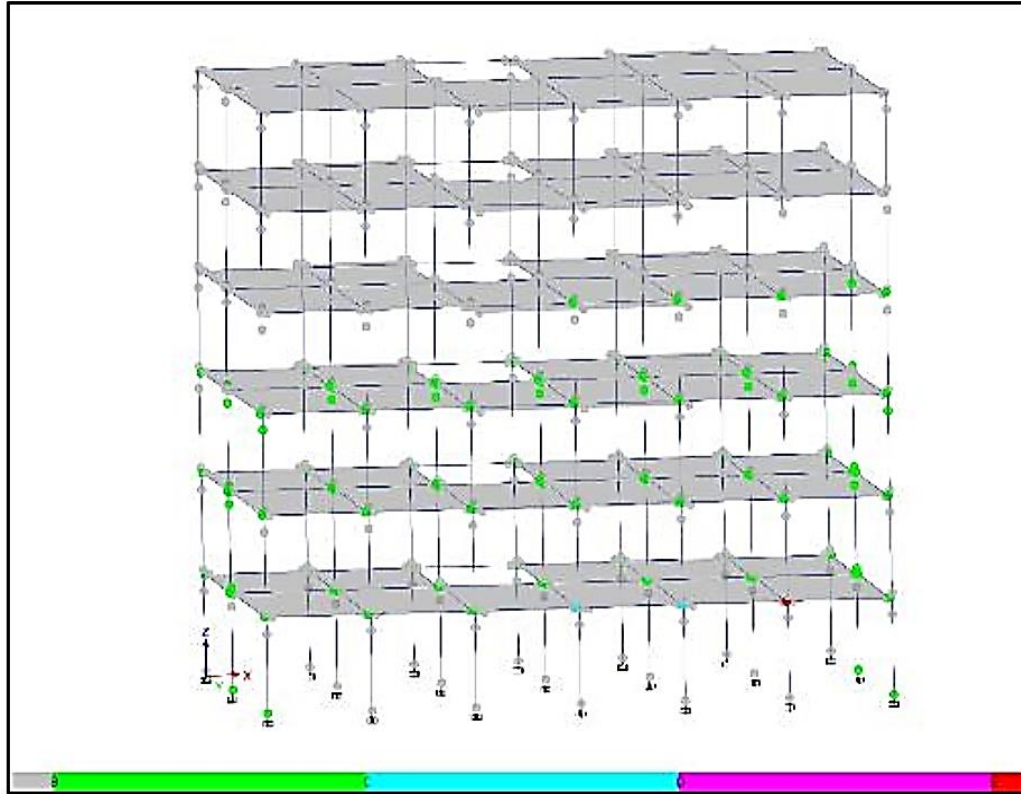
Development of plastic hinges from the nonlinear static analysis (Pushover) (mostly in states a few in the extremely plastic, rupture-prone D area, and the regions A through B on the plastic hinge growth curve)

Figure 54. Development of plastic hinges with reference to Figure 53 (the distribution of plastic hinges), for the six-story building
