A Caravanserai from 16th century in Sivas “Behram Pasha Han”

Nisa Semiz

(PhD candidate Nisa Semiz, ITU Faculty of Architecture / Department of Restoration, Yildiz Mah. Asariye Cad. 49/8
Besiktas/Istanbul, nisasemiz@gmail.com)

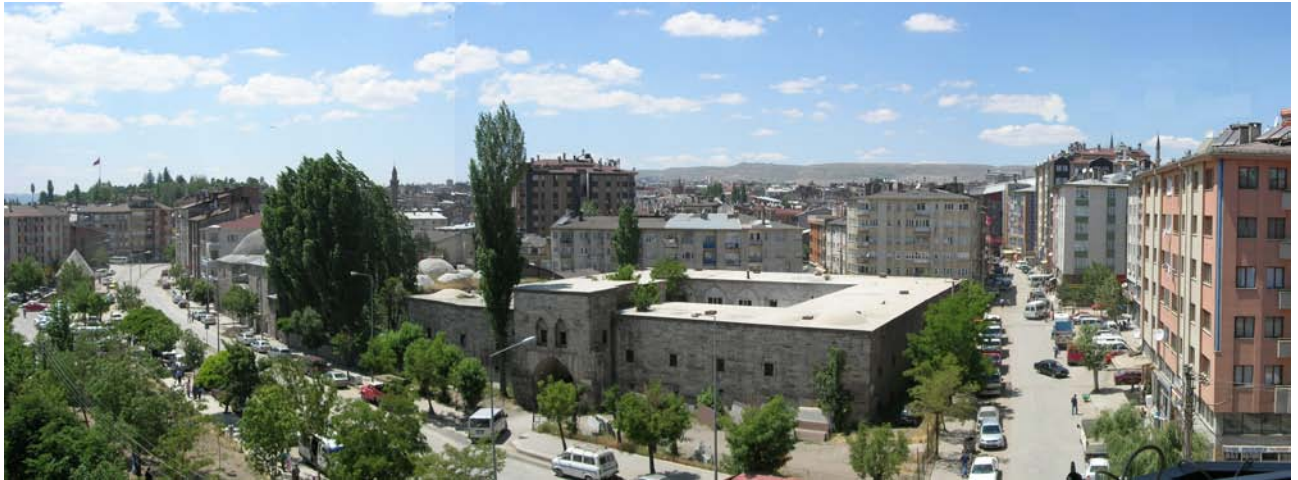
Fig. 1: General view of Behram Pasha Han.

Behram Pasha Han (*Fig. 1*) is a city inn providing combined use of accommodation for travellers and offices and storage spaces for tradesmen. It is nearly square in plan. It is a two storey building with a spacious courtyard. The courtyard is surrounded by arcades on its three sides at the ground level. There is stable along the northwest side of the ground floor.

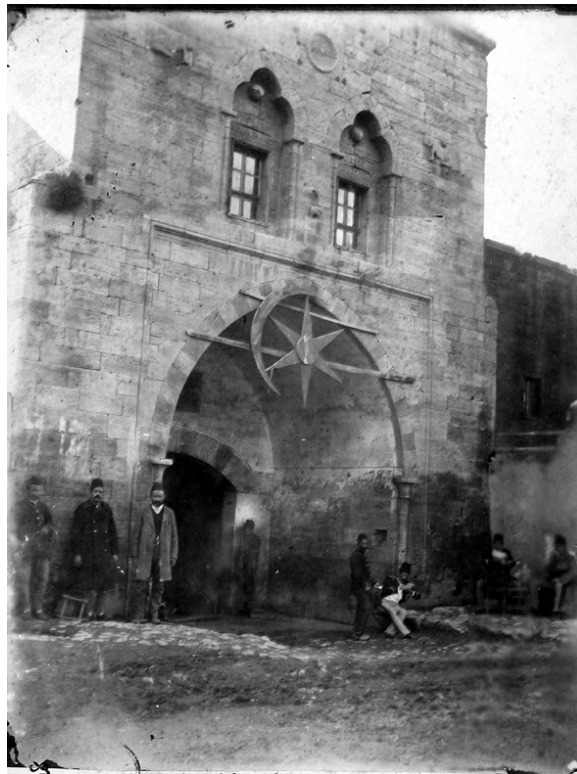
Fig. 3: Entrance of Behram Pasha Han (Photograph archive of Sultan Abdulhamid II).

According to the late Ottoman inscription over its entrance, the han was converted into a military barrack in 1316 H (1898-1899) during the reign of Sultan Abdulhamit II (*Fig. 3*) and was used by the Turkish Ministry of Defense until 1976. Since the building is of waqf origin, it was handed over to the General Directorate of Pious Foundations in 1967. After the Ministry of Defense abandoned the building, it was used for several functions like a hostel, storage building, car park, cafeteria and marble workshop.

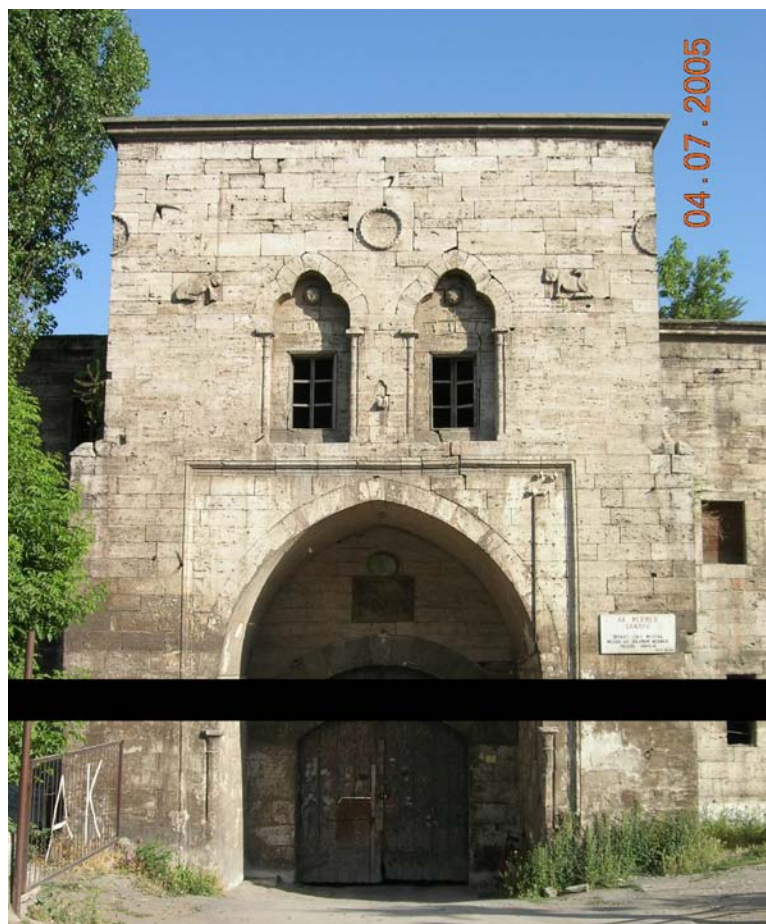
Fig. 6: The entrance of the han.

The arcades have pointed arches supported by square piers (*Fig. 5*). Some of the openings are closed. The central part of the entrance façade of the Han is accentuated by a jetty which is higher than the other rooms. Seljuk style ornaments and carvings on this façade are special (*Fig. 6*). At the level of the ground floor on all of the façades, there are irregular openings that are in different dimensions and forms (*Fig. 7*). The windows located at the level of the first floor are rectangular. On the northwest façade there is a pointed arched opening that was probably leading to the toilets.
