FROM PAST TO PRESENT: FLOODING IN EDIRNE AND ITS VICINITY (TURKEY)

Hüseyin TÜROĞLU & Musa ULUDAĞ

Abstract

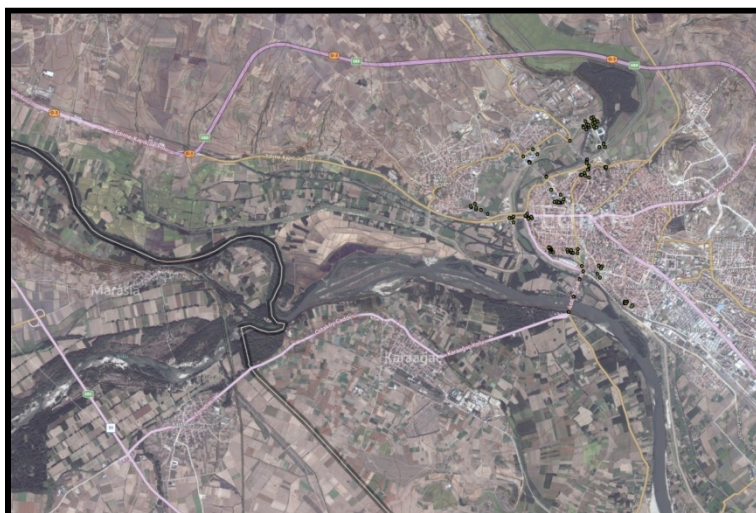
Figure 3: Connections of Meriç, Tunca and Arda Rivers in Edirne region.

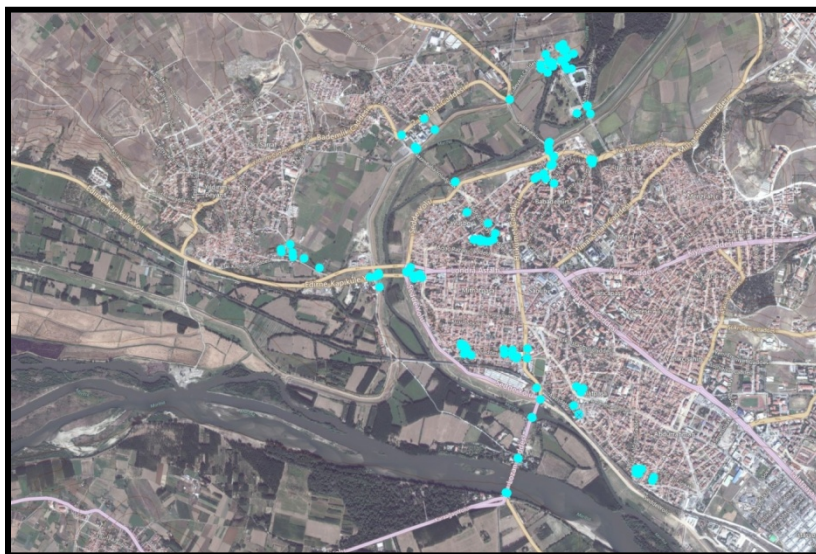
Figure 7: Locations of old buildings damaged from floods during the Ottoman period.

It is stated in the archive records that because of the old floods Ottoman period Edirne's large areas and nearby villages submerged and even as a result of floods in 16th, 17th and 18th centuries, Edirne and some villages got stuck because of the flood and the citizens there suffered from famine for days. It covers a lot of space on archive records that Ottoman Period floods stroke cultivated areas strongly. In general; another feature of the floods occurred in 16th, 17th and 18th centuries is their being at very low frequency however longer floods (Figure 7) (Photo 1, 2).

The location of damage information acquired after archive review and the Ottoman buildings remained from flooded areas were mapped (Figure 7). When the kind, strength and the location of the damages caused by old floods are investigated, it is possible to reach meaningful results for present. The most important factor on this topic is that; the flood reality which can also be named as disaster always exists but the frequency of it is so little.
