Implementation Challenges to the Adaptive Reuse of a Heritage Building in Tirana, Albania

The present paper focuses on the adaptive reuse of Selim Pashe Toptani Sarajev, a monumental building related to the creation history, ownership and administration of Tirana. The adaptive reuse of the buildings contributes to the sustainability of the urban generation, as it extends the life cycle of the buildings, avoids demolition waste, encourages energy efficient solutions and provides significant social and economic benefits to the society.

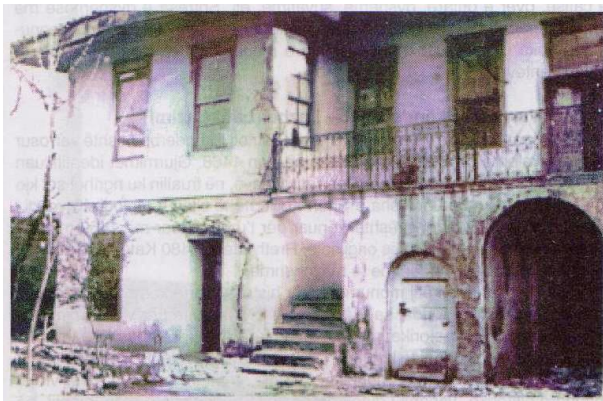
Figure 2: The house before restoration

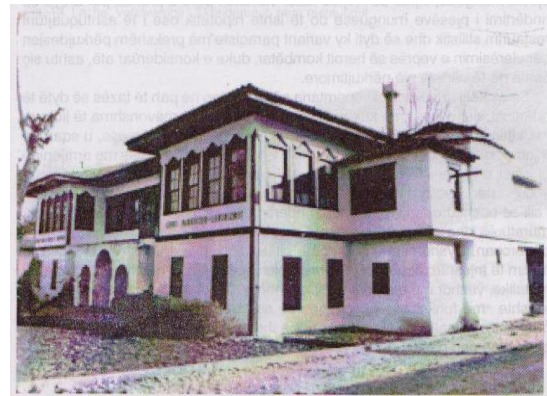
Figure 3: the House after restoration

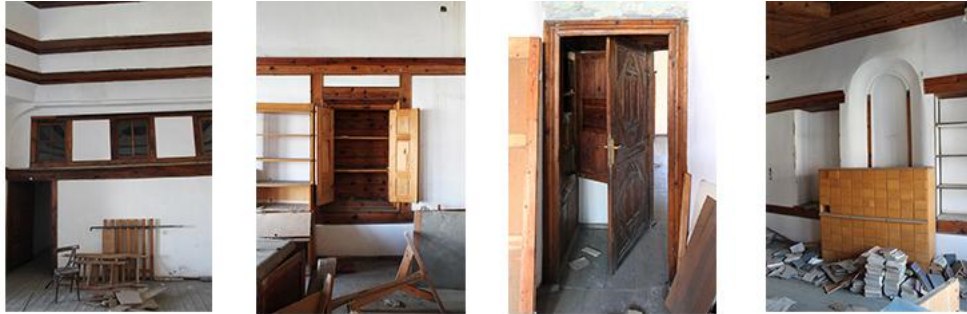
Figure 7: Illustration of wall cabinets, musandra, doors and furnitures

The house is enriched with fine decorative walls, folk motif ceilings constructed with wood and plaster. Wall cabinets, musandra, doors, especially those related directly to the central salon of the second floor are carved on wood and panelling with several popular motifs. Even decorative chimneys rooms are decorated with artistic taste (Figure 7 and 8) (Lazimi, 1976).

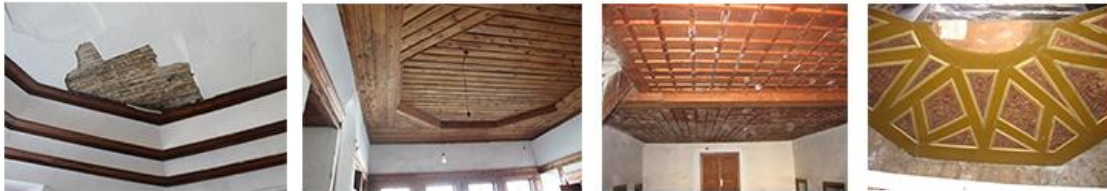
Figure 8: Characteristic ceiling decorations in different spaces

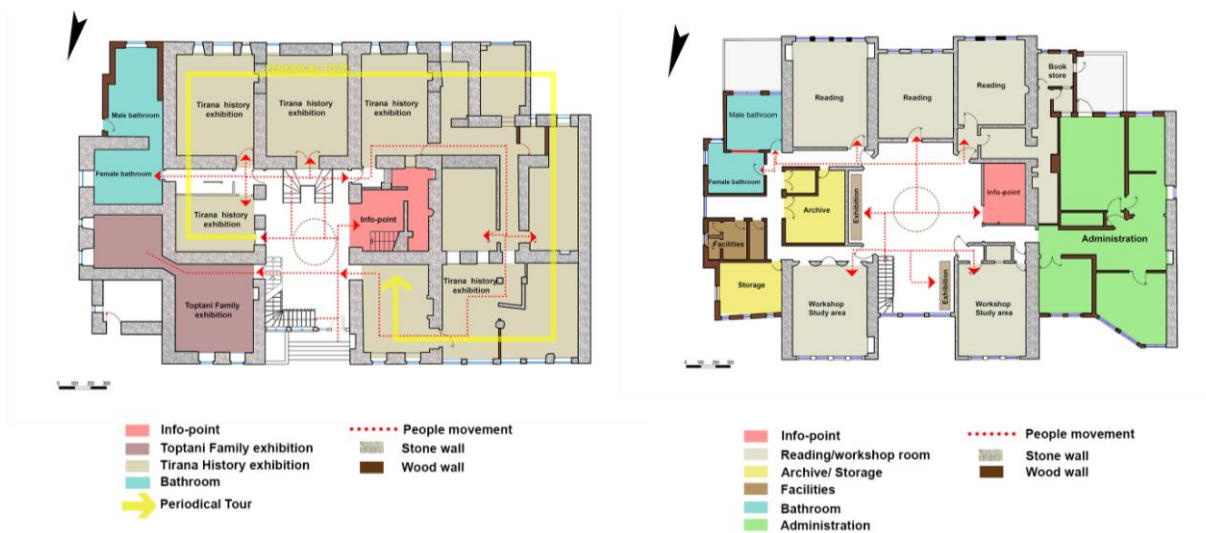
Figure 10. Proposed functions in each floor

For the new proposed function of the building, the authors refer to the legislation “On cultural heritage” to evident the level of intervention in the architectural and functional aspects. The criteria of the proposed spaces are based on i) economic benefit ii) environmental benefit iii) social benefit. The authors propose to use the ground floor (see figure 10 left) for exhibition purposes. The exhibition will be mostly concentrated on the historical part of creational and administration of Tirana (related with the Tirana castle itself and building history). The authors propose to include in the museology the history of Toptani Family together with the most known figures who have lived there (Edith Durham, Libohova Family). In the second floor (see figure 10 right), the authors propose a library. The main purpose is the education of the upcoming generations, revitalization of the building and economical benefit from the tourists.
