NATURAL ENVIRONMENT, ANTHROPOGENE ACTIVITY AND ENVIRONMENTAL PROBLEMS IN THE COMMUNE OF BALDUSHK

Klementina Ferhati *

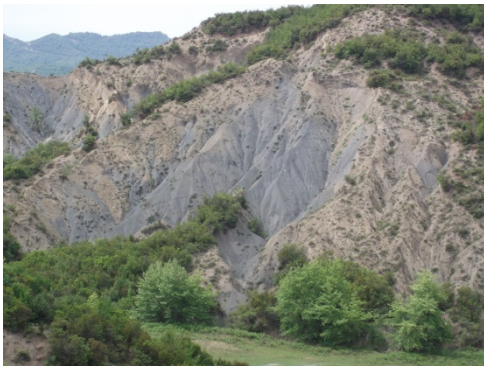
Photo 1: Erosion in Veskia

The impact of human factors is seen in the inappropriate interventions on key elements of the environment, especially on the misuse of vegetation and land. The human being has a great impact in preventing and reducing the consequences of these environmental issues on the environment and on the economic activity (Sala&Qiriazi, 2007). The natural conditions are very suitable for the intensive development of surface erosion in this territory. The erosion centers are strong and especially in some sectors the slopes are obviously degraded and deserted such as in: Tavaren, Kocaj, Veski etc. The main cause of their degradation remains the appearance of clay and alveoli rocks on the surface and the damage of natural vegetation. It is exactly in these slopes where we find the biggest centers of erosion (**Photo 1&2**).

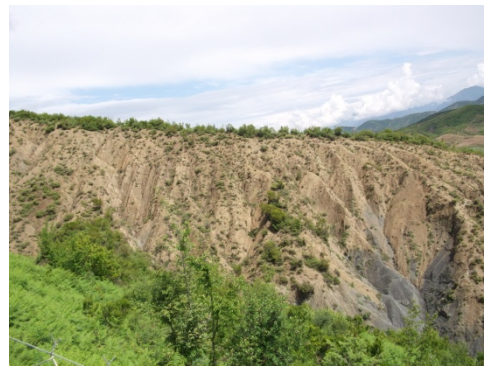
Photo 2: Erosion in Fushas

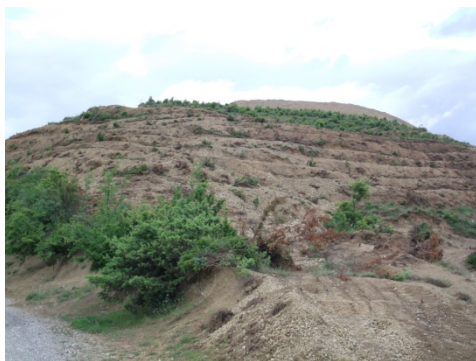
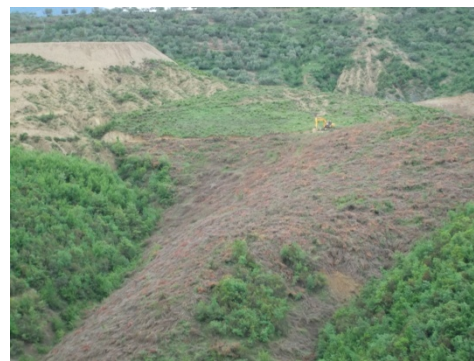
Photo 3&4: Building terraces without protective measures and uncontrolled deforestation in the village of Rova

Besides natural factors, the human being has also helped in the intensive development of erosion and degradation of the slopes through deforestation, fires, overgrazing of bushes and grass, misuse of land, terraces, roads etc., (**Photo 3&4**).

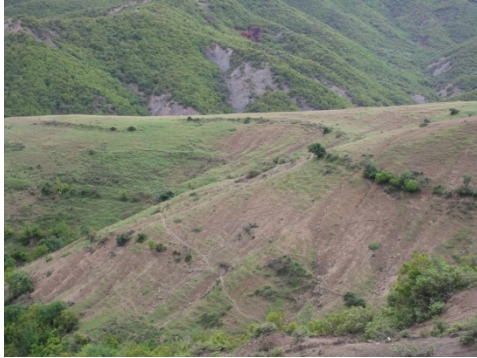
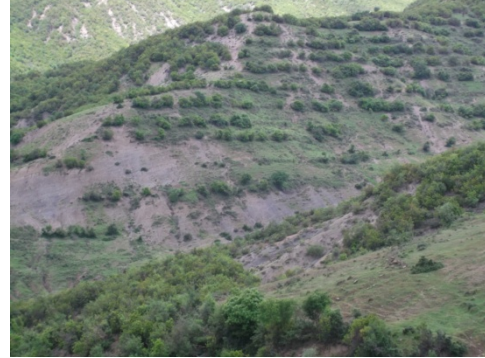
Photo 5&6: Abandonment of land accompanied with surface erosion activation (Fushas 2013)

The digging of new land in the 1980 of the 20th century has stimulated surface erosion and today in many sectors of the villages Vrap, Kocaj, Baldushk, Fushas etc., we find agricultural land which is degraded and deserted (**Photo 5&6**).

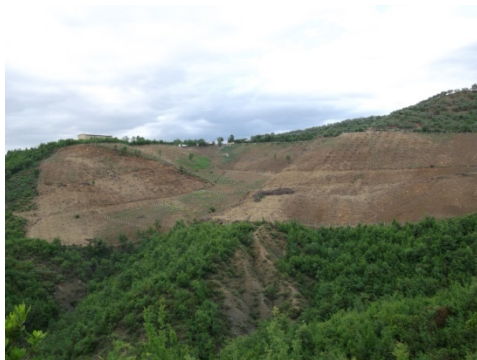
Photo 7: The risk of filling the water-collecting area(Rove 2013)

The erosion process has been threatening the water-collecting area in a significant way. The problem of filling has had the greatest rhythm after the '90s because during this period there was an entire lack of anti-erosion measures which were constructed before. In addition to these factors in the last 2-3 years their quick filling is affected by deforestation and digging of new land near the Rova reservoir (**Photo 7&8**).

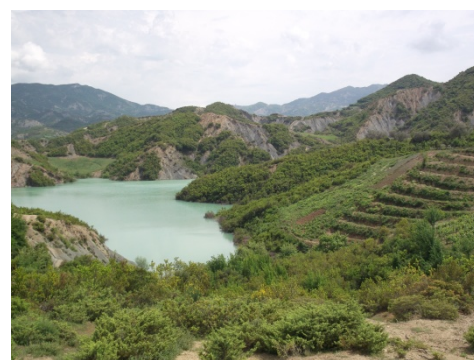
Photo 8: Filling of the water-collecting area by the creation of new land (Veski 2013)

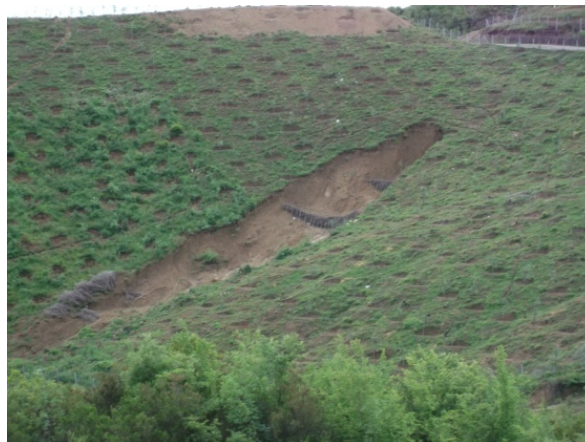
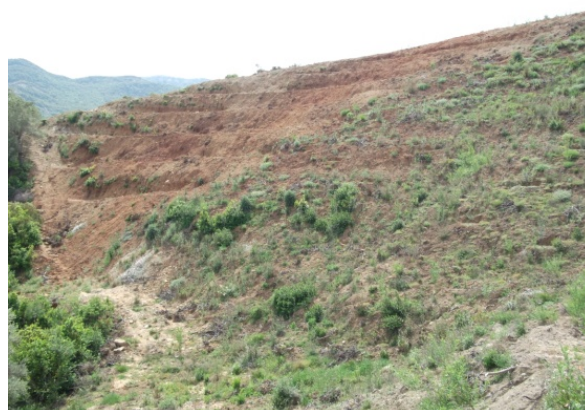
Photo 9: Digging new land accompanied with landslides(Isufmucaj 2013) **Photo 10:**Landslide of the created terraces (Kocaj 2013)

They constitute a geomorphologic risk which stimulates the degradation and desertion of the physical environment and they also cause problems in the social and economic activity of people (Qiriazzi 1990). The avoidance of this risk needs a careful evaluation of the slope peculiarities and every human intervention on them, taking preventive measures such as: constructing protective walls, careful drainage, planting trees with a deep roots system etc. There are many cases when the landslide is stimulated from human intervention in hilly slopes or the bank of streams (**Photo 9&10**).

New landslides are present almost in all the slopes where there are build new terraces, because they are abandoned and destroyed or in other cases there has been no attention in taking anti-erosion measures. Similarly in the west slope of Vrap hills, great areas of bushes have been deforested and burnt recently, so the erosion and landslides have increased considerably (Sala, 2005).

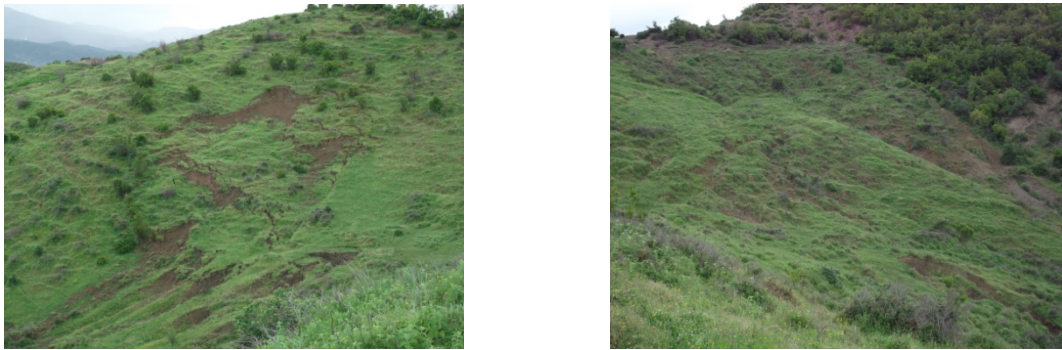
Photo 11&12: Abandonment of land and activation of landslides (Fushas 2013)

In the '70s, terraces planted with cherry trees were created in the villages of Vrap and Shpat. In some sectors they were built in sliding areas where the negligence to remove the excess water created the conditions for their reactivation. Abandonment of these terraces after 1991 was associated not only with the reactivation of the previous landslides but the activation of new ones **(Photo 11&12)**.

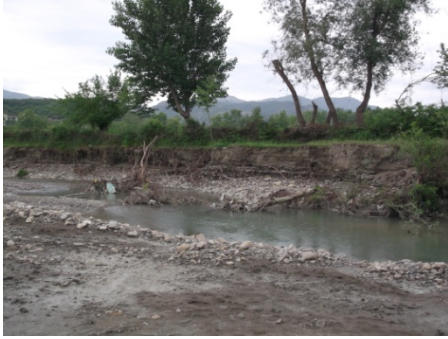
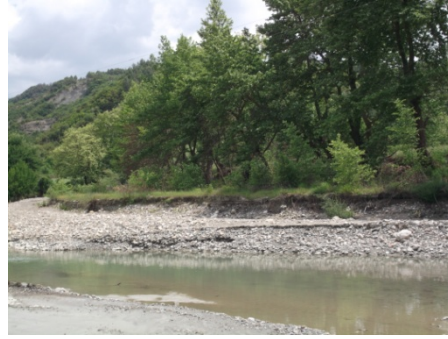
Photo 13&14: Side erosion in Zhullima valley

The landslides are spread considerably even in the slopes of Zhullima valley, especially on the slopes of the main branches. Here we find destructions, landfalls and erosion centers which threaten the agriculture land such as in: Isufmucaj, Tavarej etc. The main cause of these processes is the side erosion of water flows, the latter highly favored by uncontrolled human intervention in the bottom of the streams **(Photo 13&14)**.

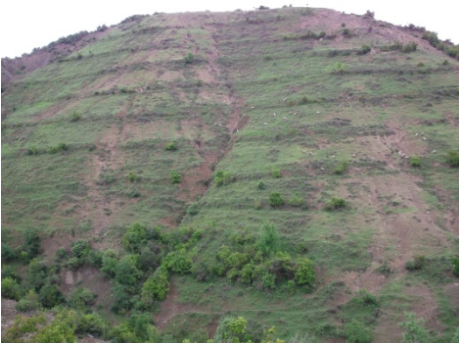
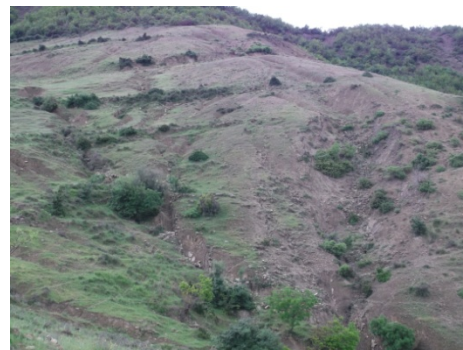
Photo 15&16: Creation of streams in the abandoned land

They have also influenced in filling the agricultural land with solid material, have damaged roads, water-collecting areas etc. In many sectors of this territory, the abandoned land is seized by small streams and ravines, which are deepening their bed as long as there is no attempt to take preventive and restrictive measures (**Photo 15&16**).

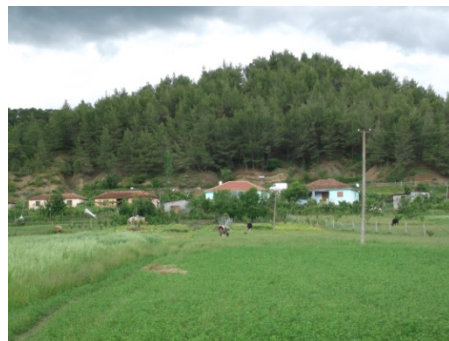
Photo 17: Reforestation with pines in the '80s to restrict erosion (Rove 2013)

In many sectors of this commune, during '55-'85, the activity of people is focused on the restriction of erosion intensity by planting 770 hectares of forest, mainly pines. So in the degraded slopes near Shenkoll, Rove, Tavaren etc., there were reforestations with pines which have affected quite well not only the degradation process, but the regeneration of the vegetation of bushes as well, forming the humus layer and vegetal part of land **(Photo 17)**.

Reforestation in this period had a positive effect in reducing the risk of filling with solid material of the Rova reservoir, but as we mentioned above the risk for this reservoir has become more threatening in the last 2-3 years due to the inappropriate deforestation and creation of new land in the hilly slopes near this reservoir.

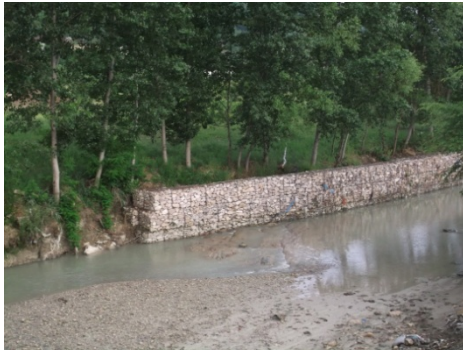
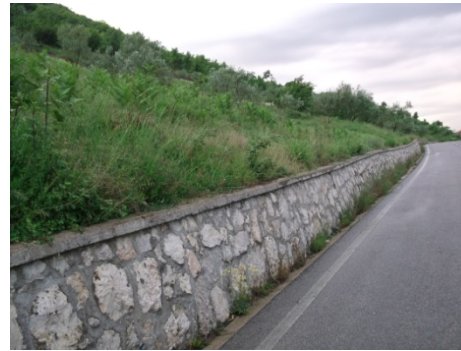
Photo 18&19: Protective measures against erosion

against the erosion process such as: construction of embankments on the road sides, stream banks, reforestation in some sectors etc., **(Photo 18&19)**.
