Conditional Assessment of Historical Structures: Earthquake Performance of Naziresha Mosque

Enea Mustafaraj[1], Yavuz Yardım[1]

[1]*Department of Civil Engineering, Epoka University, Albania*

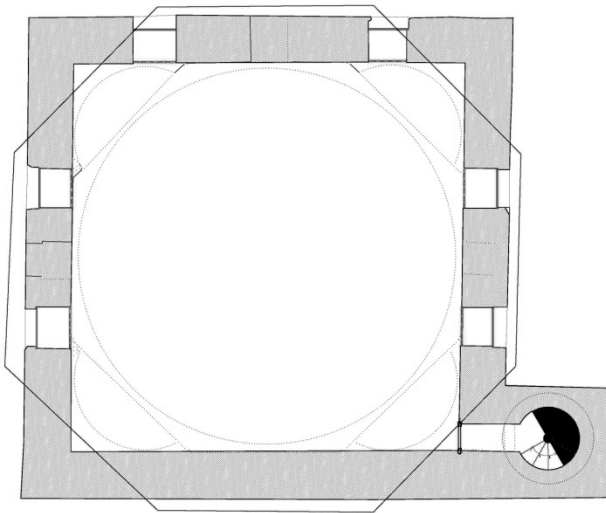
Figure 3 . Plan view of the mosque

The Mosque of Naziresha was built in Ottoman style. It has a squared 10.70 x 10.70 meters plan and only one cubic shaped central hall. The walls made of stone comprise the main load bearing system of the mosque. They are 1 meter thick and rise until a height of 8.12 meters. The materials used for building of the walls are rough yellowish limestone and red bricks. [1]

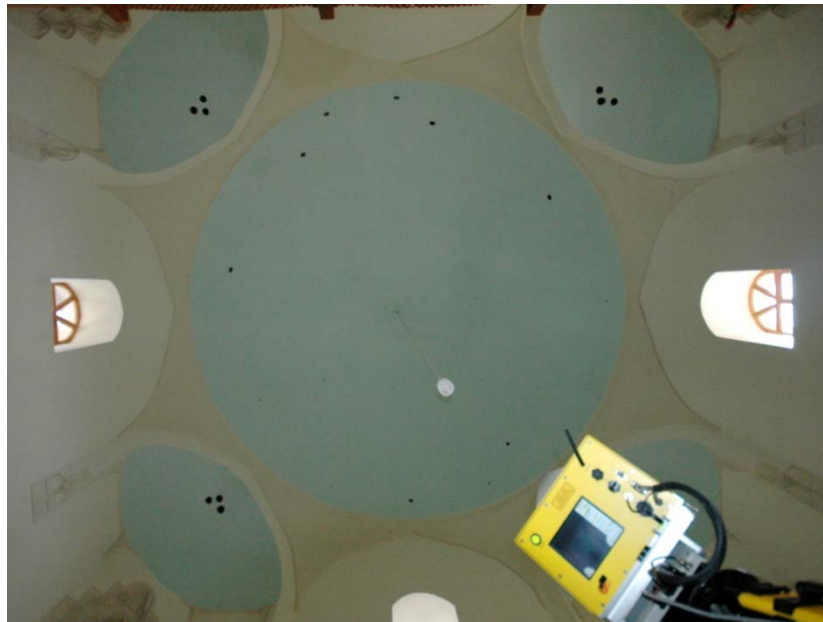
Figure 5. Interior of the dome

Dome structural conditions are not adequate to carry static load. There are structural cracks found on it. It is very difficult to be seen from the interior, as it was recently re-plastered. Tiles on the roof are broken. There is found vegetation over them. Drainage system is not functional. Rainwater is not collected, but it leaks over the roof and over the walls being a potential agent for damaging the facade and structure of the walls. The lantern hanged at the top of the dome after the construction had caused extra stresses on the dome. However, as the dome has been recently plastered and old lantern replaced, cracks cannot be seen with naked eye (Figure 5).

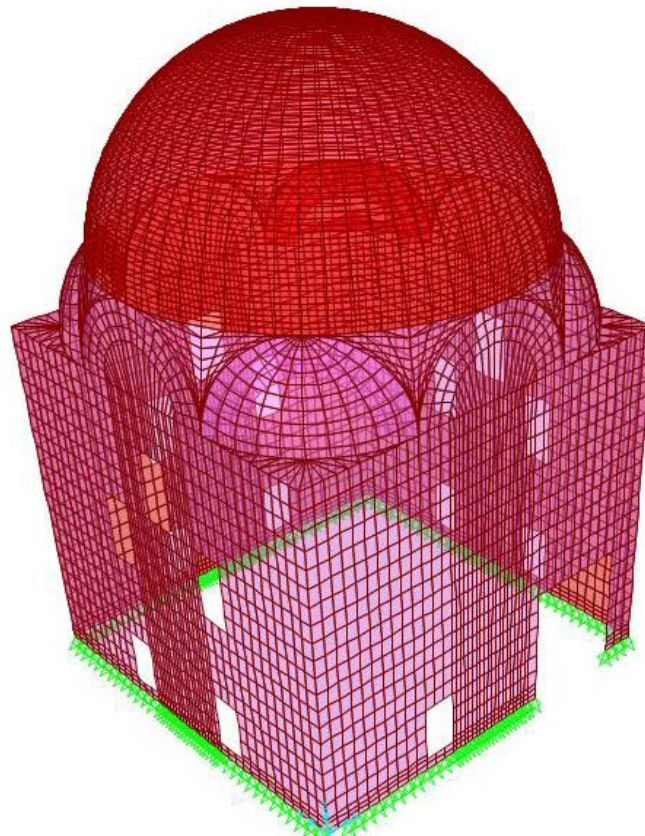
Figure 8. Finite Element Model in Sap2000

In order to define and locate the most critical regions where the maximum stress concentrations are found, a computer based linear analysis was conducted using Sap2000 v.15 software. The mosque's model consists of 9604 joints and 9563 shell elements. Material properties are taken from literature [4].

The characteristic properties of stone and masonry bricks are: Young modulus E = 1740 MPa and 2100 MPa; tangential elasticity modulus G = 290 MPa and 350 MPa; poisson ratio υ = 0.2 and υ = 0.2; unit weight γ = 18 kN/m^3 and 21 kN/m^3, compression strength σ_c = 2.5 MPa and masonry brick σ_c = 3 MPa , tensile strength σ_t = 0.12 MPa and σ_t = 0.12 MPa respectively .

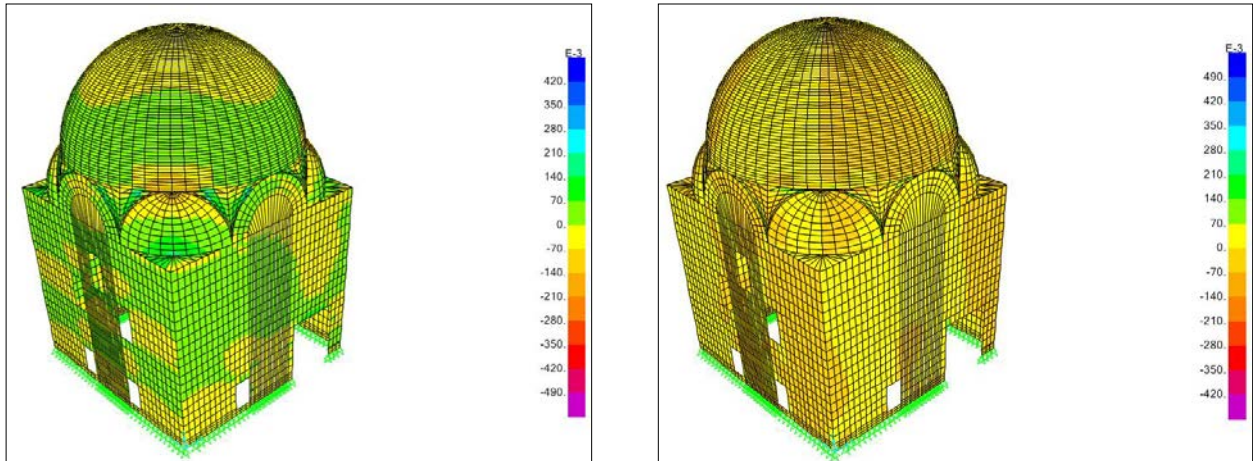
Figure 9. S11 (-0.566 to 0.567 MPa) and S12 (-0.396 to 0.399 MPa) stress distribution.

Analysis results have shown that maximum stresses under dead load exceed maximum allowable stresses of both of the materials which are 0.12 MPa in tension.

Stresses in the dome are spread over the middle part, and tension stresses occur around the middle part of the dome in circumferential direction. Maximum values for compressive and tensile stresses are 0.946 MPa and 0.945 MPa.

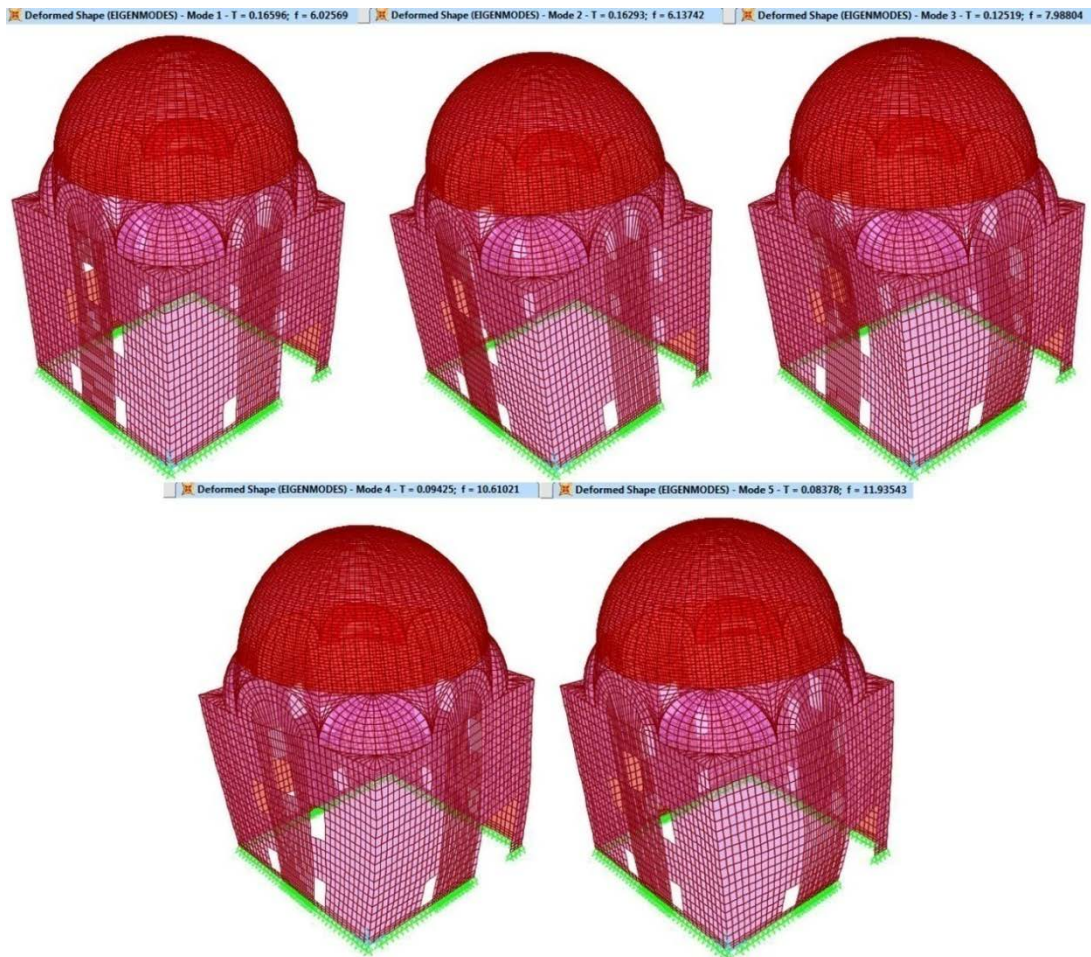
Figure 11. Mode shapes of deformation under modal analysis

To study the behavior of the mosque under lateral loads, a linear dynamic analysis is performed. The period and frequencies and mode shapes are obtained using Sap2000 Eigen-vale analysis.

S11 (hoop stress) maximum stresses develop at the main dome. Compression stresses develop at the middle part and tensile stresses are observed in circumferential direction along the middle part of the dome. Maximum value of S11 is 1.058 MPa, whereas minimum value of S11 is 0.531 MPa which is more than allowable tensile capacity of the material. Maximum and minimum values of S22 (radial stress) are 1,382 MPa and -0,527 MPa respectively.

Maximum and minimum of S12 (in-plane shear stresses) are 0.931 MPa and -0.304 MPa. Results have shown that maximum displacement of the dome is observed to be in x-direction and is 2,82 mm.
