Rehabilitation of Schools Damaged by Earthquake in Kraljevo on Sept.3th,2010

Zoran Petraskovich 1, Jasminka Petraskovich Dzuklevski 2

Over forty schools are analyzed and solutions of seismic rehabilitation are given by technology of System DC90. Masonry schools up to four floors and reinforced concrete skeletal structures are analyzed. The paper shows way of researching, technology design and the work carrying out technology. Shows the technologic and design solutions for strengthening the walls, for stiffening the ceilings, for joining ceilings with walls, for vertical prestressing of the walls and the interconnection of the walls. The technology is especially effective on a mass repair of masonry structures with aspect to the level of safety, cost and schedule.

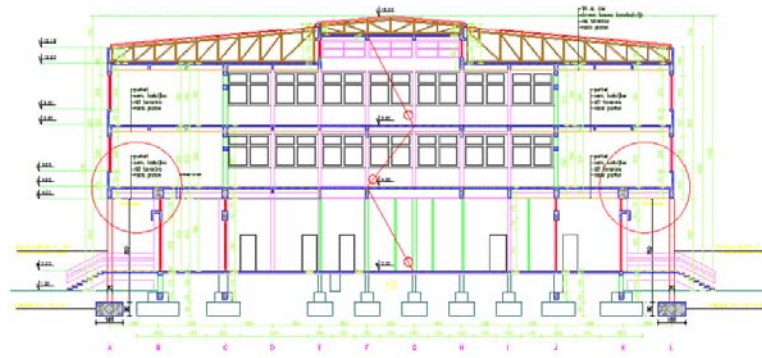
Figure 39. Shape of vertical stiffeners

Soft frame reinforced concrete structures has caused large damage on the walls. Vertical oscillations are heavily damaged consoles 3000 mm in length.

Accepted stiffening type "D" at X and Y direction made of diagonal solid square profiles and diagonal square tube profiles in fields of 2,80m and 3,80m: at the ground floor 200x200x6mm., at the first floor # 80/30...1 and 160x160x4mm. and at the second floor # 60/20...1 and 160x160x4mm
