## Effect of errors on execution and design of key details in the object

Alush Shala<sup>1</sup>, Jelena Bleziffer<sup>2</sup>

### ABSTRACT

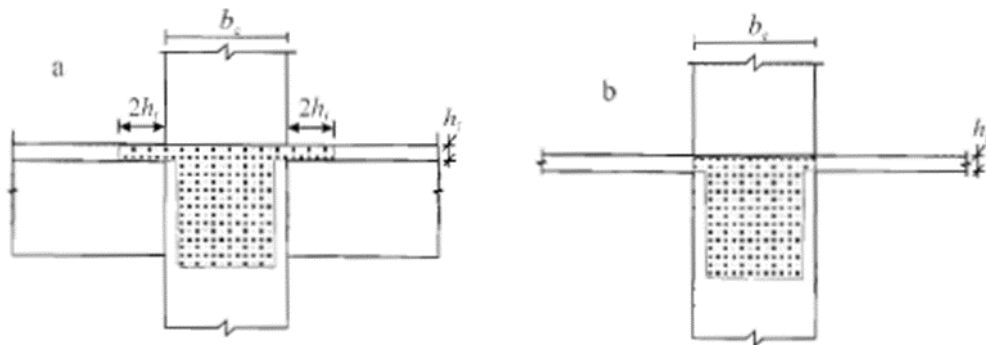
Figure.5 Effective flange width  $b_{eff}$  for beams framing into columns [1]

Execution error not good according to the site view, we now have the connection between the column and the beam. In picture 9 below we present the error in realization, while in figure 5 will present the regular way of execution according to EC8. Resistance for bending forces and cross section forces according to rule 3a of EC8 we have: for primary seismic beams framing into exterior columns, the effective flange width

is taken, in the absence of a transverse beam, as being equal to the width  $b_c$  of the column ( fig.5.b) or if, there is a transverse beam of similar depth equal to the width increased by  $2h_f$  on each side of the beam (figu.5.a) [1]

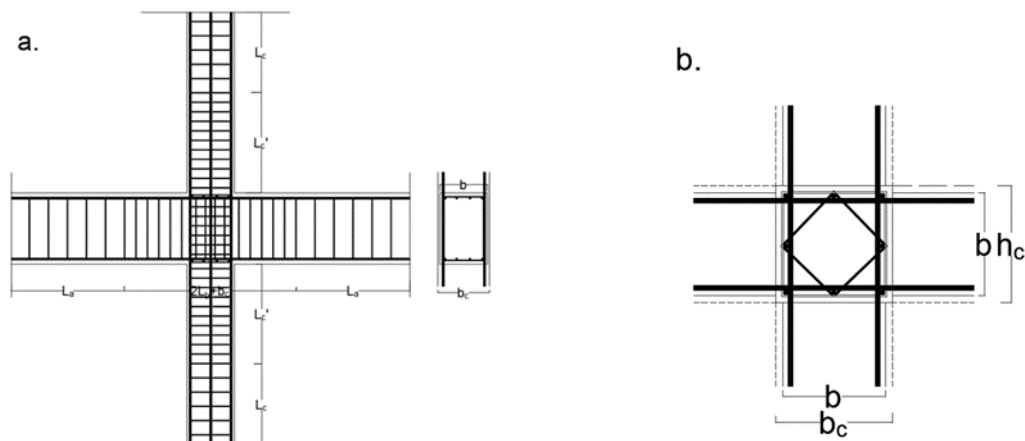
Figure 6 a. Outline of beam column connection armature, b. the detail of the connection of the column beam joint

In figure 7 we present figuratively how the regular way of reinforcement for objects in seismic areas is. This detail satisfies the seismic requirements of reinforcement. In detail (fig.7.b) it is presented how reinforcement should be placed in the beam junction to meet the seismic requirements for buildings in areas with seismicity that should not be neglected by the designer and the contractor. In our inspections it was noticed the omission in reinforcement of beams and columns near the joint has not been respected the recommendation of EC8 that near the node to have a density of staff as in fig.7a. Therefore, designers must always take into account that in their design must respect the technical conditions and norms for areas seismic and have a more rigorous supervision of the implementation of works on site.
