Strengthening and Restoration of Historical Structures - Mirahor Ilyas Beg Mosque in Korça

Enea Mustafaraj, Yavuz Yardim

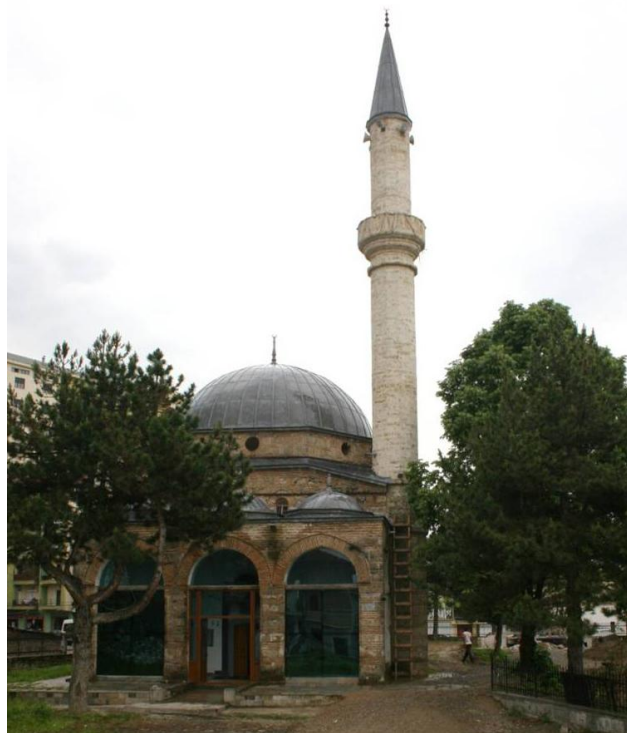
Figure 1. Mirahor Ilyas Beg Mosque in Korça

From the documents in the archives, it is seen that the used timber in the mosque is original. For this reason it has great values and is to be conserved. The damaged varnish and paste layers above the entrance gate (Figure 1), will be cleaned. Areas where there are mass losses will be filled with the same type of timber. Then, all timber elements will be varnished with a water based timber protection layer.
