EVALUATION OF RECENT EARTHQUAKES IN ALBANIA

Erdal Emre Çeçen, Nikolla Nika, Fatjon Saliu, Anxhela Lama
Metropolitan University of Tirana
Tirana, Albania

Agim Seranaj, Altin Serenaj, Altin Piqari
Polytechnic University of Tirana
Tirana, Albania

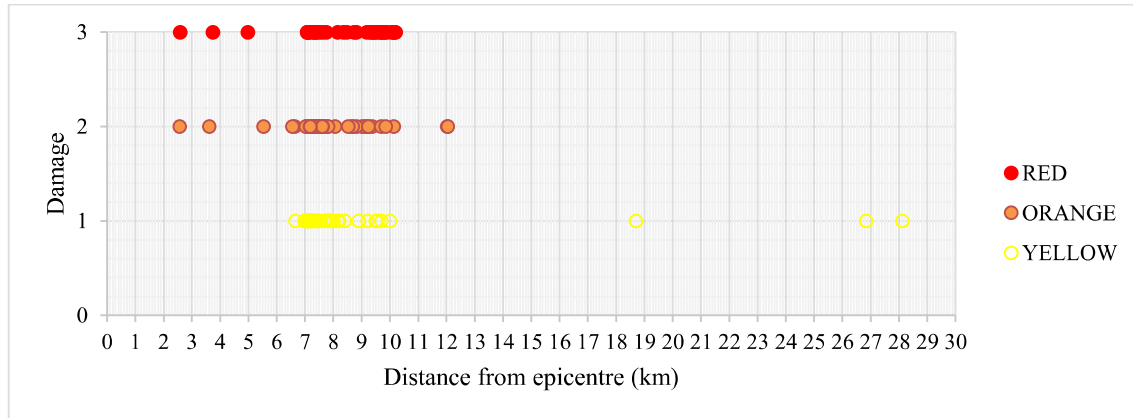
Figure 14. Scatterplot of Epicentral distance with respect to damage levels.

It is searched how the attenuation relation to be demonstrated in terms of damage levels. Higher damage levels were concentrated especially within the epicentral distance with radius of 6 km (Figure 14). However, there is not a good correlation of epicentral distance

with damage level beyond this distance. This can be interpreted as an indication of local soil conditions effects. Moreover, a poor geotechnical investigation or evaluation followed by poor structural design without anti-seismic detailing would also be counted.
