REVIEW OF THE STRUCTURAL IRREGULARITIES ON  
ALBANIAN RC BUILDINGS WITH A CASE STUDY

A THESIS SUBMITTED TO  
THE FACULTY OF ARCHITECTURE AND ENGINEERING  
OF  
EPOKA UNIVERSITY

IN PARTIAL FULFILLMENT OF THE REQUIREMENTS  
FOR  
THE DEGREE OF MASTER OF SCIENCE  
IN  
CIVIL ENGINEERING

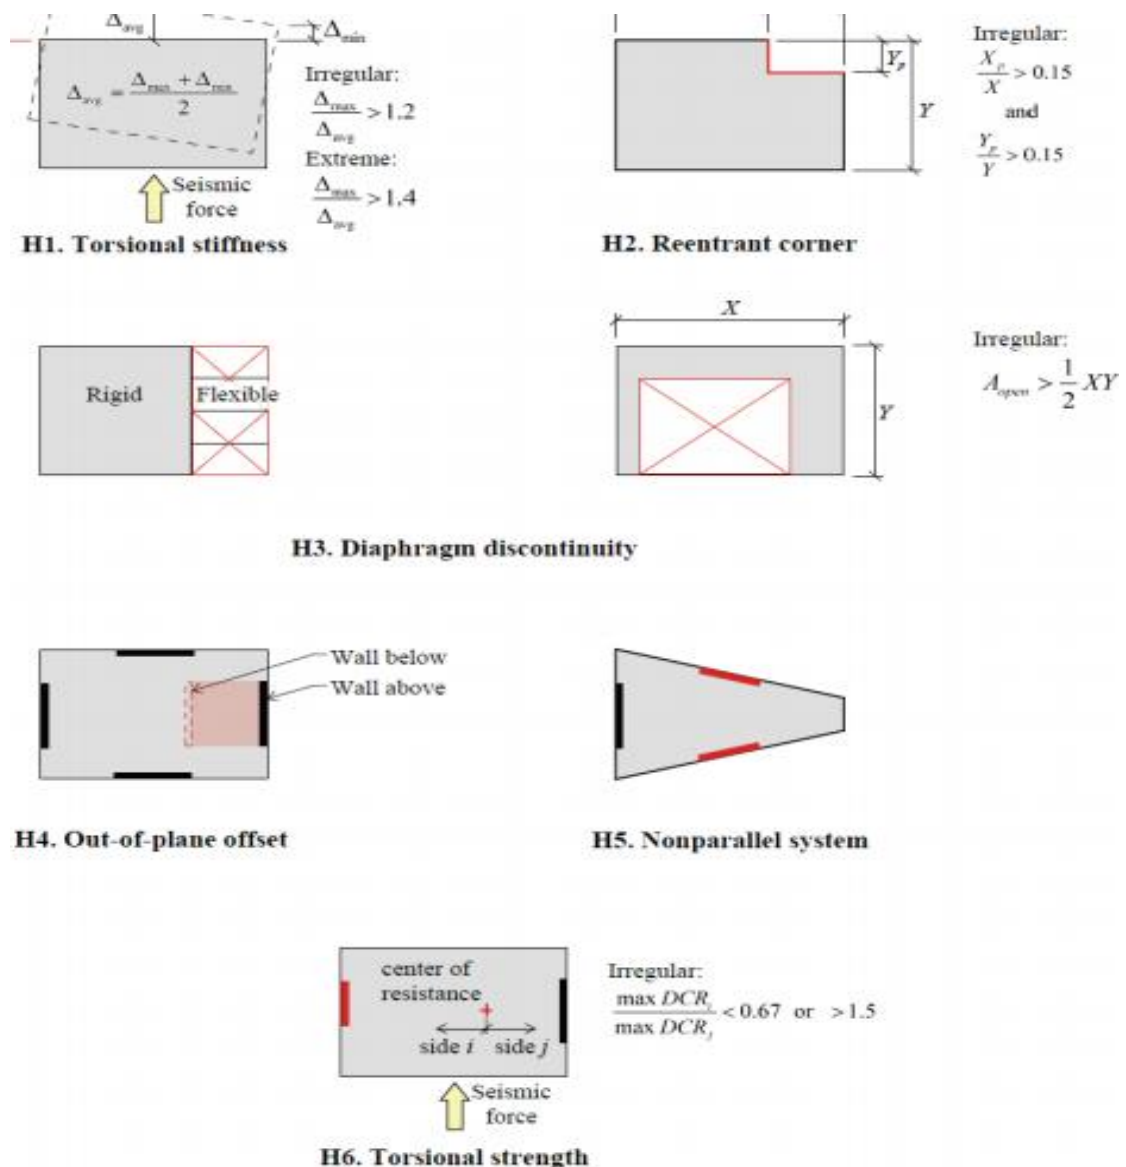
Figure 2. Horizontal irregularities. [FEMA\_P 2012]

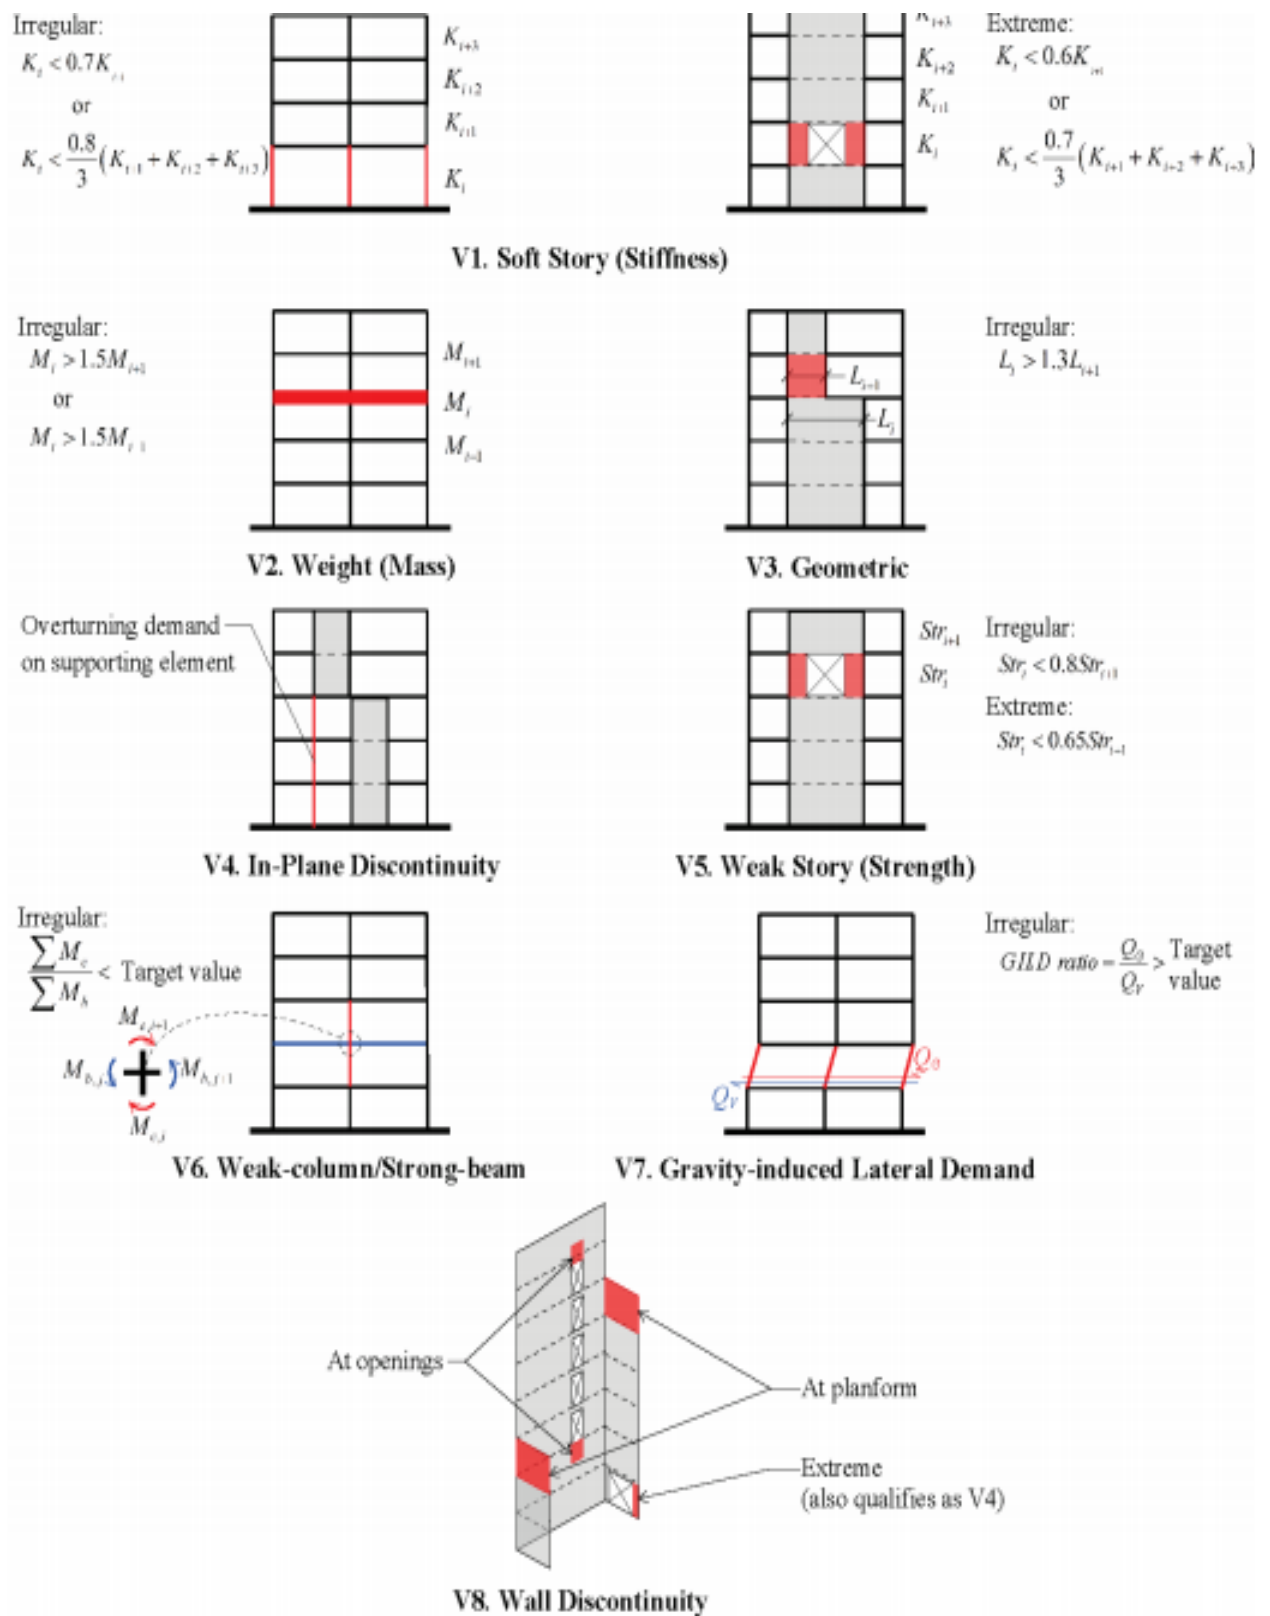
Figure 3. Vertical Irregularities [FEMA\_P 2012]

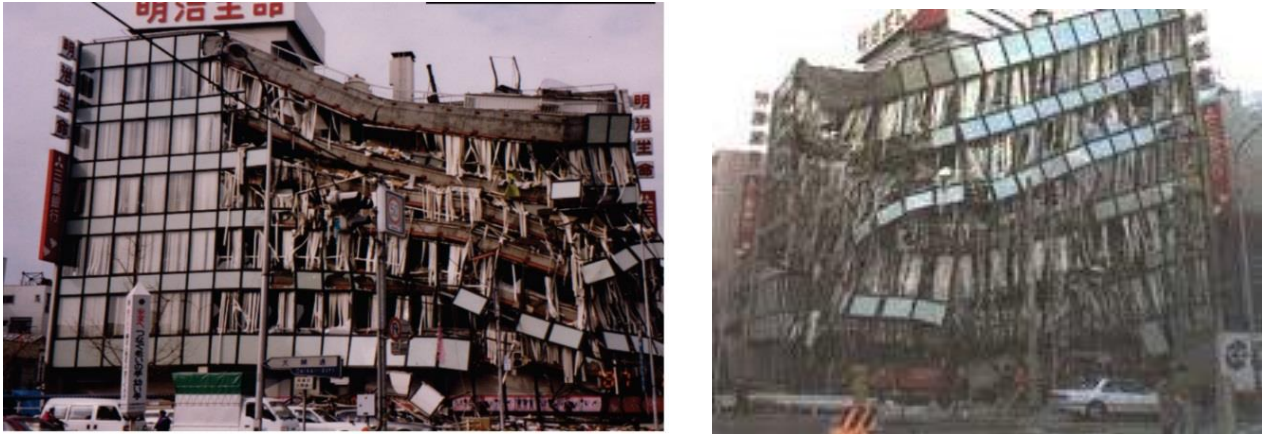
Figure 7. Partial collapse of a 6-story commercial building (Chou Ward) with a torsional irregularity. [Photo courtesy of Charlie Kircher]

The torsional irregularity caused the RC building to rotate during the earthquake. During the rotation, there was caused a large displacement of the gravity frames at the corner away from the stiffer walls which exceeded frame capacity causing failure of columns and collapse of the above floors. (Fema\_P, 2012)

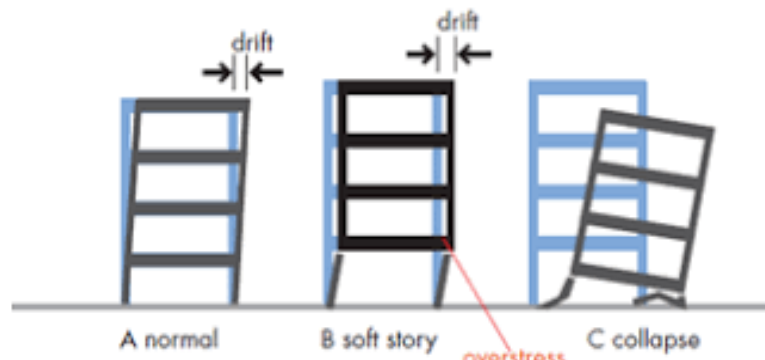
Figure 8. Ground soft story mechanism.

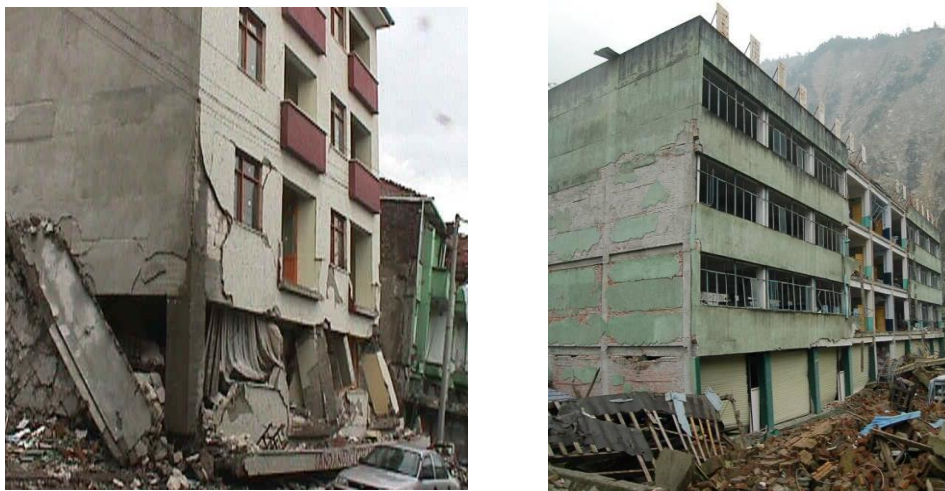
Figure 9. Soft story failure in an Izmit apartment building. Figure . Reinforced concrete framed structure, masonry infill with soft story failure at the bottom level. [Pathmanathan Brabhaharan, 2012]

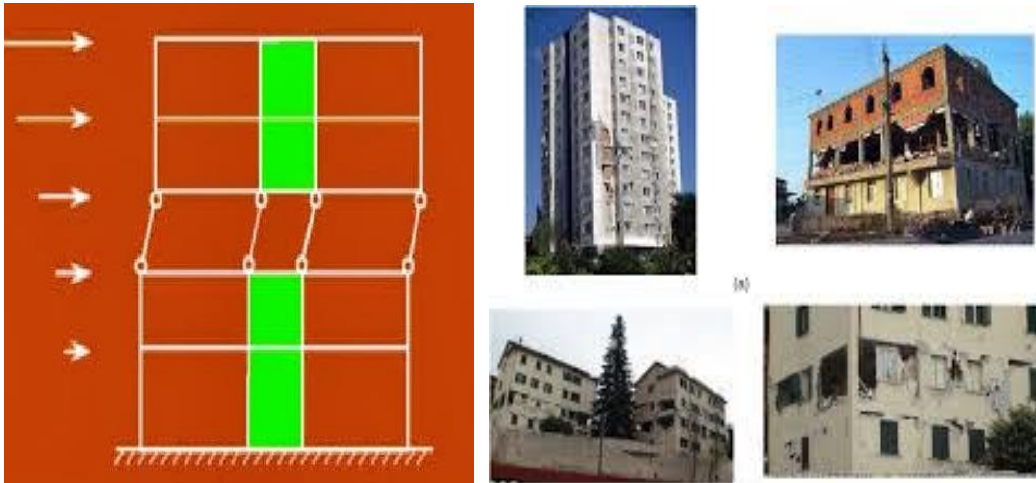
Apart from the soft ground stories, even an upper storey can result in being weak when comparing to others if the lateral bracings are skipped or consumed, even if the horizontal stiffness is reduced above a specific floor, it may result in a sway mechanism.

Figure 10. Intermediate soft story scheme. Figure 8. Progressive Collapse of Concrete Frames with Unreinforced Masonry Infill Walls Considering In-Plane/Out-of-Plane. [Khalid M. Mosalam and Selim Günay, 2015]

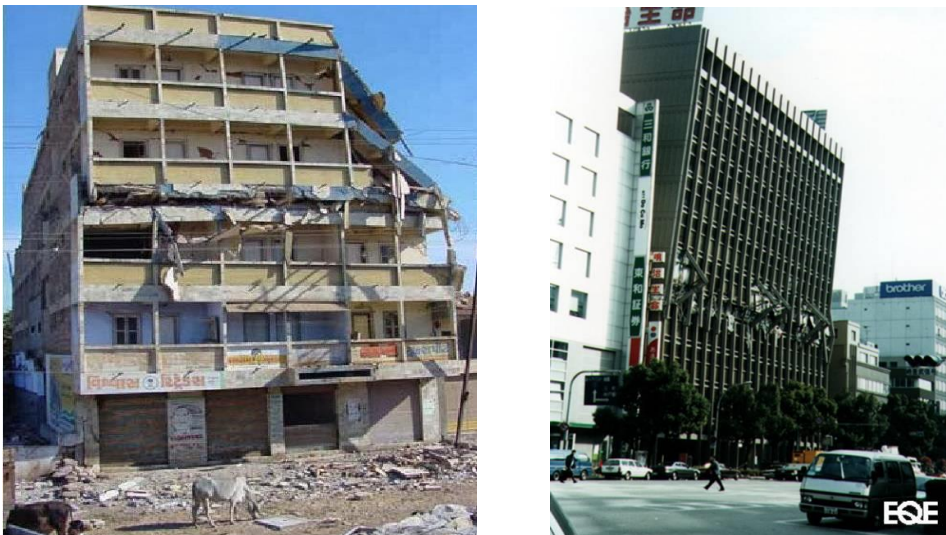
Figure 11. Collapse of intermediate story in a 6 storey RC frame commercial building in Bhuj.  
Figure.12. Mid-story collapse, Kobe earthquake.

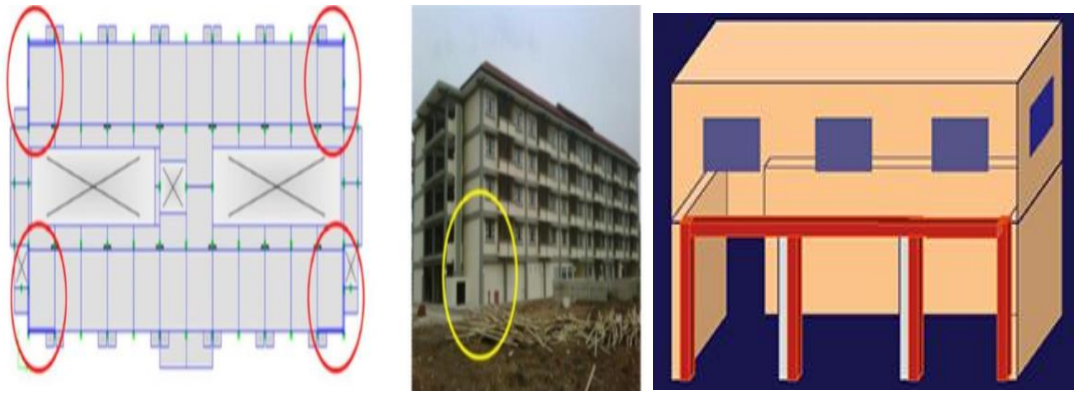
- In order to satisfy the standard in preventing soft storey effect, the lateral stiffness of the first storey should exceed 70% of second storey stiffness, and 80% of average stiffness of 3 storeys above.

- Even steel bracings or concrete walls at the first storey, improve the design wished to achieve.
- Constructing RC walls in all buildings corners with required dimensions and thickness helps avoiding the soft storey effect.<sup>34</sup>

Figure 13 . Retrofitting strategies of soft stories.

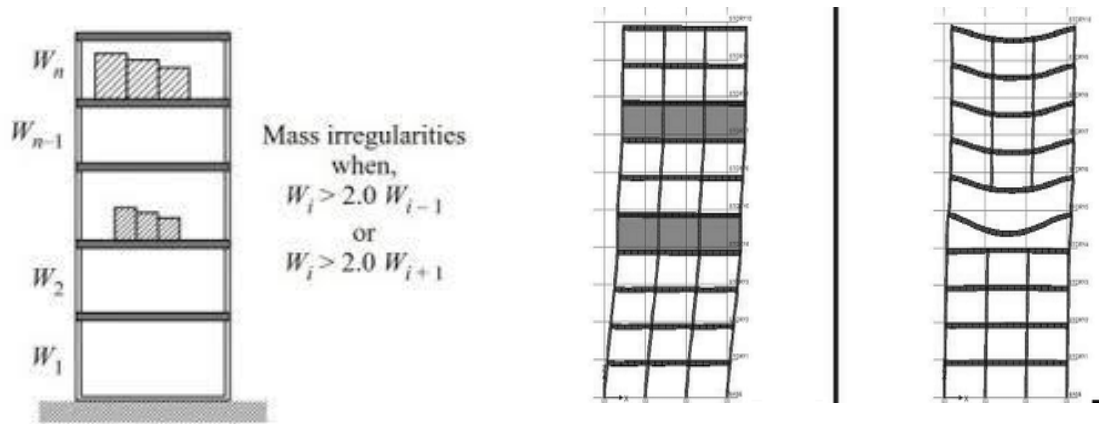
Figure 14. Mass irregularity scheme and limits in RC frame structures.

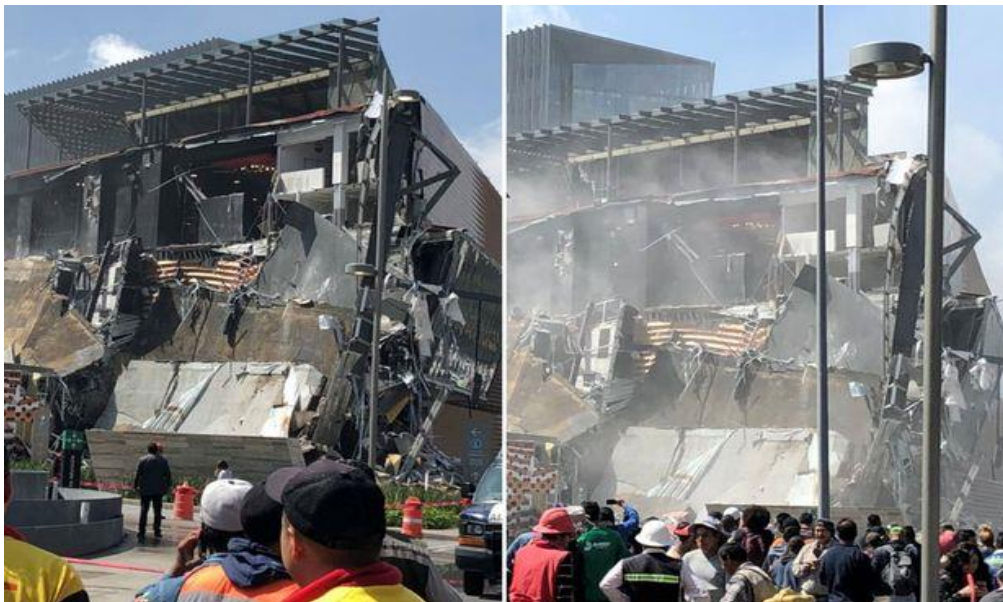
Figure 15. Brand new shopping centre in Mexico collapses under weight of heavy roof garden. [News Locker, 2018]

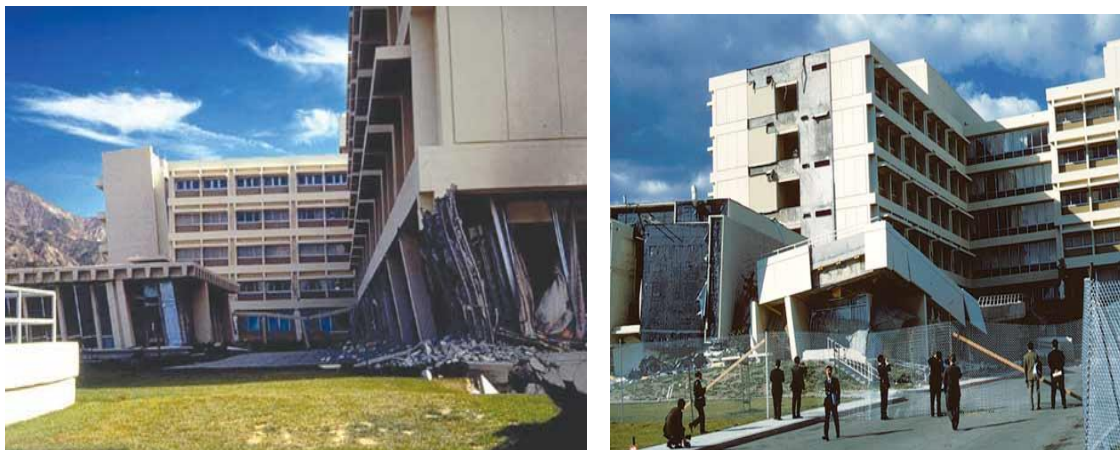
Figure 17. First floor collapse of the main buildings of the Olive View Hospital [by L. Hashizume, E. Loh]

The structural system has significant discontinuities. While the upper four stories show presence of shear walls combined with moment-resisting space frames, the lower 2 stories had only a moment-resisting space frame system. The plan and reinforcement of structural members differed from one story to another. [L. Hashizume, E. Loh, .2002]

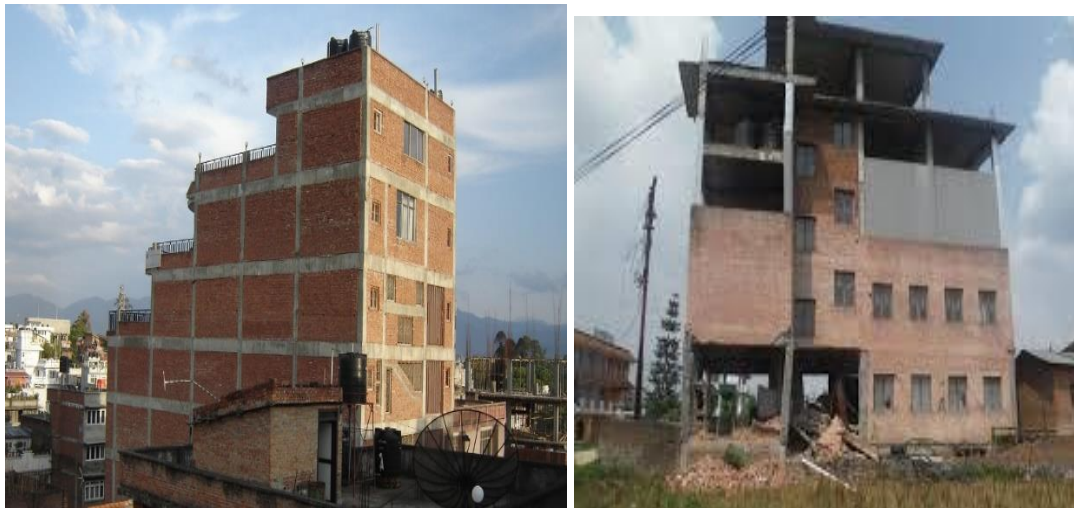
Figure 19. Stepped RC building with masonry infill. [Yukta Bilas Marhatta, Nepal].

This kind of irregularity shown above disturbs the direct path of load transfer due to the weakness they cause for the bracing elements ductility. Also, they influence at columns and slabs causing displacements. The seismic codes discourage all type of discontinues, because

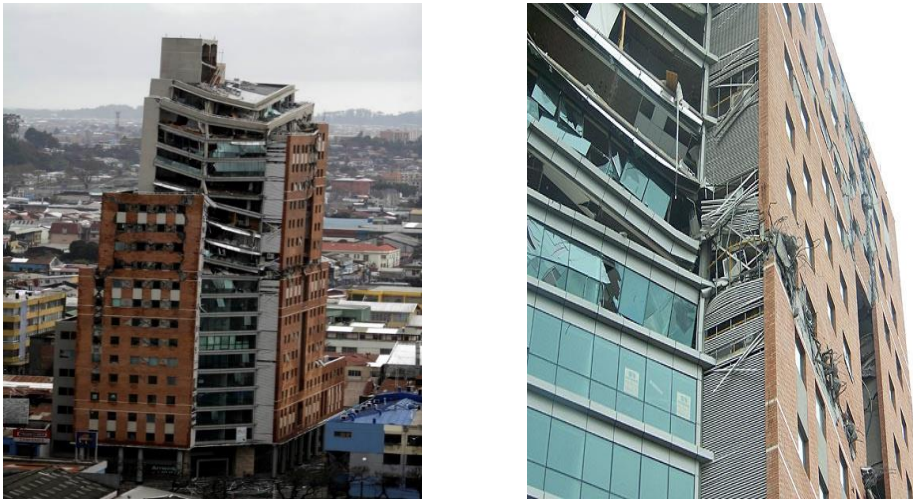
Figure 20. Torre O'Hings high rised building., built in 2007 and consisiting in many structural setbacks along the building height. The earthquake damage included partial collapse at three levels above mid-height.

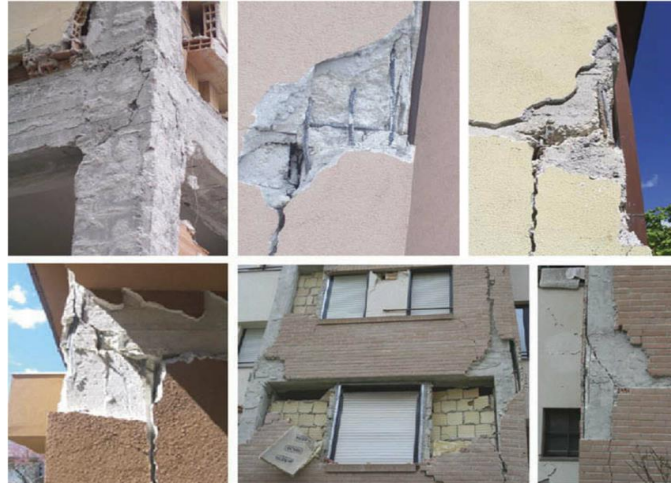
Figure 23. Corner beam-column joint failure during the Abruzzo earthquake [ReLUIS, 2009]

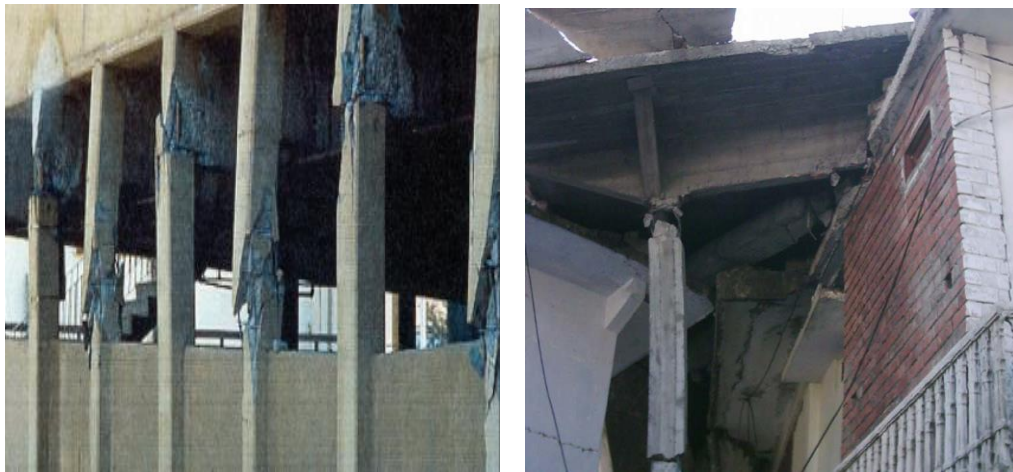
Figure 24. Damaged parking structure Whittier Narrows (Los Angeles) earthquake, 1987 The deep spandrels create a strong-beam, weak column condition.

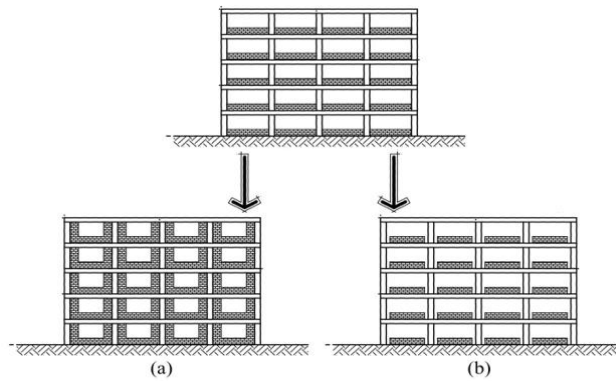
- Column has to be designed stronger than beam so that, during strong earthquake it will provide stability and strength for the upper stories.
- The development of plastic hinge should be located at the end of beam, so the energy dissipation occurs in there.
- The plastic hinge region should be properly reinforcement detailed in order to improve ductility and inelasticity.
- (a) Decreasing the size of continuous openings. (b) Separating walls from structure.<sup>37</sup>

**Figure 26.** Effective measures to prevent strong beam-weak column: (a) Decreasing the size of continuous openings, (b) separating walls from structure

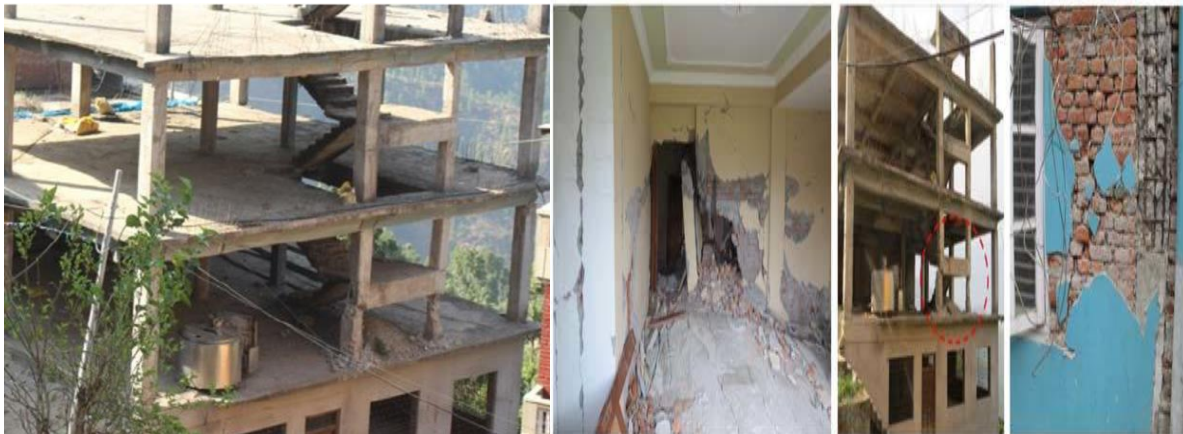
Figure. 30 RC frame building under short column effect. (Vahidi 2009) Figure 31. Examples of short-column failure due to the presence of (A) staircase landing and infill, (B) staircase landing beam, and (C) infill panels with openings. [H.Varum 2015 Nepal]

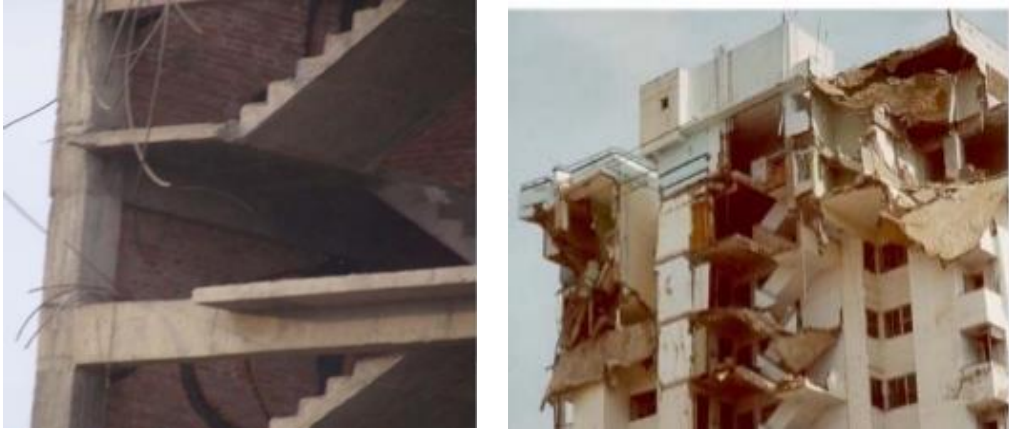
Figure 32. Short column effect due to staircase landing beam. [Binay Shrestha, 2015]

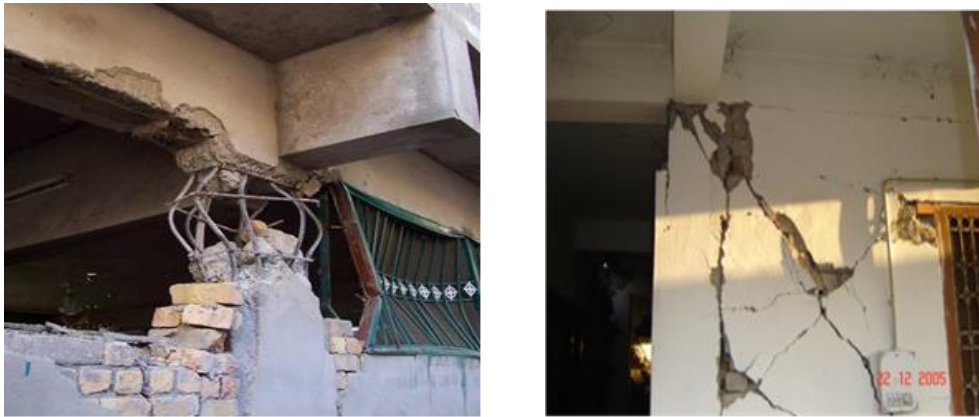
Figure 33. Short column due to partial height infill wall [WHE Report, Nepal]

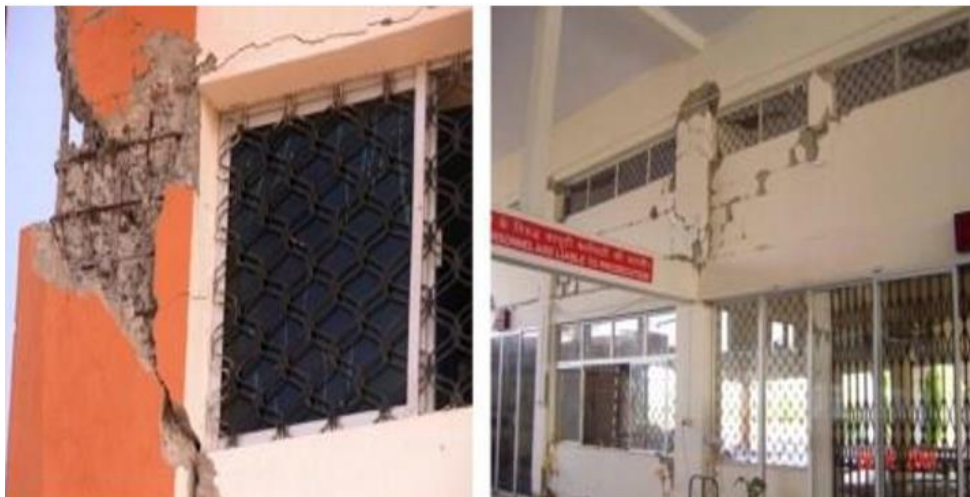
Figure 34. Shear failure due to short column effect observed in Port-Blair, India, during Sumatra earthquake 2004.

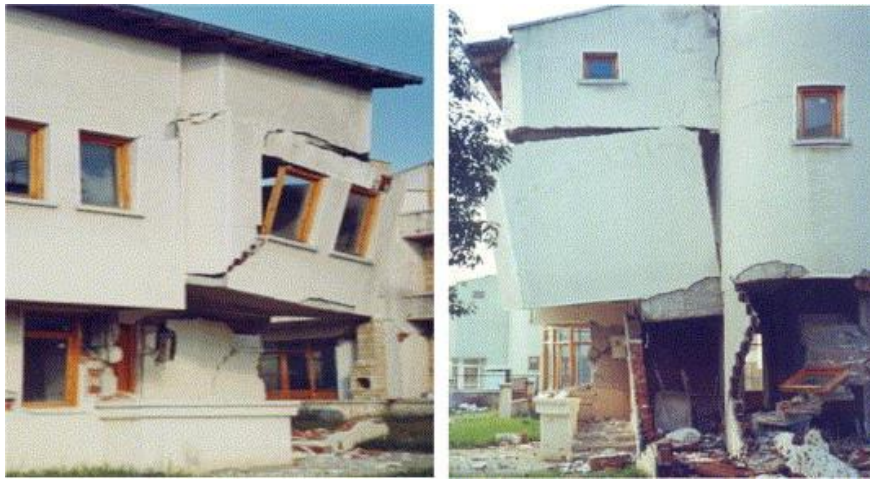
Figure 35. Earthquake failures of cantilever projections buildings in Turkey. [M.Dogan 2007]

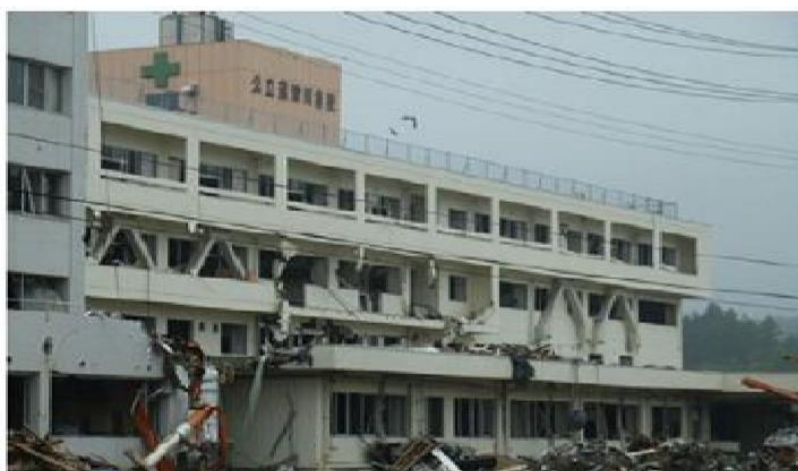
Figure 36. Failure of balconies at Shizugawa Hospital during Tsunami 2011 [Fraser et al. 2013]

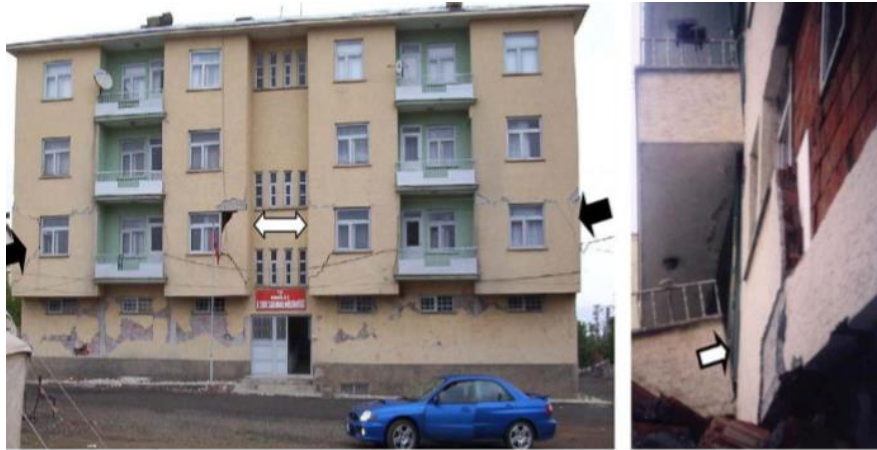
Fig 37. Failure due to overhangs [Dog˘angu˘n 2004]

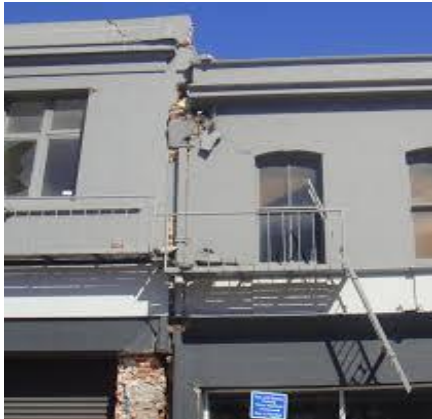
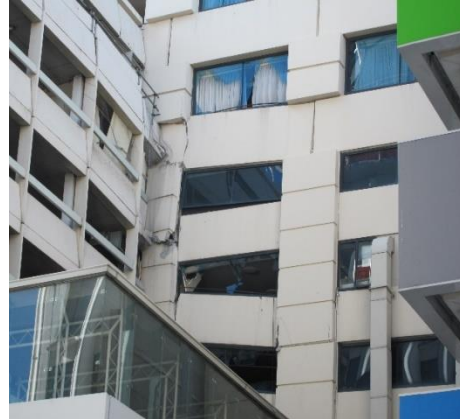
Figure 39. Buildings Pounding Damages Observed in the 2011 Christchurch earthquake  
Christchurch Earthquake.

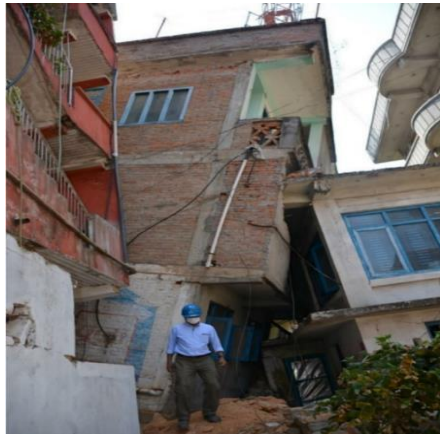
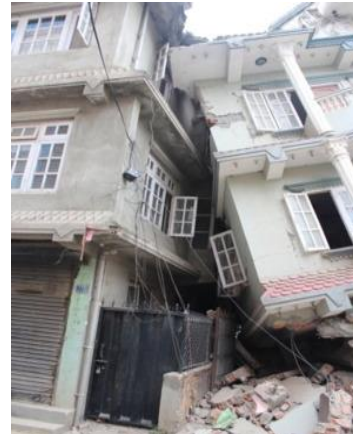
Figure 40. Collapse of buildings results in pounding in adjacent buildings in Chautara,  
Sindhupalchowk.

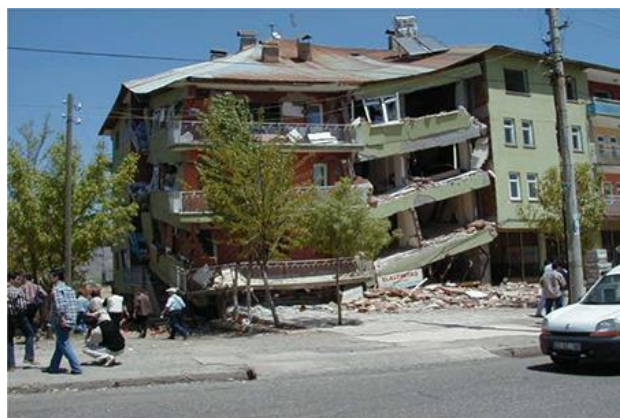
Figure 41. Collapse of adjacent buildings during the Bingöl earthquake.2003.

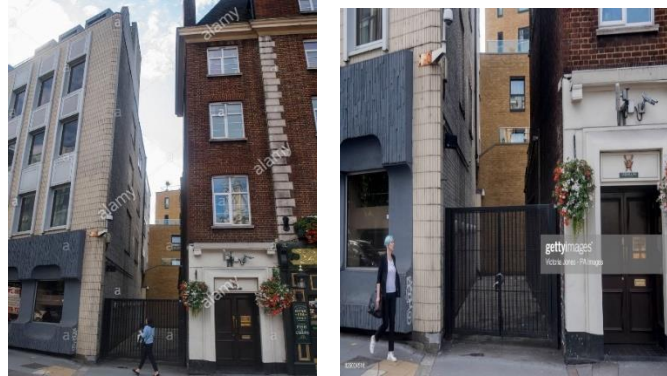
Figure 42. The three-metre gap between two buildings on Euston Road in central London.

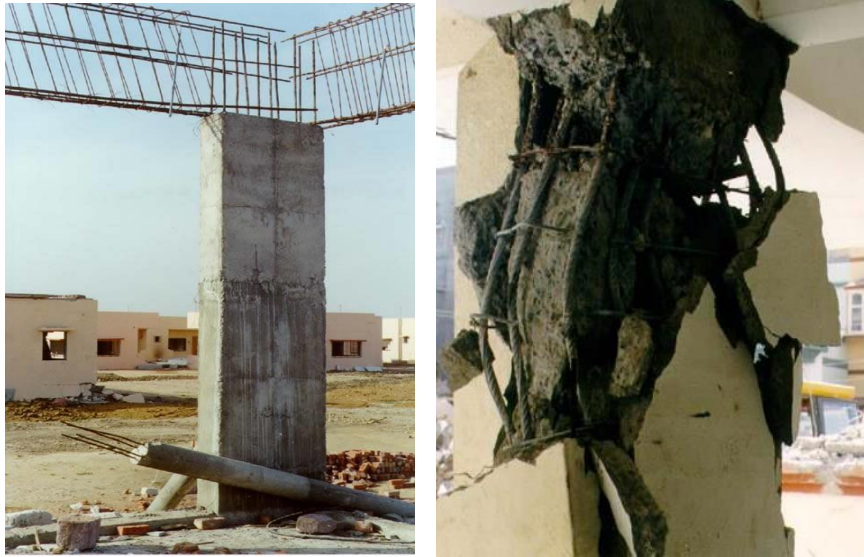
Figure 46. A Zoom+ view of building in on-going construction with not proper reinforcement detailing for Beam-Column joint.

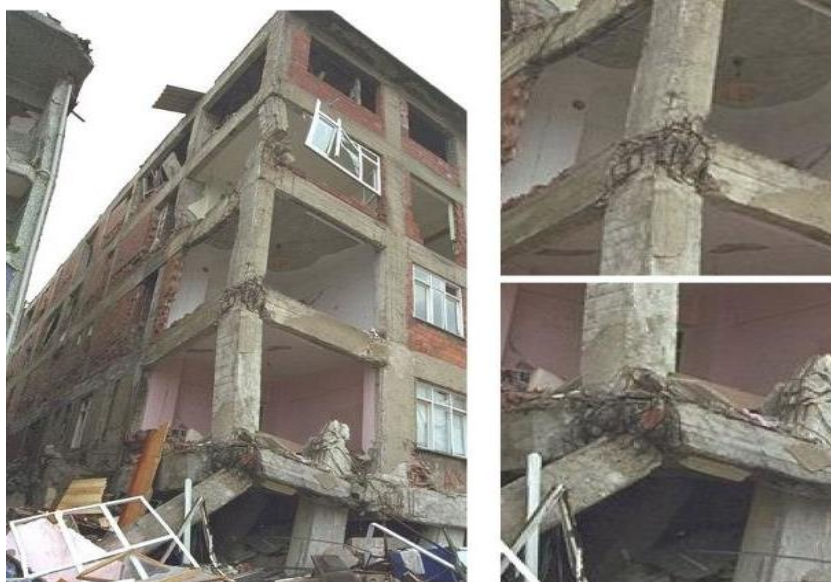
Figure 48. Partial Building Collapse due to failure of beam-column joints in the Izmit, Turkey earthquake of August 17, 1999.

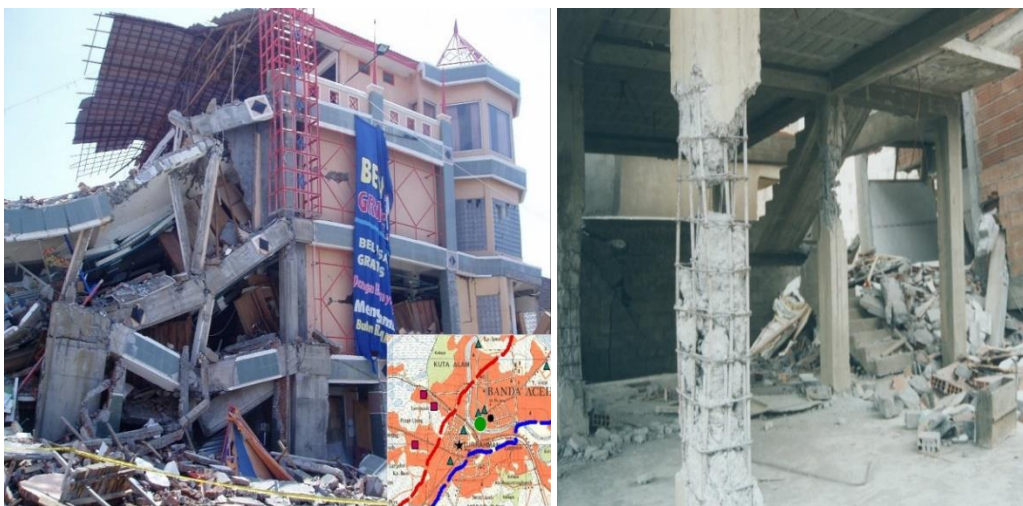
Figure 50(left).Pante Pirak Supermarket, a 3-story building, the collapse was due to poor quality of construction, and right, Seismic deficiencies - very poor quality of concrete (2003 Boumerdes earthquake)

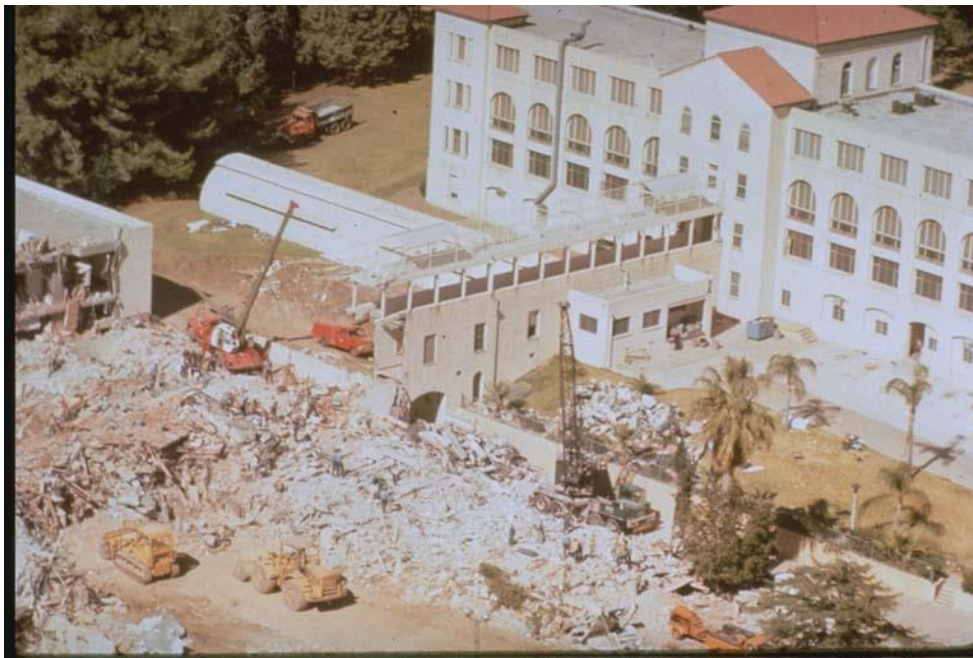
Figure 52. Example of non-ductile concrete frame building collapse at the Veterans Administration (VA) complex in the 1971 San Fernando earthquake.

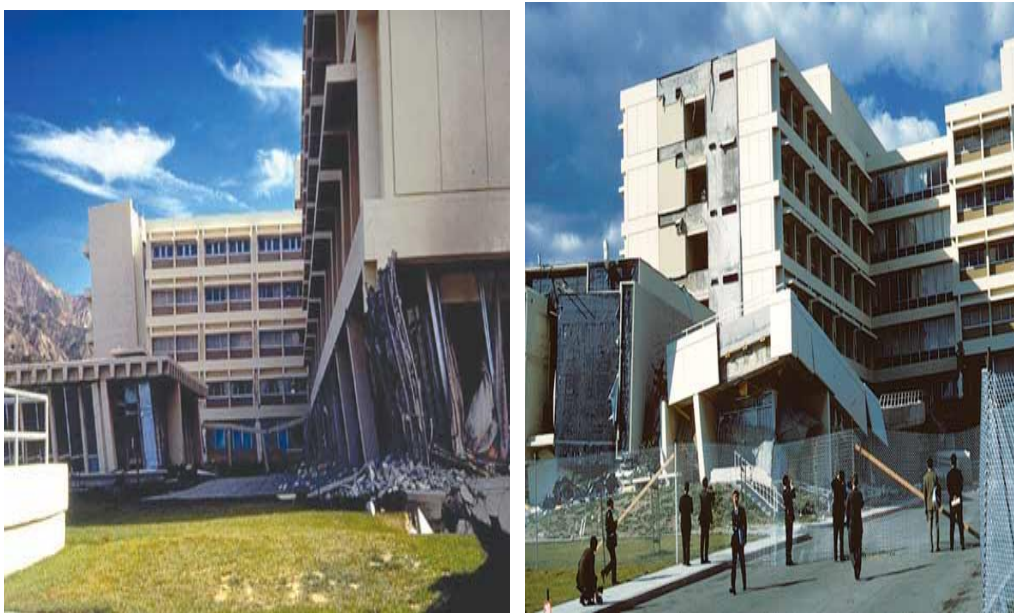
Fig 53. Damage and collapse of buildings of the Olive View Hospital and Sylmar hospital due to the 1971 San Fernando earthquake.

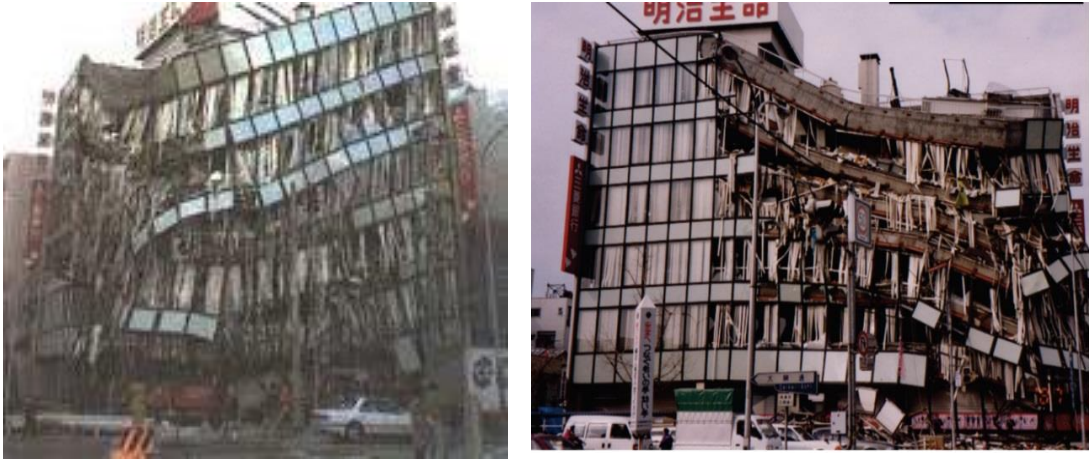
Fig 54. Partial collapse of a 6-story commercial building (Chou Ward) with a torsional irregularity.

The above building was a reinforced concrete structure with perimeter shear walls on two orthogonal sides of the building and gravity framing on the other two orthogonal sides of the building. The torsional irregularity caused the building to rotate during the earthquake. As the building rotated, large displacement of the gravity frames at the corner away from the stiffer walls exceeded frame capacity causing failure of columns and collapse or sagging of floors above.

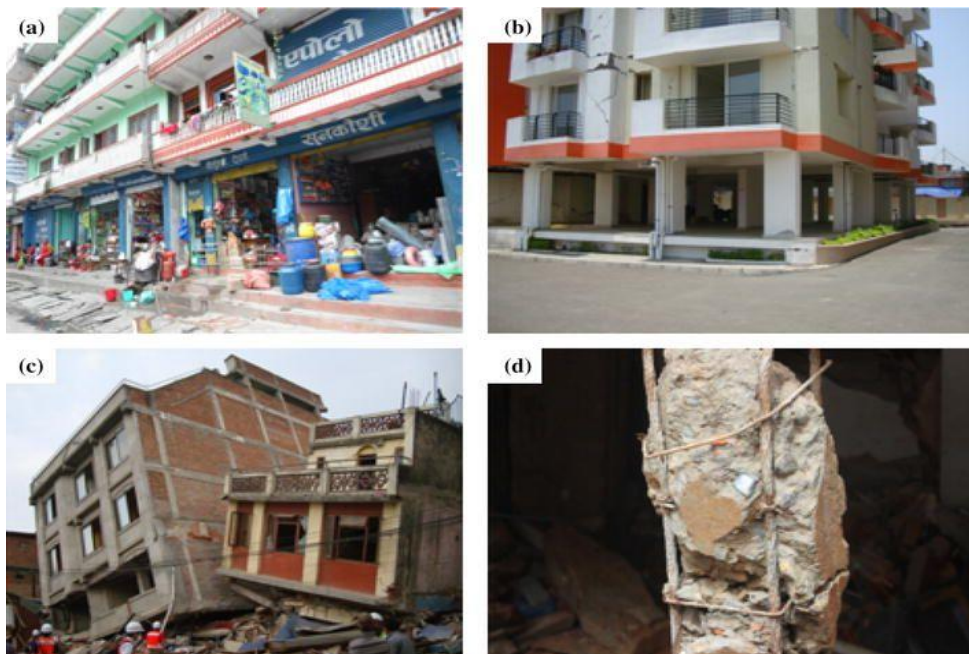
Figure 55. 2015 Gorkha earthquake

In Gorkha earthquake, 2015. (fig 55) such failures happened due to the:

- a. Ground floor of buildings without infill walls.
- b. Ground floor of an apartment building without infill wall.
- c. Soft storey and structural pounding failure.
- d. 16 mm diameter rebar but lack in quantity (only 4 and corroded) from a collapsed building in Kathmandu. ([link.springer.com](http://link.springer.com))

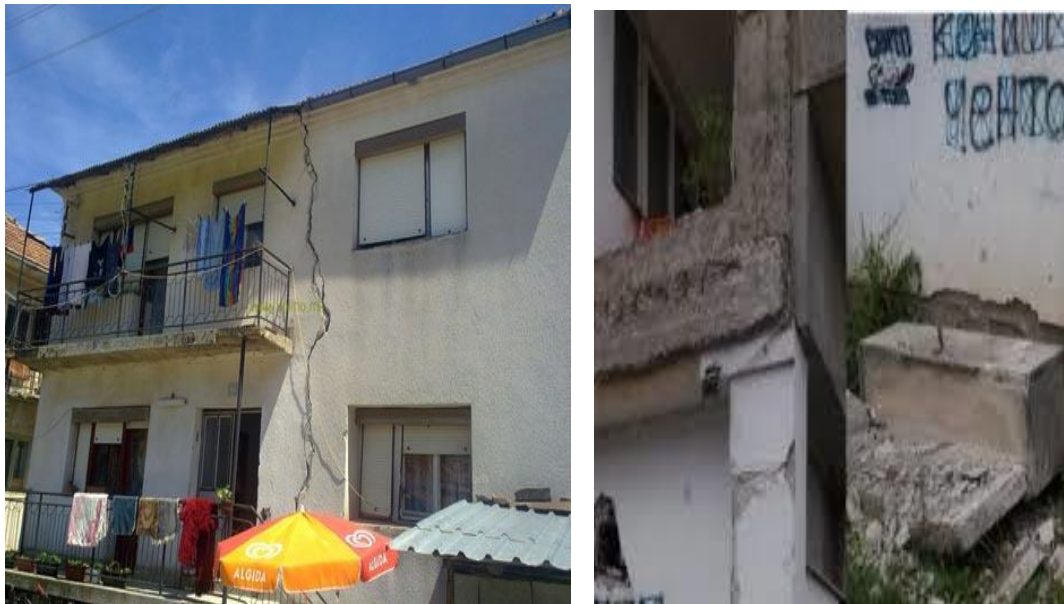
Fig 56. Building damages during an earthquake of 4.5 magnitude in Oher, 2012 due to non-ductility of structure and poor materials quality.

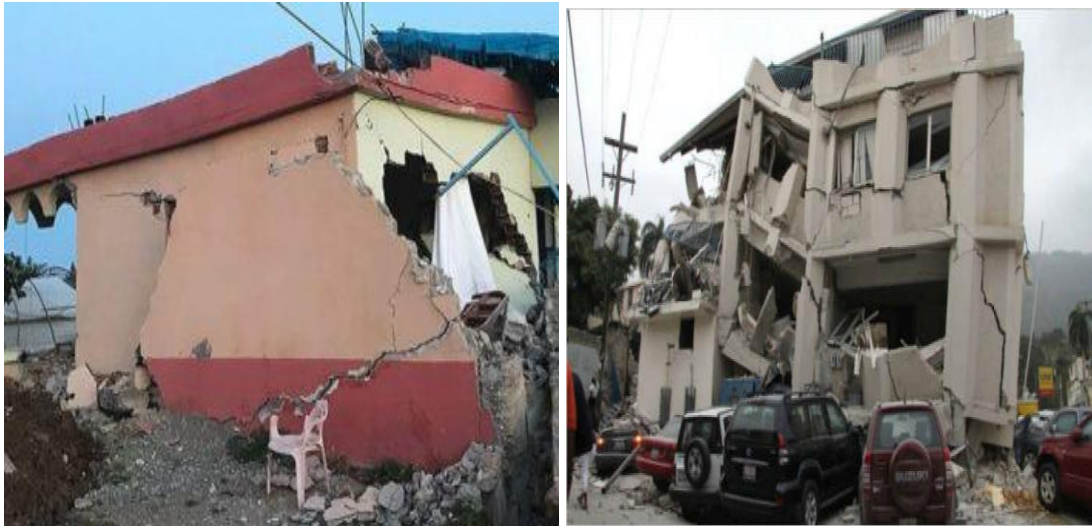
Fig 57. Building collapse due to an earthquake of 5.1 magnitude in Bulqize, 2018. Building are lack of shear walls and they also are constructed with no proper structural design.

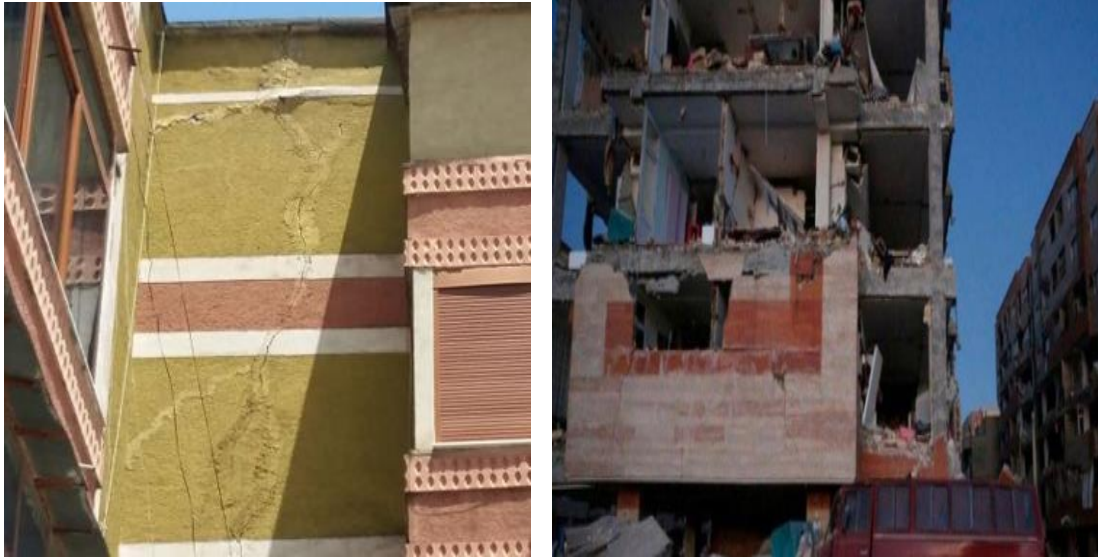
Fig 59. Albanian buildings damaged during earthquake disasters in Elbasan. Many buildings designed according to old designing codes, with no good reinforcement design for shear.

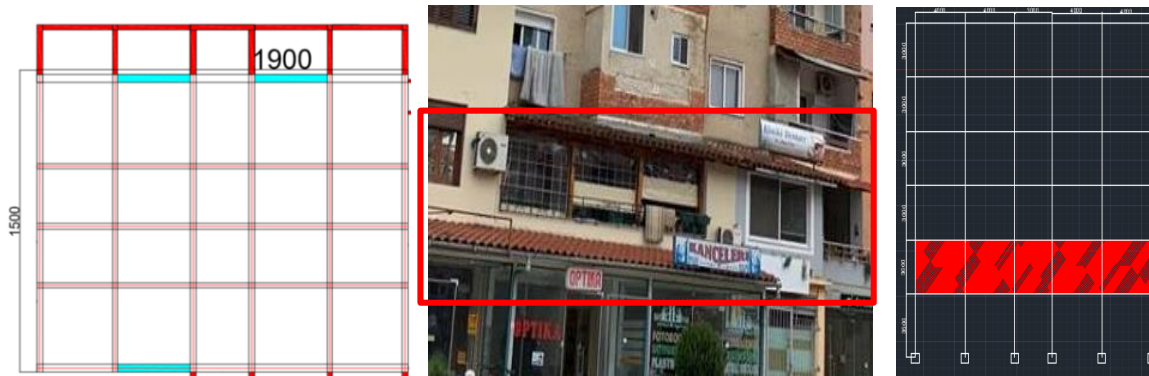
Apart from many structural irregularities due to poor construction quality and materials, many occupants of these buildings started to make additions in the existing structures. In our case, the second floor is subjected to many overhangs just in one side of building. They shift the mass center upwards and displace it from the centre of rigidity, being dangerous and negatively affecting the building under seismic load.

Fig 68. second floor overhangs due to human intervention by adding extra rooms.

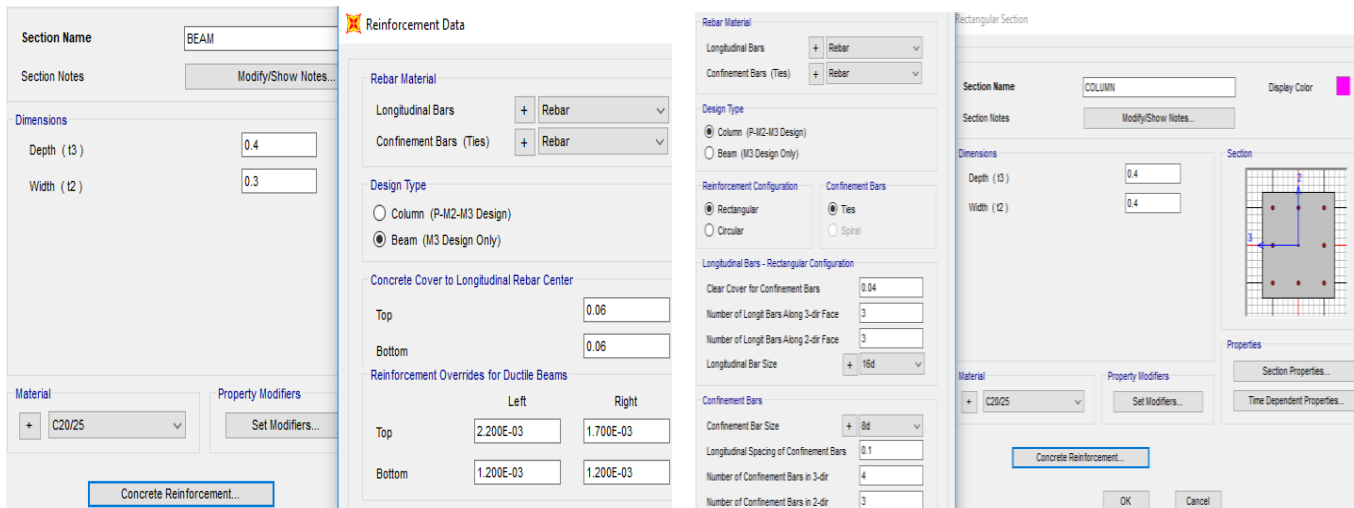
We input the typical columns and beams of structure with their respective parameters and design type, such as M3 design type for beams and P-M2-M3 design for columns.

Fig 71. Beam reinforcement data and column.
