REVIEW OF THE STRUCTURAL IRREGULARITIES ON  
ALBANIAN RC BUILDINGS WITH A CASE STUDY

A THESIS SUBMITTED TO  
THE FACULTY OF ARCHITECTURE AND ENGINEERING  
OF  
EPOKA UNIVERSITY

IN PARTIAL FULFILLMENT OF THE REQUIREMENTS  
FOR  
THE DEGREE OF MASTER OF SCIENCE  
IN  
CIVIL ENGINEERING

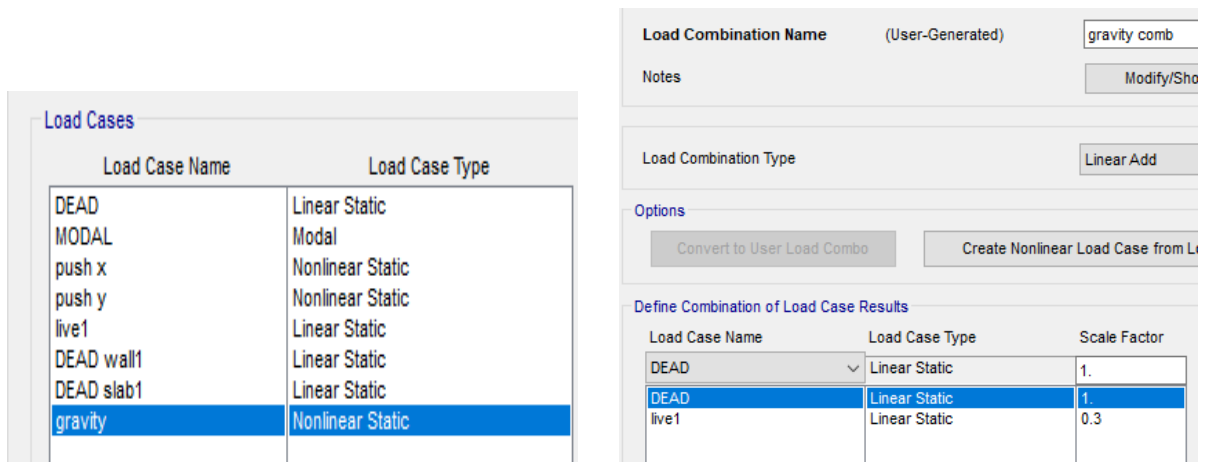
For easily applying in Sap modelling we define the gravity loads as: dead loads = 1 (dead wall, dead slab, dead) and live loads = 0.3. We also define all load cases to be considered in

our model approach, which will be shown in details. Load cases consist in linear static, non-linear static and modal.

Fig 72. Defining load cases and load combination.

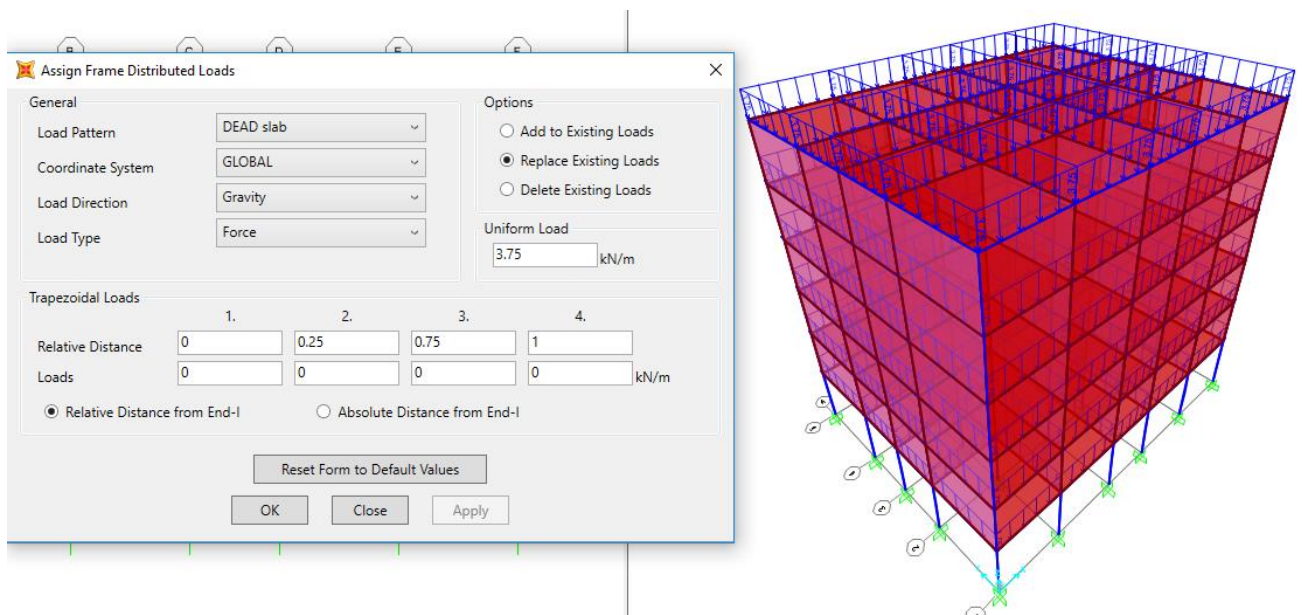
After selecting all structure's beams we also assign slab load distributed on Beams as dead slab distributed load.

Fig 73. Frame distributed load, dead slab = 3.75KN/m

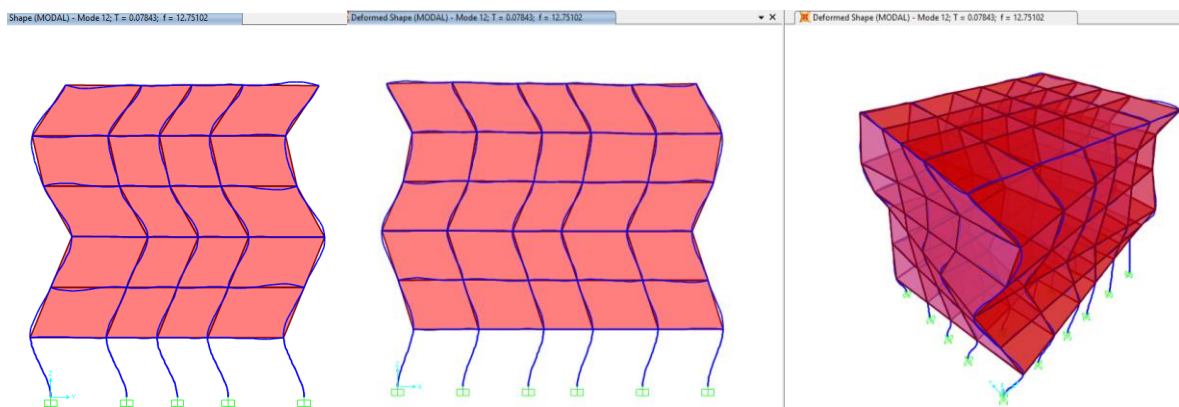
Fig 75. Deformed shape of ref building in modal analysis, step 12.

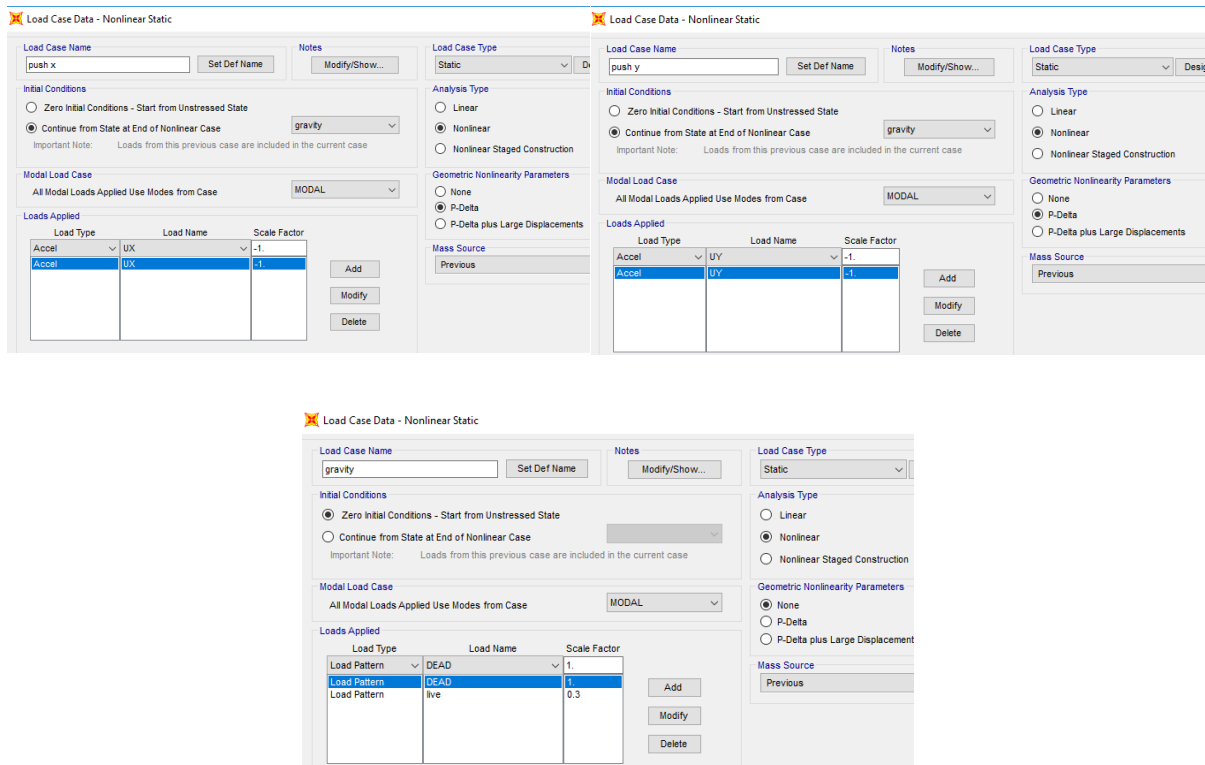
The defined load cases to perform non linear static analysis are represented below, consisting of Pushx, Pushy and Gravity.

Fig 77. Non-linear static load cases.

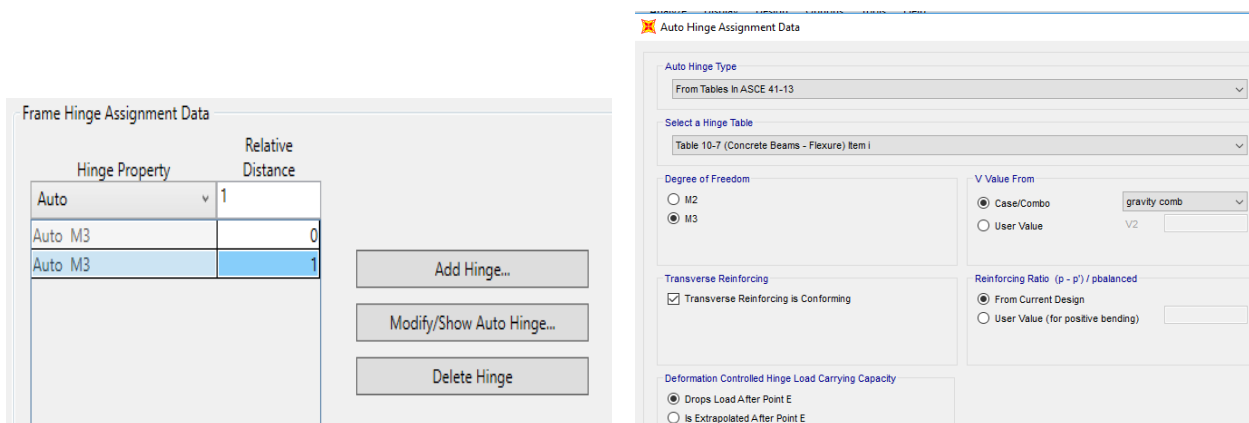
Sap 2000 gives default-hinge properties and recommend PMM hinges for columns and M3 hinges for beams as described in FEMA – 356. The flextural default hinges M3 were assigned to the beam at two ends. The interacting (P-M2-M3) frame hinges type, a coupled hinge property is also assigned for all columns at upper and lower ends .

Fig 78. Beam hinges assignment

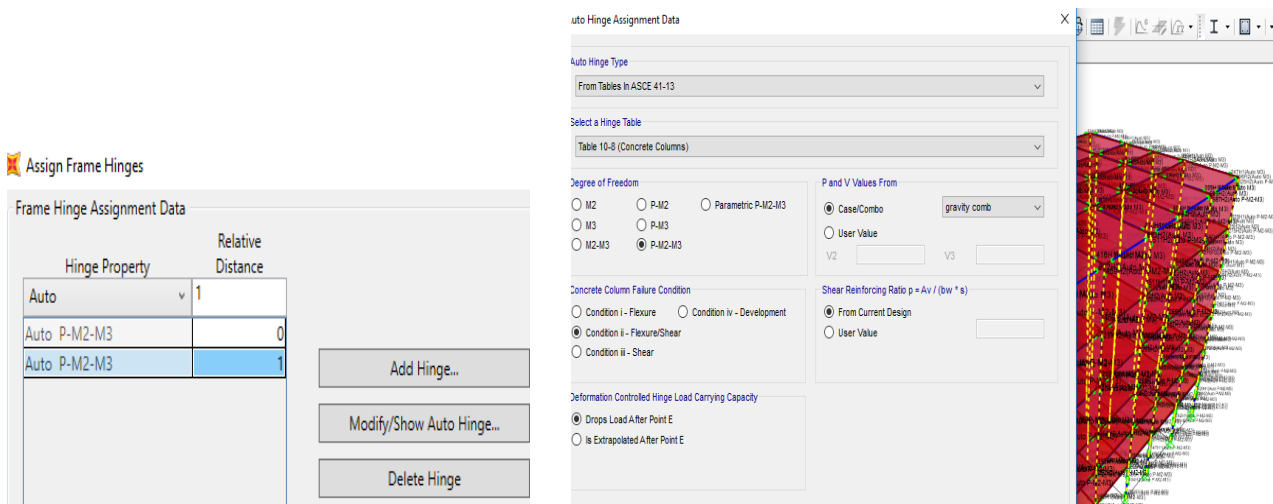
Fig 79. Column hinges assignment.

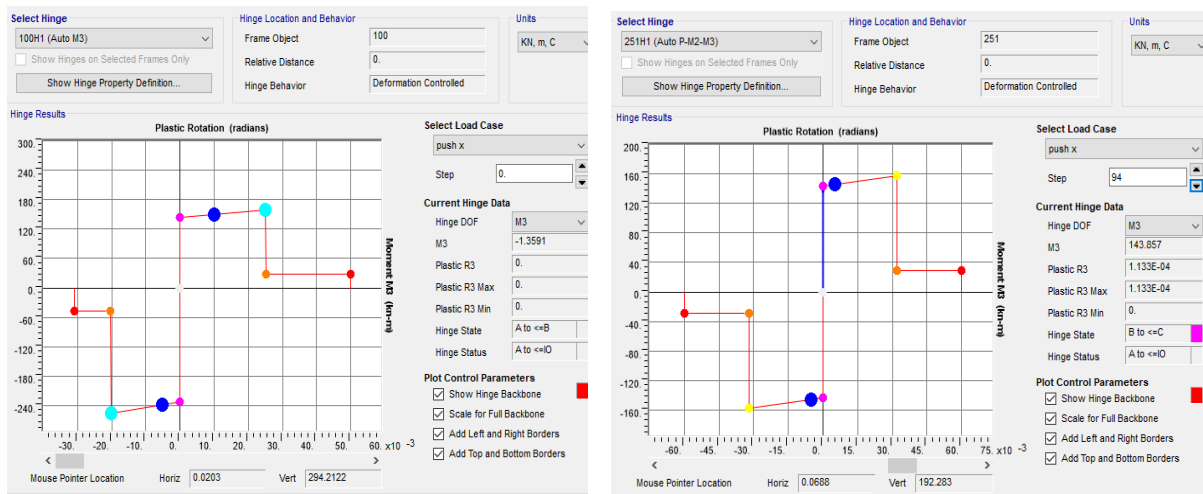
Fig 83. Hinges result for beam and column in pushX.

The results for formation of plastic hinge and stage of hinge at different levels of building performance are given through pushover analysis. The data gives information about the weak element in the structure. For getting a clear understanding about the formation of hinges at each step of displacement, higher value of multiple steps is selected.

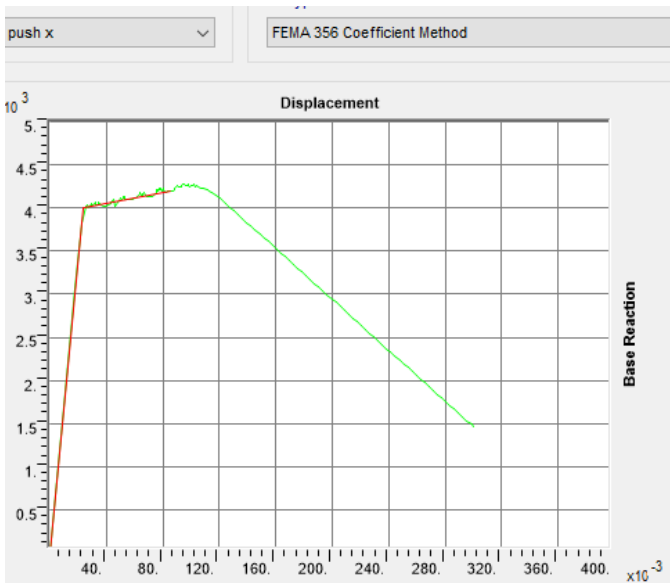
Target Displacement (V, D)	( 4196.242 , 0.086 )
----------------------------	----------------------

Fig 88. Displayed curve for FEMA – 356 coefficient method. Push X

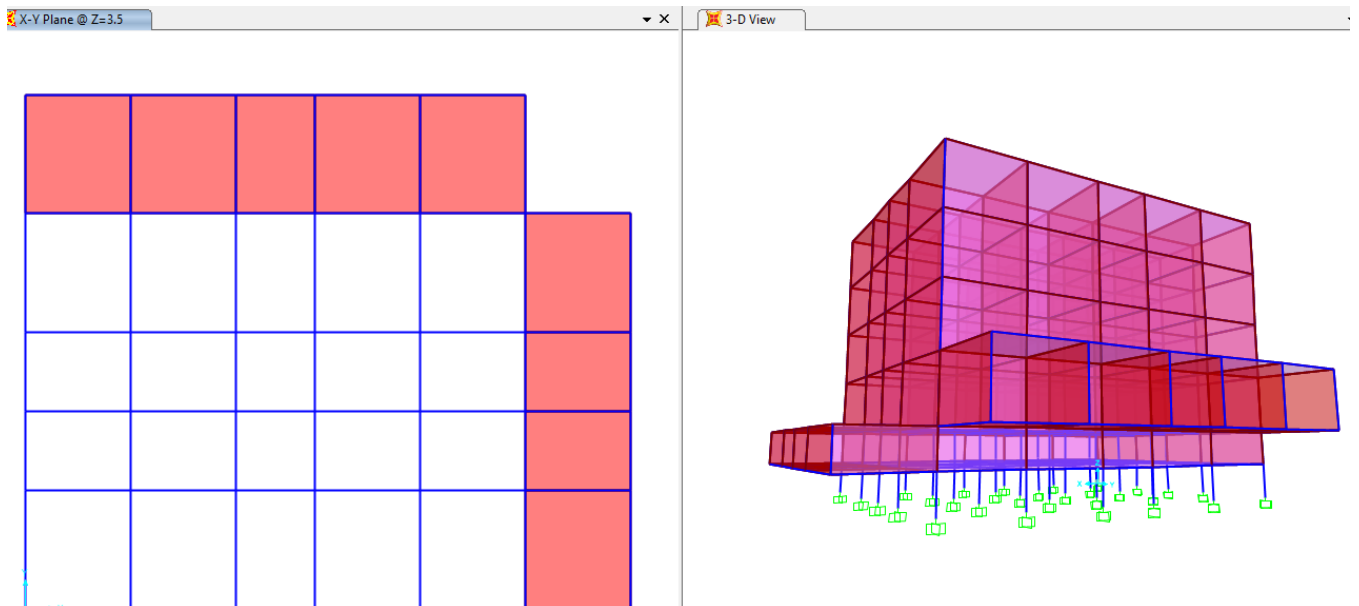
**SOFT STORY DUE TO ABSENCE OF MASONRY INFILL WALL AT GROUND STORY AND TWO SIDED OVERHANG**

Fig 104. Undeformed shape of plan and 3D SSWTSO case model

The worst case observed is that of presence of soft story due to height irregularity, open ground story with absence of masonry partition walls and two sided overhanged (SSWTSO).

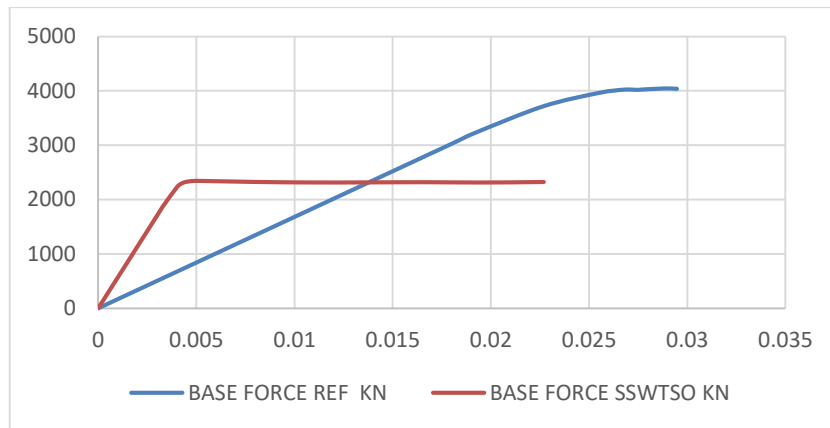
Fig 108. Fema 356 capacity curve for reference case vs sswtso, in push y load.

Comparing reference frame and the case of Soft story due to irregularity in height – absence of masonry infill walls and even more, two sided overhanged, results that reference frame shows better ductility, while SSWTSO performs earlier yield deformability. Currently: Reference case 2.9% and SSWTSO 2.2%
