Compatibility issues regarding mortars for repairs and additions in interventions on historic masonry

Andreica Ligia¹, Berindean C. Alexandra¹

¹*Department of Civil Constructions and Management, Technical University of Cluj-Napoca, Romania*

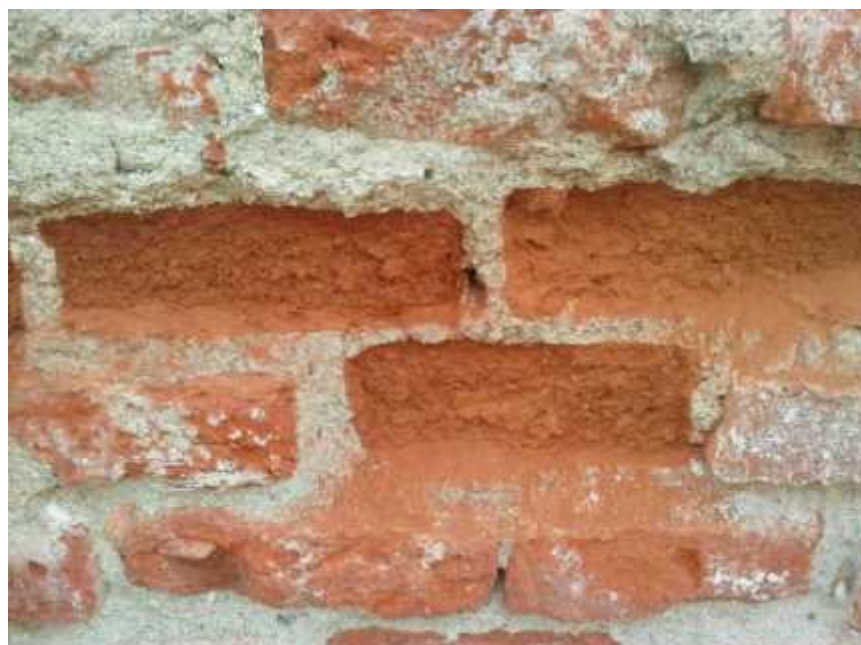
1. Compatibility issues: higher mechanical strength and impermeability in cement-based mortar: Romania, Cluj-Napoca, Str. Fortaretei. Foto (c) Ligia Andreica

In the absence of specific legislation, as is the case in Romania, normal values for mechanical resistance of mortar for masonry and values compatible with that of the historical masonry units may differ. Also, the hypothesis that lime -based mortars, hydraulic lime and cement mechanical resistance increases with age must be taken into account. After Ashurst [59] among the objections to the use of hydraulic limes, natural cements and Portland cement we find (1) high mechanical resistance, (2) impermeability and (3) the risk of salt transfer towards sensitive masonry materials.

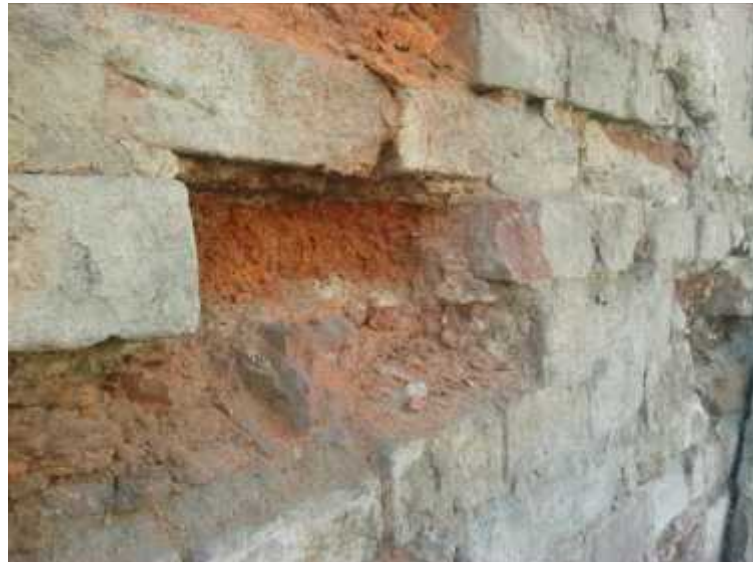
2. Compatibility issues: Romania, Cluj-Napoca, Str. I.C.Bratianu (Foto: Ligia Andreica)

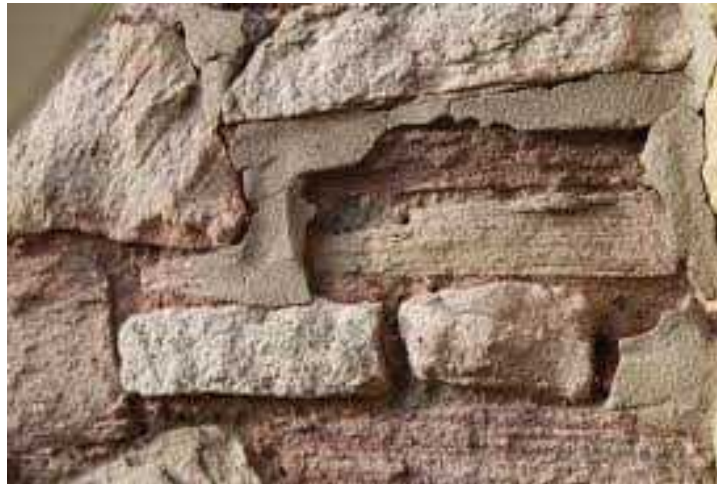
3. Compatibility issues: cement-based pointing causing stone exfoliation:
<http://heritagehouse.twoclicks.co.uk/pages/damp-and-condensation/damp-problems-caused-by-cement-pointing-of-brick-or-stone.html>

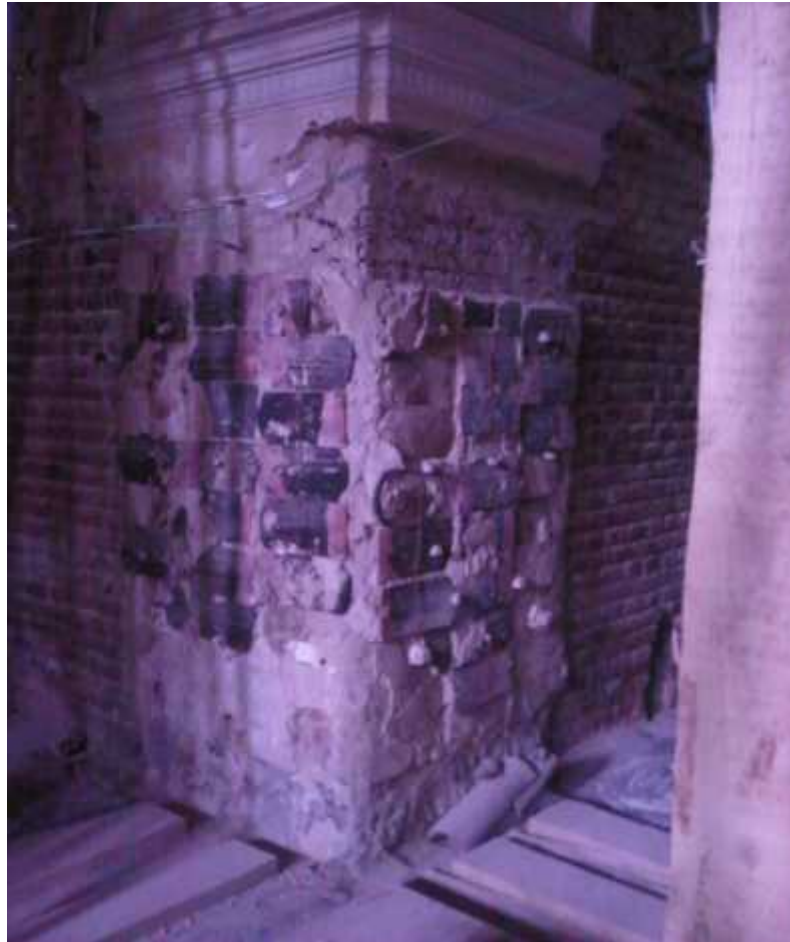
4. Historical waterproofing – with roof tiles –Károlyi Castle, Carei, Romania. (Foto Ligia Andreica)

For each intervention, compatibility properties and criteria differ to some extent. For example, in certain cases, historical coatings may have been employed for waterproofing. (Example – the historic "waterproofing" at Károlyi Castle in Carei, Romania). In these cases, the documentary value of the historical intervention must also be assessed and considered.

properly protected with biocides, for example. On the other hand, in the case cited above, at the Károlyi castle from Carei historical vertical waterproofing, dating from the nineteenth century, proved ineffective and can be removed, as far as interest in the history of past interventions does not require that the least a part or a segment of it to be kept. Documenting the intervention (with photos and descriptions) remains, in any case, of significant interest for the history of the building technologies.

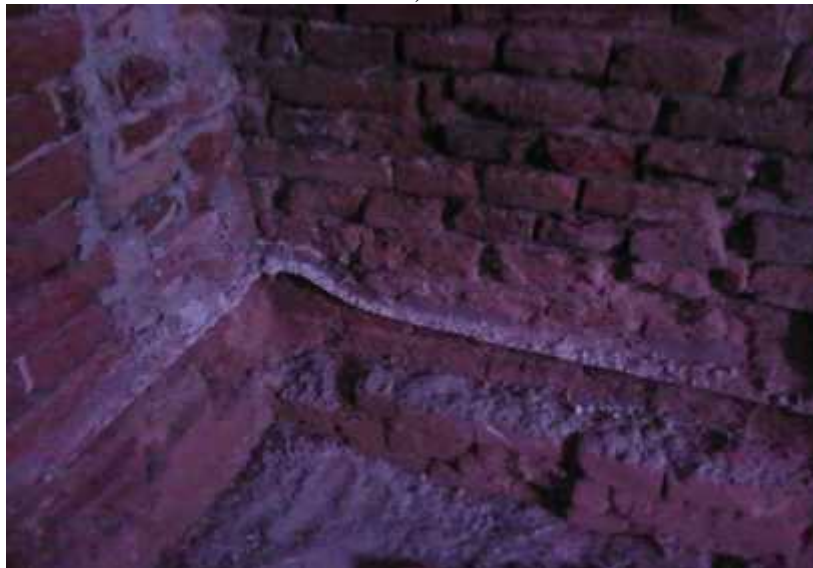
5. Contemporary waterproofing –Károlyi Castle, Carei, Romania. (Foto Ligia Andreica)
